ROCHESTER CATHEDRAL: THE WEST FRONT
REPORT ON THE CONSERVATION OF THE 12th CENTURY STONEMWORK OF THE WEST FRONT

Nicholas Durnan
Broadacres
Old Way
Ilton
Ilminster
Somerset TA19 9EA

25th November 1991

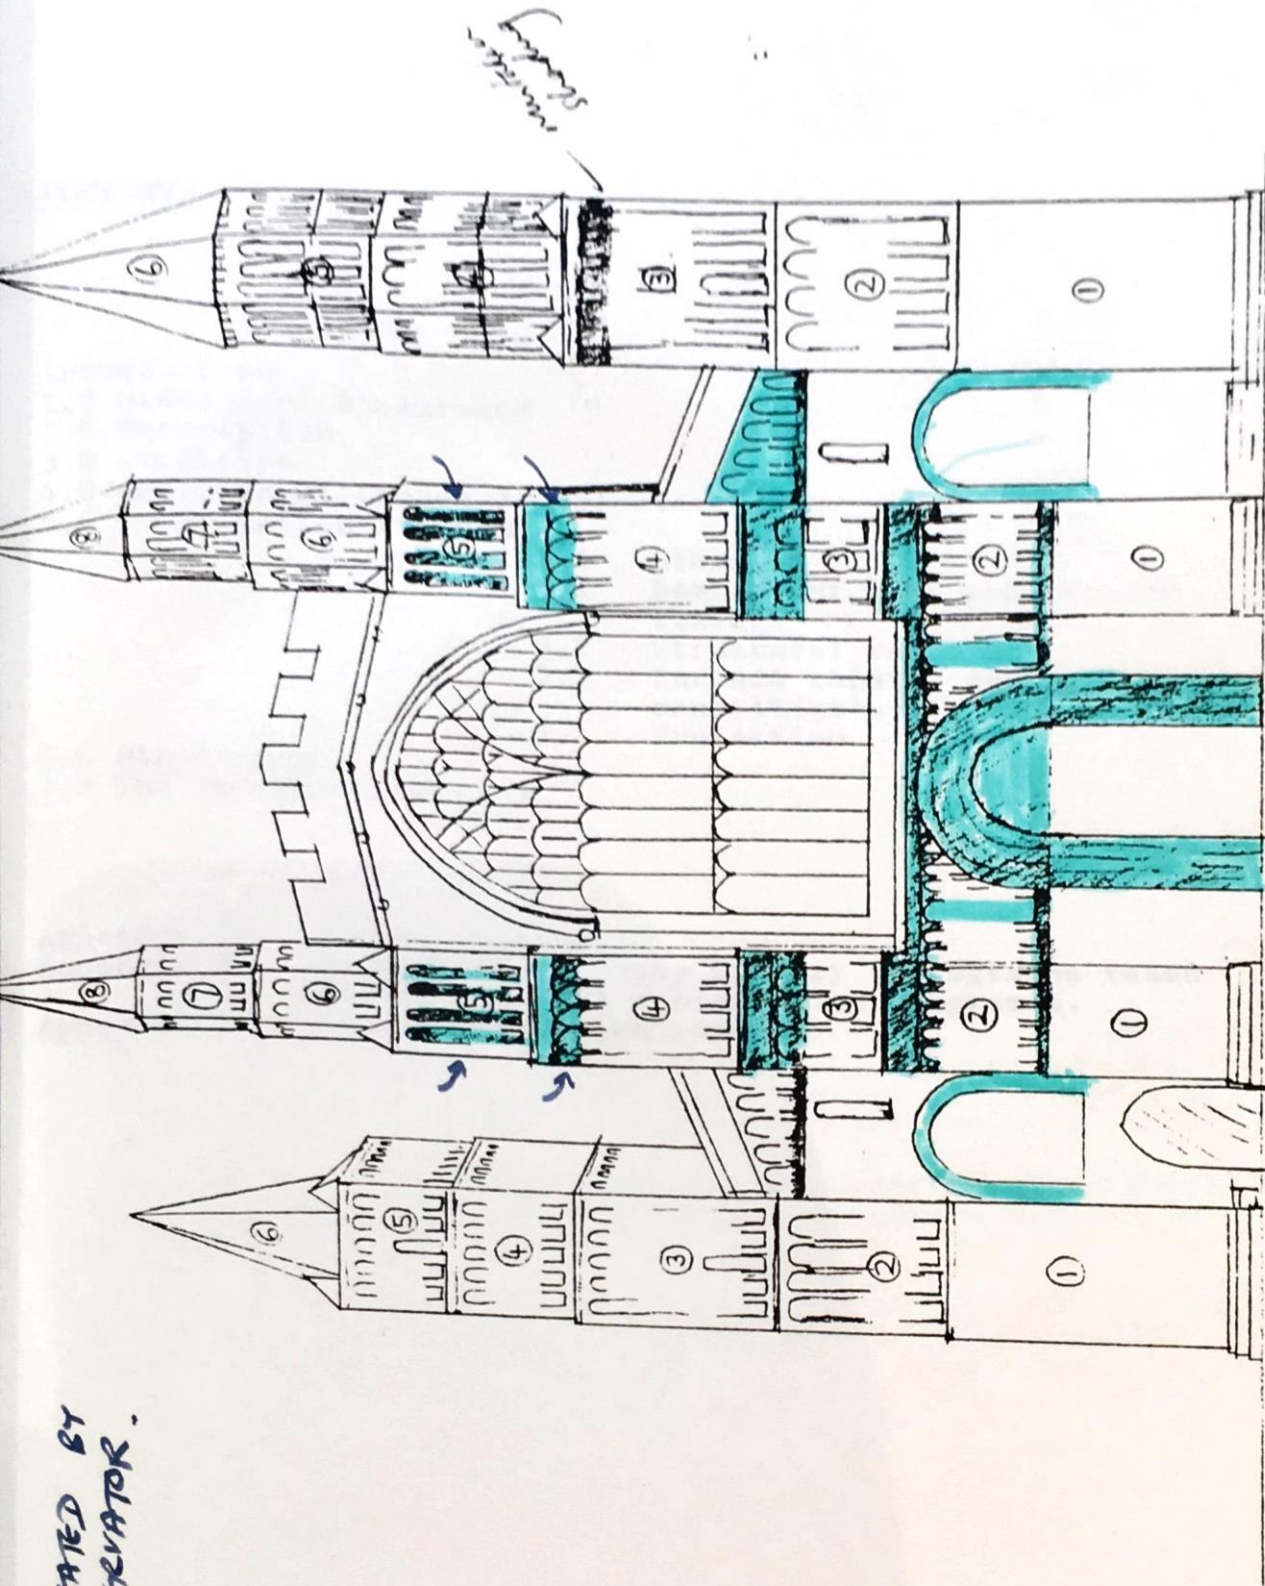
ROCHESTER CATHEDRAL:
WEST FRONT ZONES.

- AREA TREATED BY THE CONSERVATOR.

For the purposes of the contract the west front was divided horizontally into zones (1-8) and vertically into turrets (1-4), aisles (N & S) and nave area (see illustration 1).

Apart from the west door, virtually all the surviving 12th century work is contained within zones 1-5 on turrets 2 & 3 and nave areas. Most of the N & S aisle areas are also predominantly mid 12th century stonework. The conservator's work was confined to the carved and ornamented areas (see shaded areas of illustration 1) as follows:

Cleaning is known to have been carried out in 1967 and a post 1967 photograph shows that the areas cleaned were the west door and zones 1, 2 & 3 of the nave and turrets 2 & 3. (see Illustration 1). This is consistent with the scoured/scratched surfaces found in parts of these areas.
