**ROCHESTER CATHEDRAL, MEDWAY, KENT
NGR TQ 742 684**

**REPORT OF ARCHAEOLOGICAL SURVEY AND
WATCHING BRIEF IN ASSOCIATION WITH
CONSERVATION WORK ON THE SOUTH TRANSEPT
AND LADY CHAPEL, 2007-8**

Text by Graham D Keevill
Keevill Heritage Consultancy
For the Dean and Chapter of Rochester
March 2009

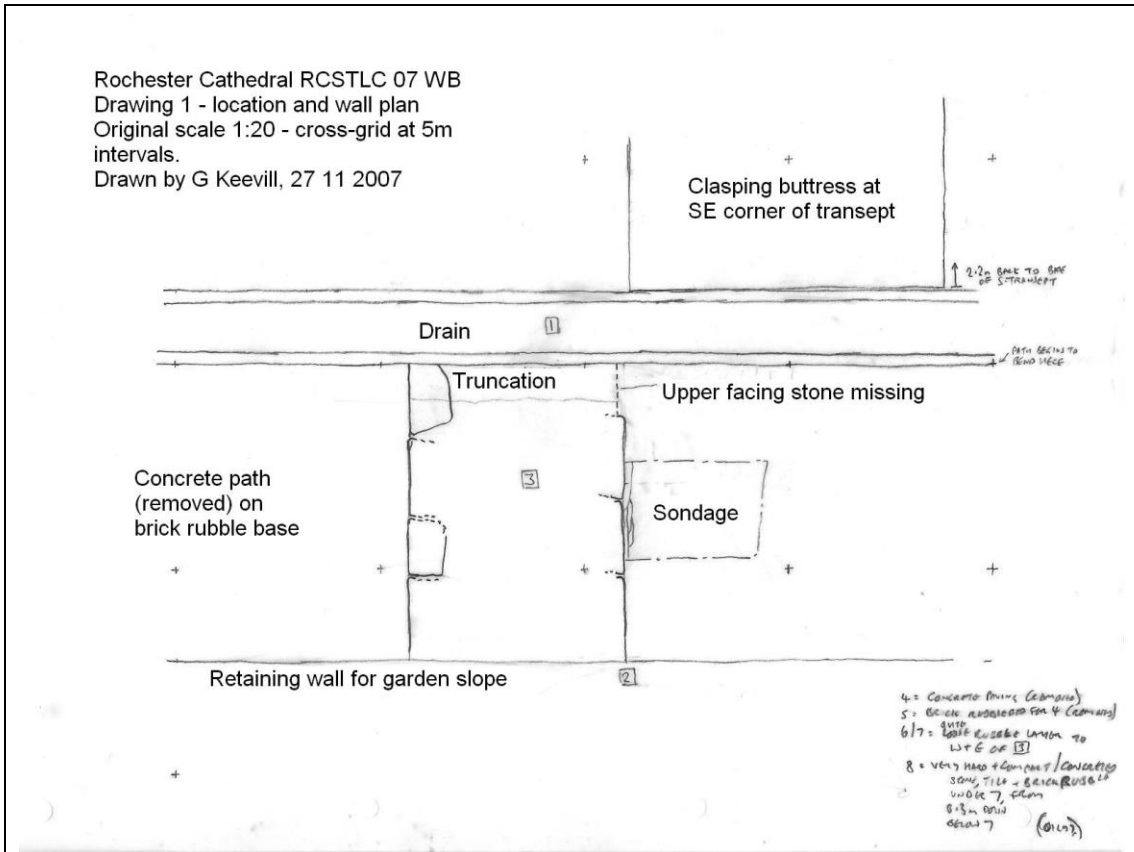
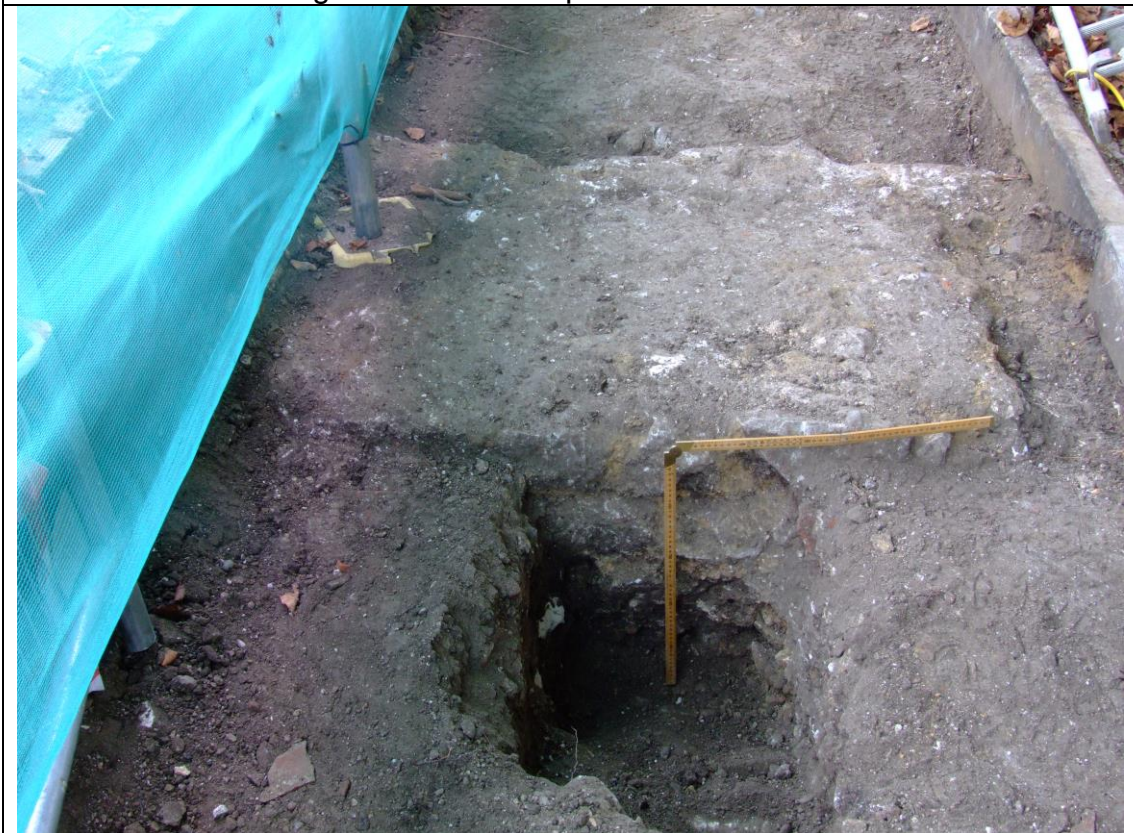
The concrete footpath (4) and its compact brick rubble base (5) were removed as part of the process, but the brick drain (1) and the retaining wall (2) on the north and south sides respectively were retained. These are of no importance except that the path sealed the archaeology below. The brick rubble rested directly on fairly loose rubble in a dark brown silty soil matrix. This was recorded as layer 6 to the west, and layer 7 to the east, of the most significant feature uncovered. This was a stone wall or foundation (3) running at a right-angle across the pathway. The surviving upper surface lay directly beneath the brick rubble base (4). The wall was immediately adjacent to the west face of the southern clasping buttress on the south-east corner of the transept. The masonry was 1.05m wide, and with a rubble core and facing stones of Kentish rag. One of these was missing on the east face where a shallow area had been truncated (cut away) by the construction of the brick drain. Otherwise the remaining part of the wall was in good condition. A 0.5m-wide and 0.7m-long sondage was dug down the east face of the wall to a maximum depth of 0.5m. The masonry appeared to be laid in courses, and continued beyond the base of the sondage.

Plan (above) and photograph (below) of wall 3 viewed from the east showing the excavated sondage. 1m scale in equal 0.5m halves.

The loose rubble (7) was present for the first 0.3m of the excavated sondage. It sealed a very hard and compacted layer of stone, tile and brick rubble (8), which had a distinctive 'oily' appearance and aroma. This layer continued to beneath the maximum excavated depth and was visible in all faces of the sondage.

Masonry structure 3 was clearly medieval in character, and the exposed part would appear to represent a standing wall rather than a foundation. The top facing stones and the courses exposed in the (albeit limited) sondage were carefully laid and well built, in a fashion not to be expected in foundations. The wall was in precisely the position anticipated for the outer (west) wall of the Cellarer's Lodging or Range on St John Hope's plan of the cathedral (see page 3). There is no obvious reason to doubt that wall does indeed belong to the Cellarer's Range. The latter survived the Dissolution of the Monasteries, and indeed is shown in a remarkable sketch of 1801 (see following page). Sadly the building was demolished c 1805, at which point a Prebendal House was built in the south-west corner of the cloister. The compacted rubble (8) found against the east face of the wall in the sondage can be interpreted as demolition rubble dating from around 1805. The subsequent layers (6 and 7) are likely to date from the re-landscaping of the cloister and adjacent areas in the mid-late 1930s.
