THE PERRY LITHGOW PARTNERSHIP

● CONSERVATORS

22nd April 1988

ROCHESTER CATHEDRAL

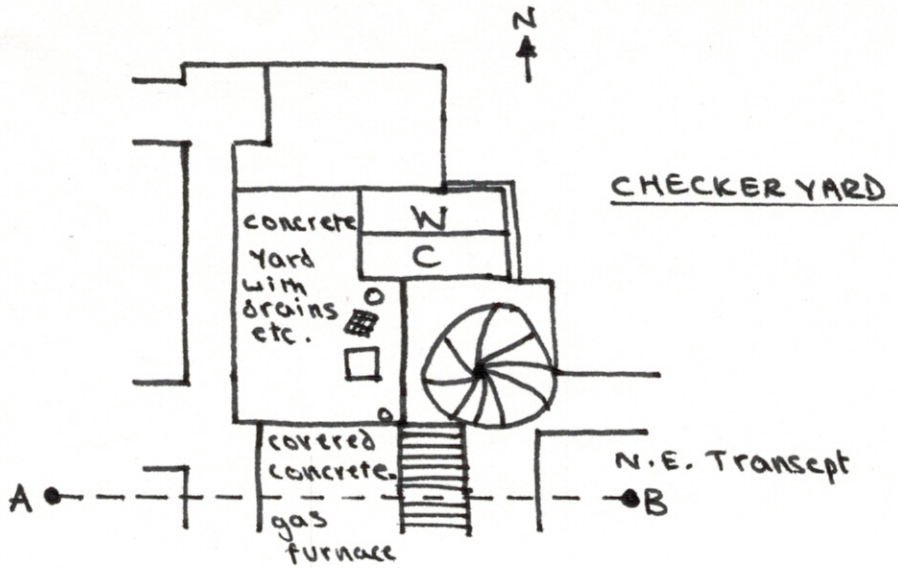
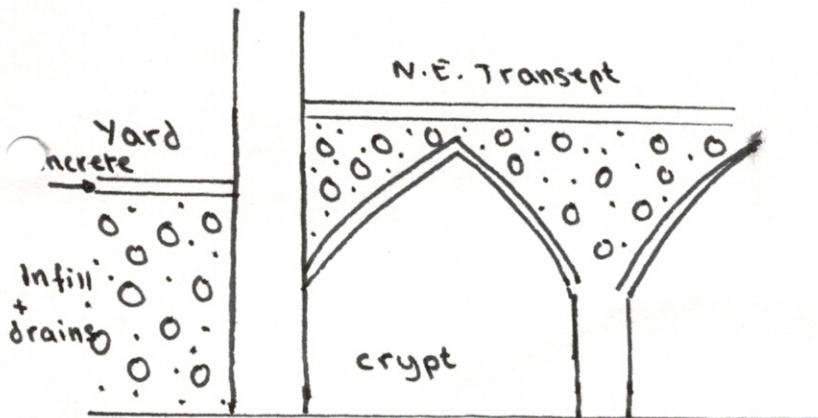
PLAN 2

- a) Past incursions of moisture. There appear to have been several alterations to the areas above and to the west of of the northwest wall, immediately adjoining this bay. These include the blocking of windows and subsequent infilling of that area and the creation of a concrete floored yard with w.c.'s. (See detail plan2). The drains in this area are constantly blocking with pigeon refuse, and, as the walls are so high, any moisture that builds up takes a long time to disperse.

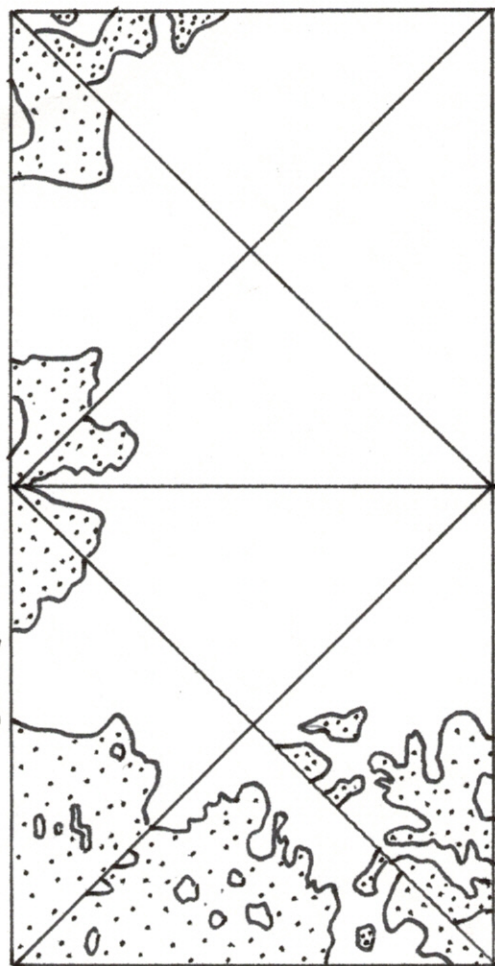
PLAN 3

It was in bay 40 that the most vulnerable areas of painting were located, with three of the four sections either partially or, as in section C, almost totally lost through detachment. The reasons for this extensive damage are many fold:

- c) Constant changes in temperature and humidity have caused movement of these salts, resulting in the breakdown of both the support and the surface, causing detachment, efflorescence and blistering. It is interesting to note that the worst areas of damage in these two bays are directly related to the position of the north door and window, which would create dramatic temperature changes. (See plan 3).

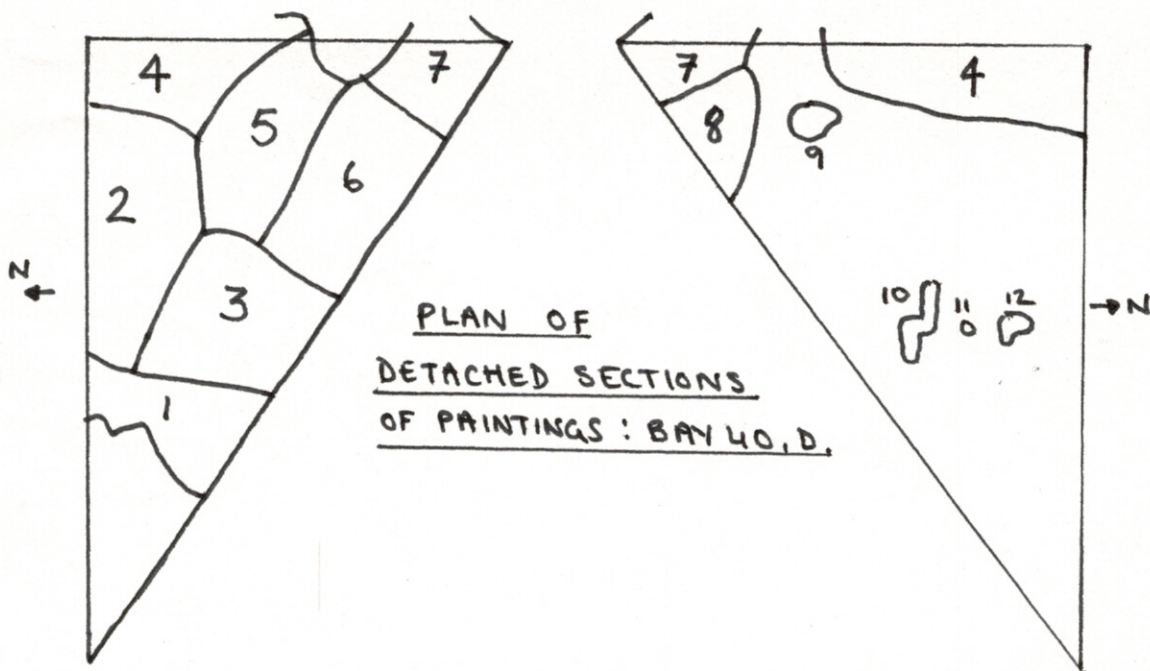
PLAN 4

This section was in a terribly precarious state, areas hanging free of their supporting plaster, blisters, etc., and was clearly in need of detachment and transfer.

- ii) When dry the coating was keyed up to marks on the stone and the painting, plus facing, was cut down in sections, (see plan 4), the size and shape of each being dictated by both manageability and suitability of cut positions.
