Plates 1 & 2 : Bay 13 Spandrel, west wall
Overall views before (above left) and after (above right) consolidation treatments.

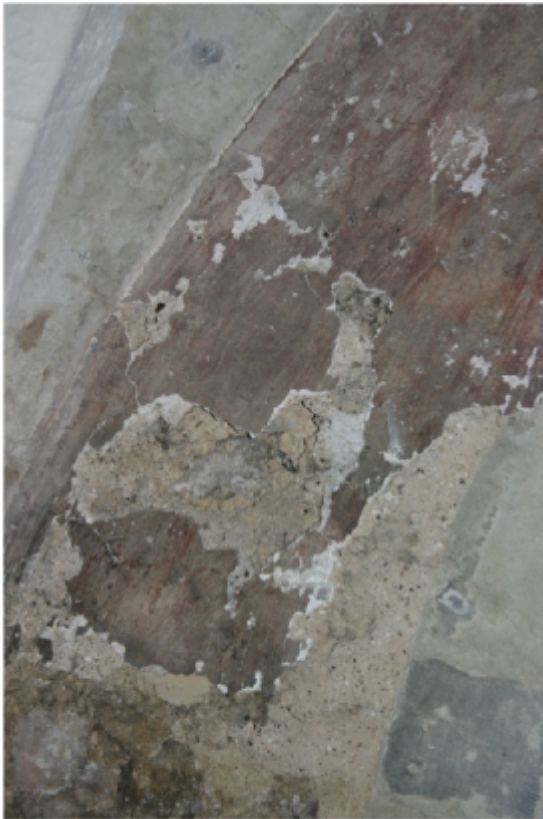
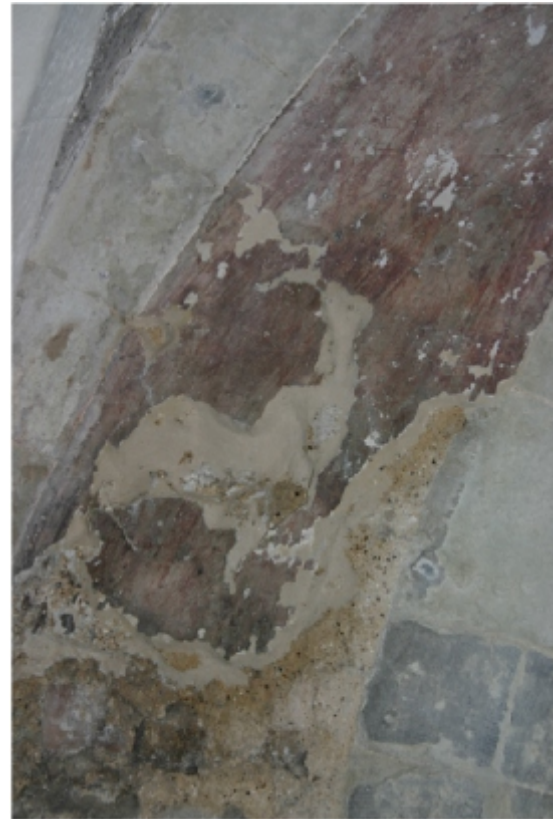
Plates 3&4: Details before (above left) and after (above right) treatment. A plaster bridge was built up consolidate vulnerable edges prior to injection grouting.

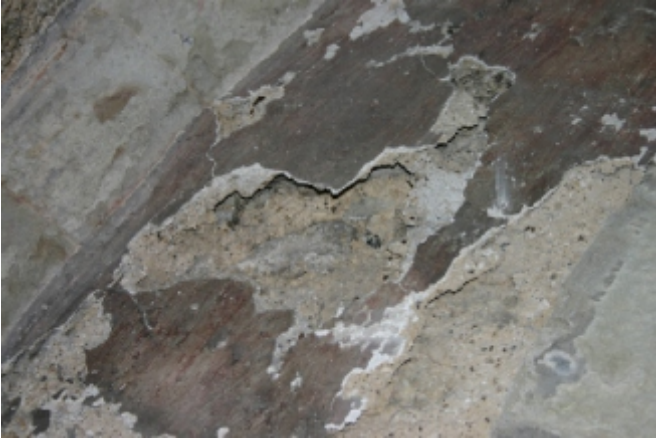
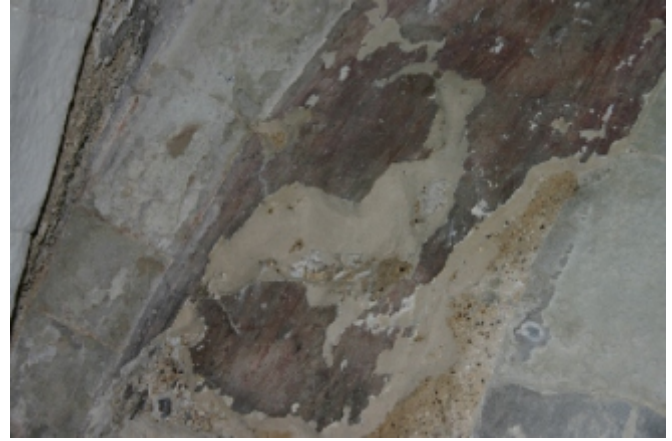
Plates 5&6: Details of the lower central area, showing the severely delaminated section of painted plaster before (above left) and after (above right) treatment.

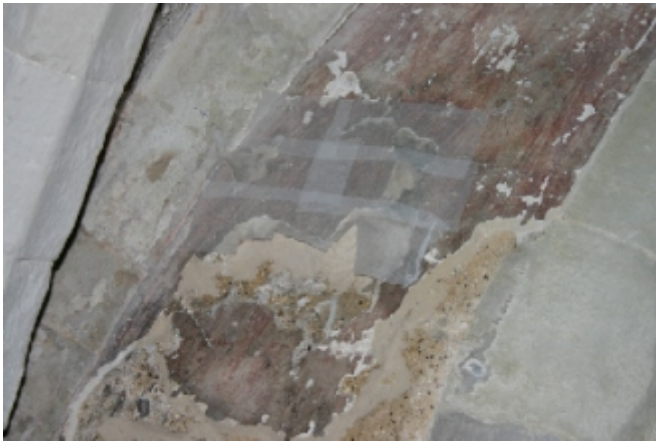
Plate 7: Detail (left) after the application of a facing to support the fragile plaster during the grouting and repair process.

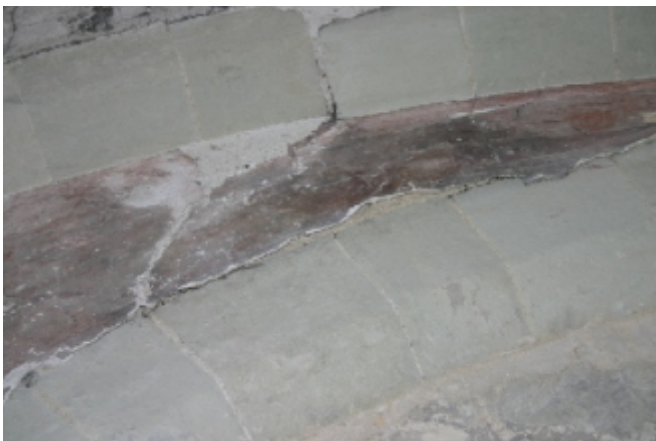
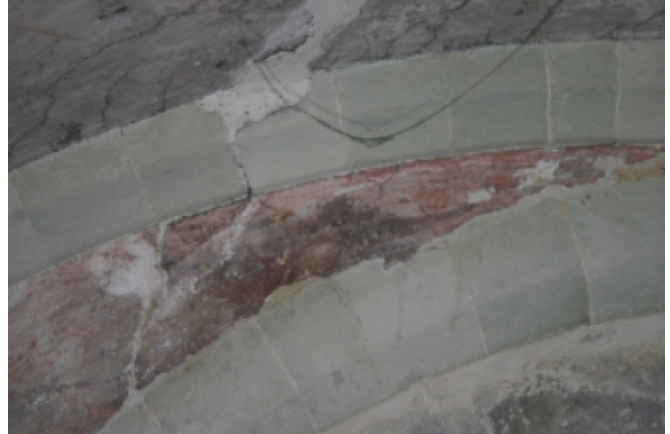
Plates 8&9: Details of the upper area of the spandrel, before (above left) and after (above right) treatment. Plaster fillet repairs were applied to delaminating edges and a grout injected into voids in the area to the right of the vertical crack. The large piece of white, later inappropriate repair plaster was removed, to reveal the original painted surface.
