Rochester Cathedral Crypt
Medieval Paintings and Plasters - Conservation Project

Condition Review Following Water Ingress

Richard Lithgow
 July 2016

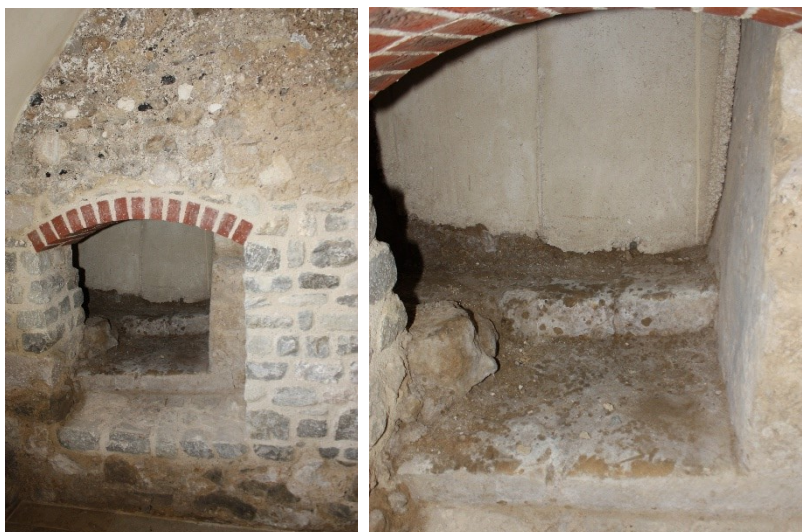
One finding of particular note was that recently discovered Norman Steps - an opening within the west wall of vault Bay 50 - were moisture laden and covered by a film of salt efflorescence: as was the face of the south wall within the opening. It is uncertain whether this is a consequence of the recent flood or a chronic moisture issue so recommend this be investigated.

Fig 2. (right) The Norman Steps.

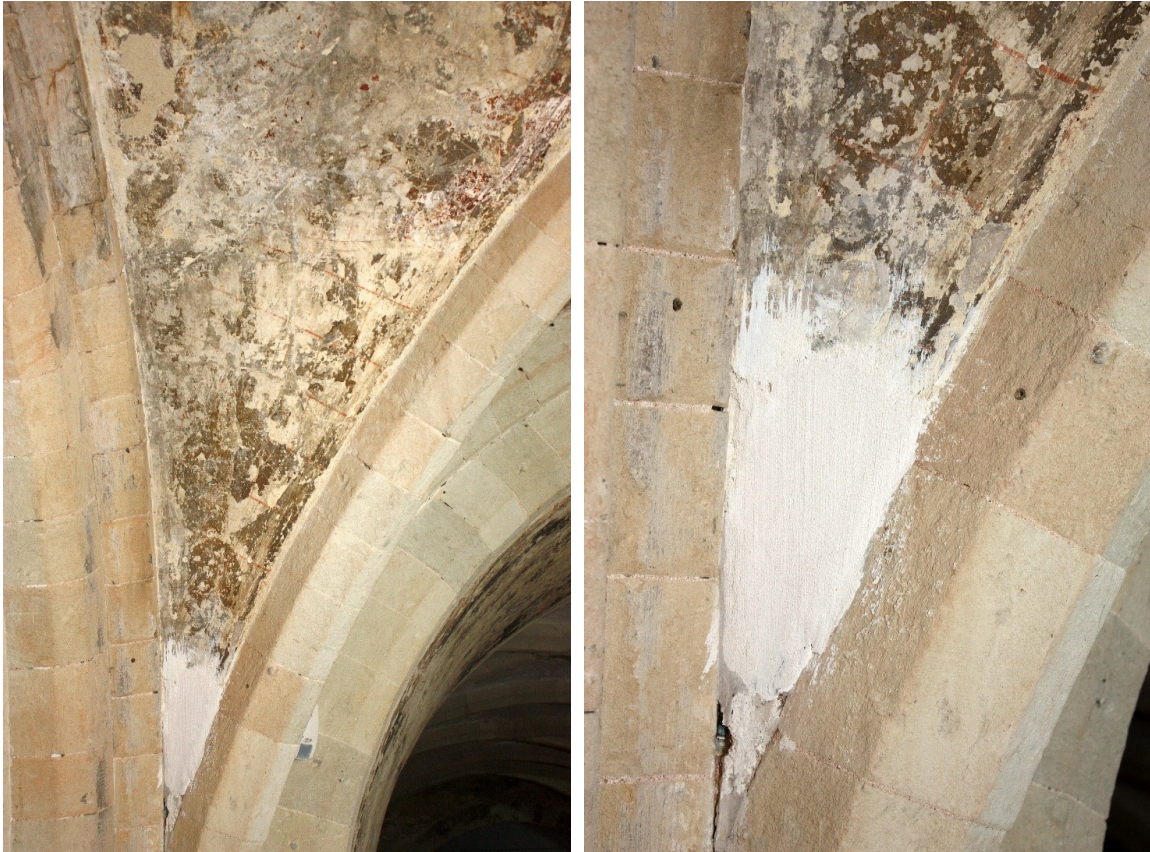
Fig 3. (above) An inappropriate plaster repair to Bay18b² inserted during the recent Crypt renovation works should be replaced and toned in to match other repair plaster in this vault.

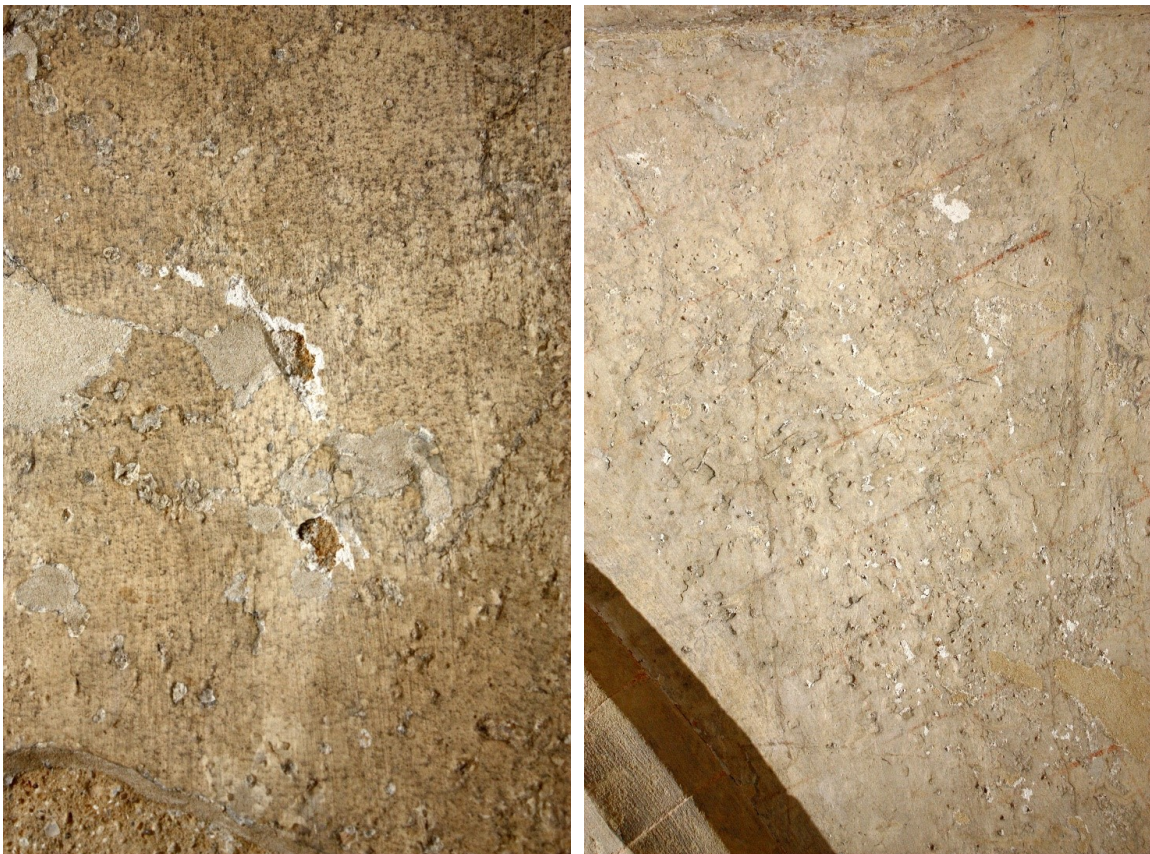
Fig 4. (above) Instances of recent indents, loss and scrapes to the plaster and ground of Area J and Bay 2a¹.

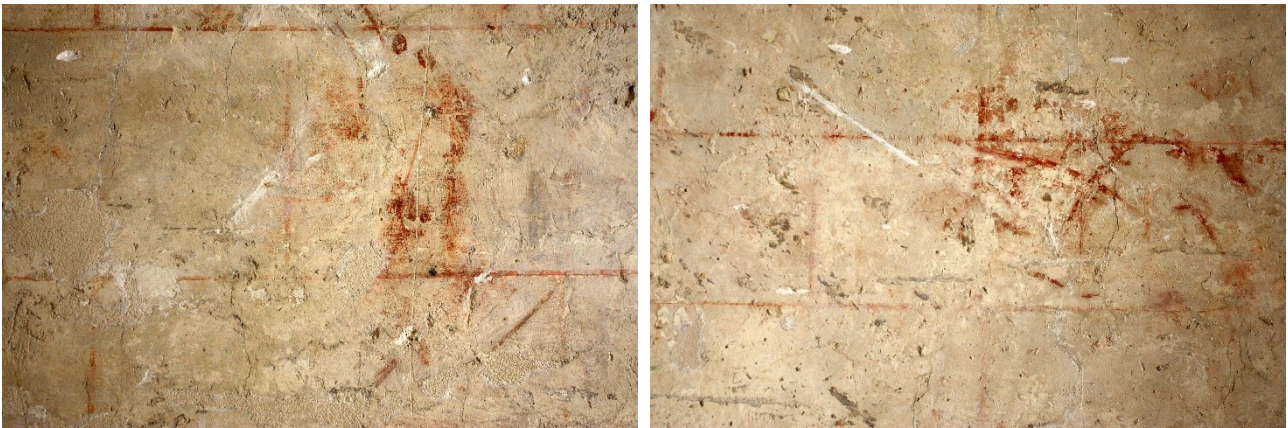
Fig 5. (above) . Area E arch soffit. Raking light details showing scrapes and indents: accidental impact damage which has occurred since the 2013 Phase 1 treatment works.

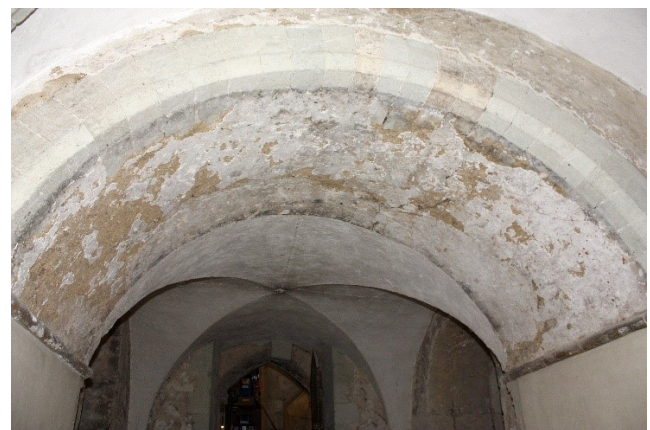
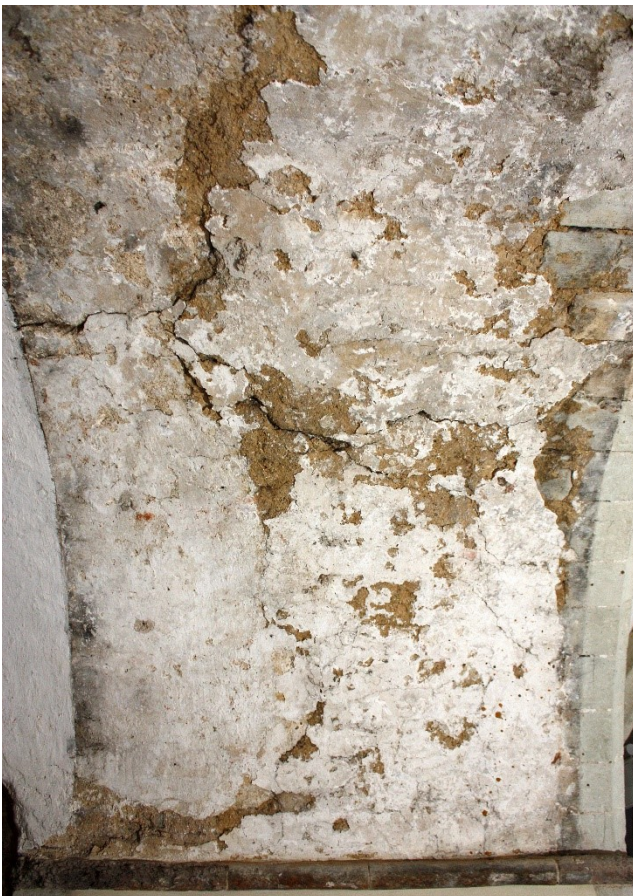
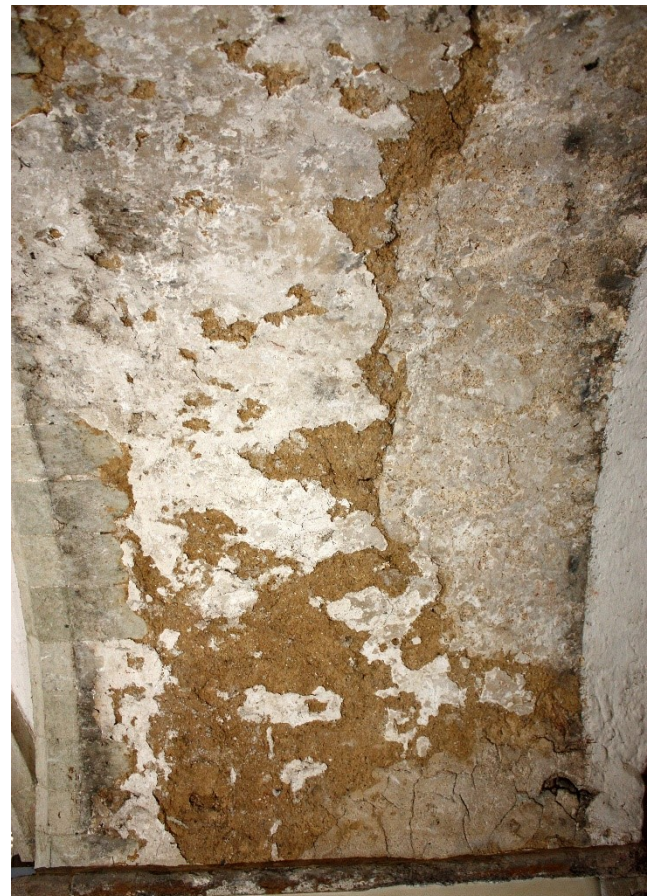
Area revealed since 2013 (not included in previous treatment proposals)			
49/35	Arch soffit		This area of original plaster, limewash ground and traces of painted decoration was revealed when the brickwork infill was removed from this archway. Condition: numerous areas of plaster loss, unstable plaster and limewash ground. Treatment: plaster stabilisation (1 man day); surface clean, paint and ground fixing (4 man days); plaster repairs (3 man days); limewash grounds (2 man days) = Total 10 man days. N.B. Additional access scaffolding required for this period.

Fig 6. (right and below) Soffit of the arch between vault Bays 49 and 35. This area of original plaster, limewash ground and traces of painted decoration was revealed when the brickwork infill was removed from this archway. Traces only remain of painted decoration on the limewash ground which itself has suffered considerable damage and loss: as has the surface plaster skim and the substrate plaster which in places is cracked, displaced and unstable.

Sub-total (repairs to recent damage)	3	1,150.00	1,150.00
Proposed treatment of Bay 49/35 arch soffit:			
Plaster stabilisation; surface clean, paint and ground fixing ; plaster repairs; limewash grounds	10	3,470.00	
Access scaffolding, conservation materials, documentation		500.00	
Sub-total (treatment of Bay 49/35 arch soffit)	10	3,970.00	3,970.00
TOTAL ALL WORKS			11,440.00
