The Roman Wall

Work is currently taking place in the grounds of the Cathedral to preserve a precious section of the wall that once surrounded and protected the Roman town of Durobrivae. This summer we are doing trial archaeological pits, thoroughly surveying the wall and carrying out emergency repairs.

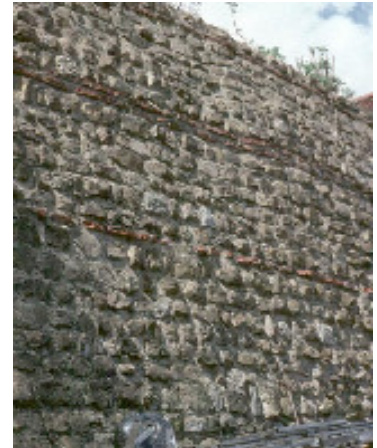
It was probably in the first half of the 3rd century AD that this current stone wall was built to replace earlier earthen defences. It was a massive structure, 2.5m wide at the base and not less than 6m high. The photograph (right) shows what the wall would have looked like—this is a section of the Roman wall at Colchester. Note the typical Roman tiled courses. The Roman walls were used in Anglo-Saxon times, and still formed the city boundary up until the 13th century, when new walls extended the limits southwards.
