## ROCHESTER CATHEDRAL

### CONDITION OF GRAVESTONES IN THE LAY CEMETERY AREA OUTSIDE THE WEST FRONT

## Rochester Cathedral: condition of gravestones in the lay cemetery area outside the West Front

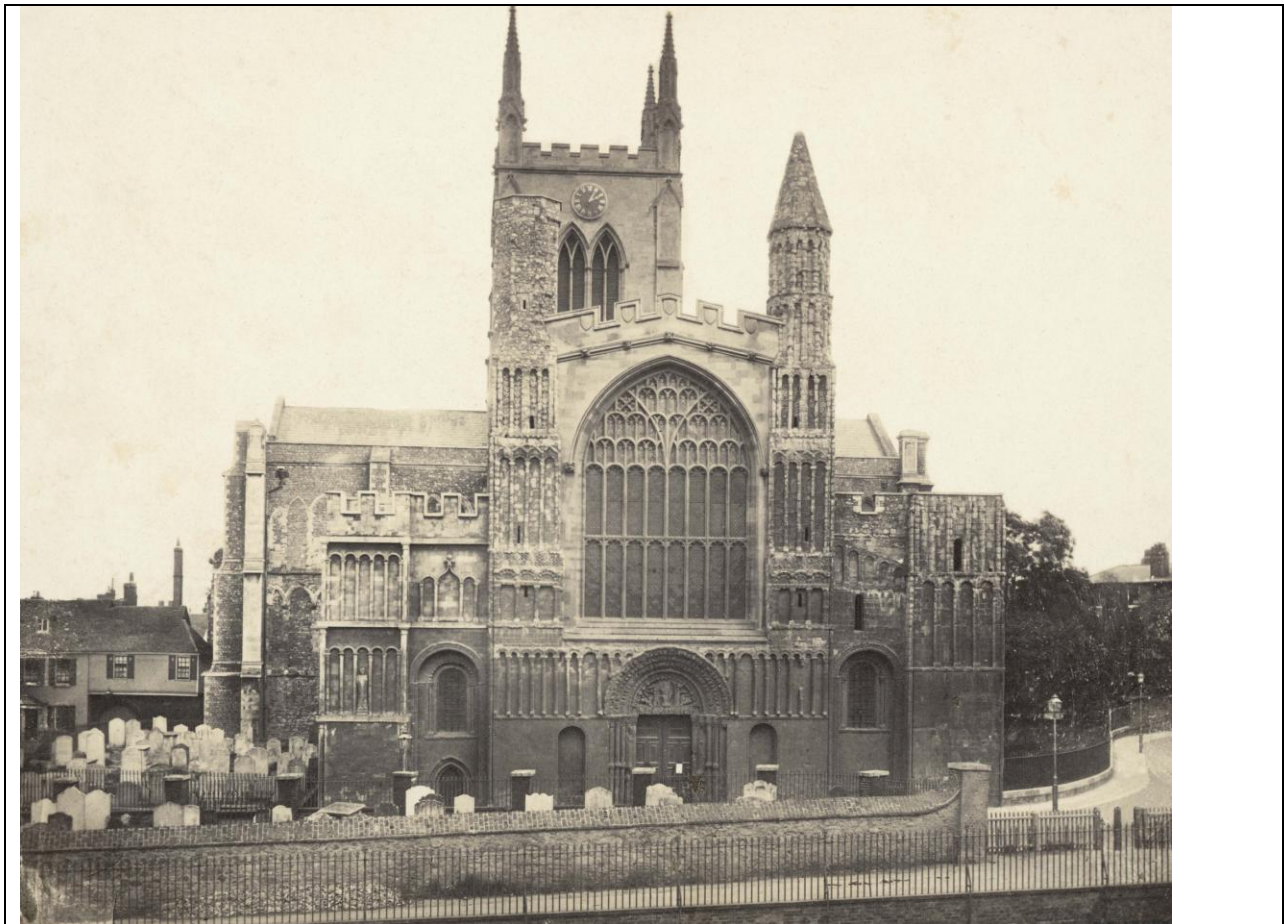
The lay cemetery in the middle decades of the 19<sup>th</sup> century (source: English Heritage)
