## ROCHESTER CATHEDRAL, MEDWAY, KENT

REPORT OF ARCHAEOLOGICAL WATCHING BRIEF AND BUILDING  
RECORDING AT DEANERY GATE HOUSE (PROJECT CODE RCDGH 07)  
NGR TQ 74304 68556

Text by Graham Keevill; Graphics by Paul Hughes  
Keevill Heritage Consultancy  
For the Dean and Chapter of Rochester  
21 December 2010

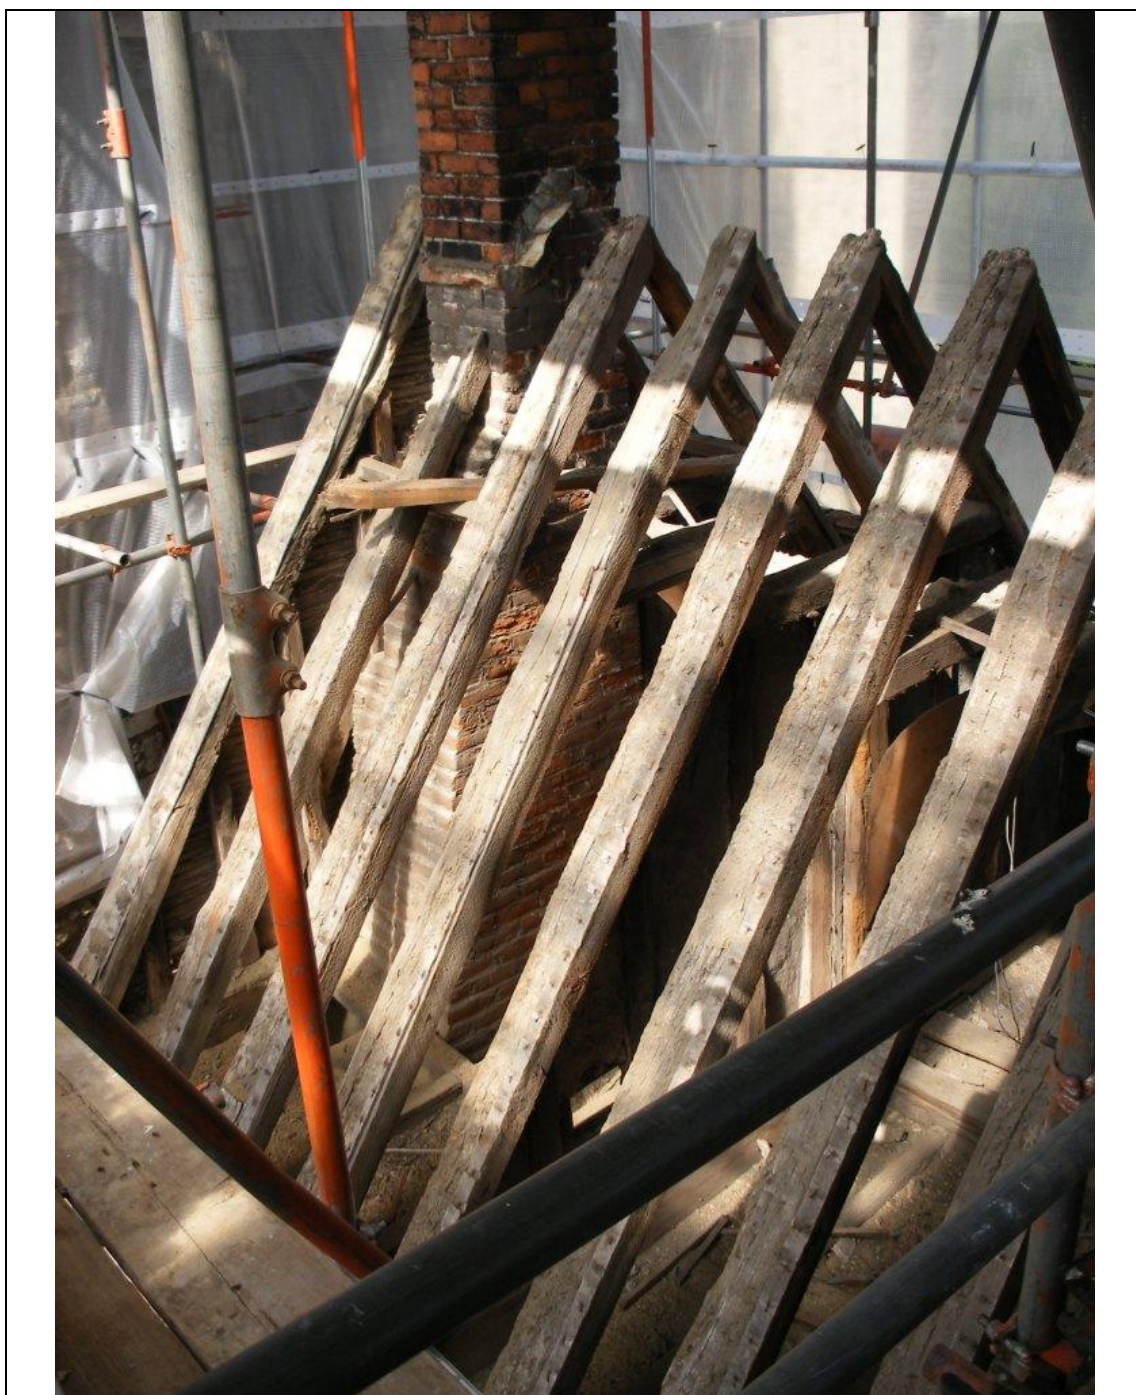
Figure 1: The roof over the Deanery Gate during repair works in July 2007.

Deanery Gate House has two roofs running north-south over the two-storey structure, with a valley between them. Each roof features 23 common/paired rafters, with two dormer windows cutting into these on the external slopes of each roof. These dormers had caused significant weakness in both roofs, which accordingly displayed major structural problems and rot around them. Many of the timbers were therefore beyond repair and had to be replaced.

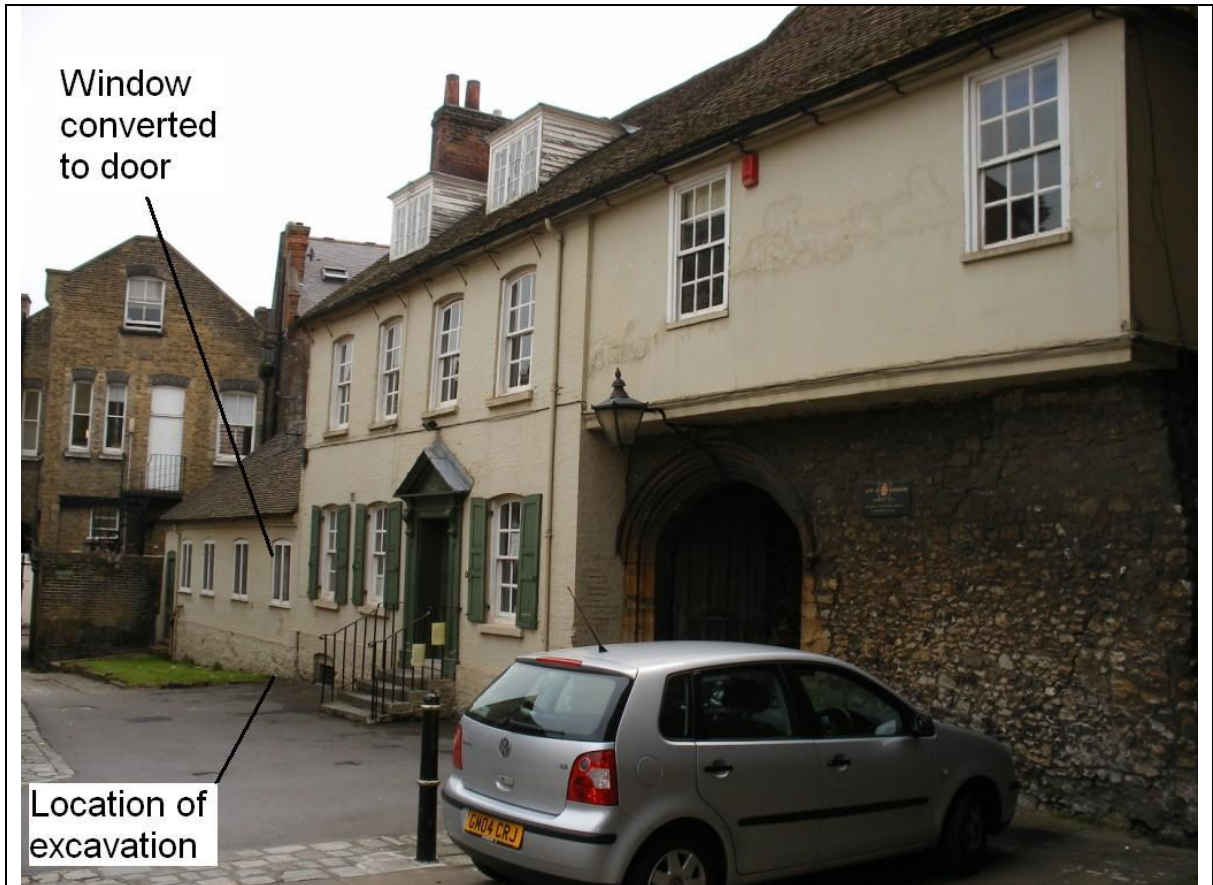
Figure 4: Location of the new staircase foundation excavation photograph (top), and plan (bottom) at scale of 1:200.

The new door in the frontage of the house required the lowering of an existing window cill to the internal floor level. This was still c 0.6m above the external ground level (which slopes down northwards towards the High Street). Therefore a new staircase had to be built up to the requisite threshold level, matching the one to the existing front door (see Figure 4, top). The foundation pit for the new stair was 2.7m long (north-south along the house frontage), 1.2m wide and up to 0.95m deep; its location is shown on the plan at Figure 4 (the east end was initially excavated as a trial pit, and then extended to its full length). The main contractor carried out the excavation of the coarse rubble layers that characterised the whole of the stratigraphic sequence except for the very bottom of the excavation, with the author in attendance throughout. The rubble layers contained post-medieval building material (brick, tile etc), oyster shell and several sherds of post-medieval to Victorian pottery. Neither this material nor the rubble layers merit further description here. The author took over the excavation at the base of the pit, for reasons described below.

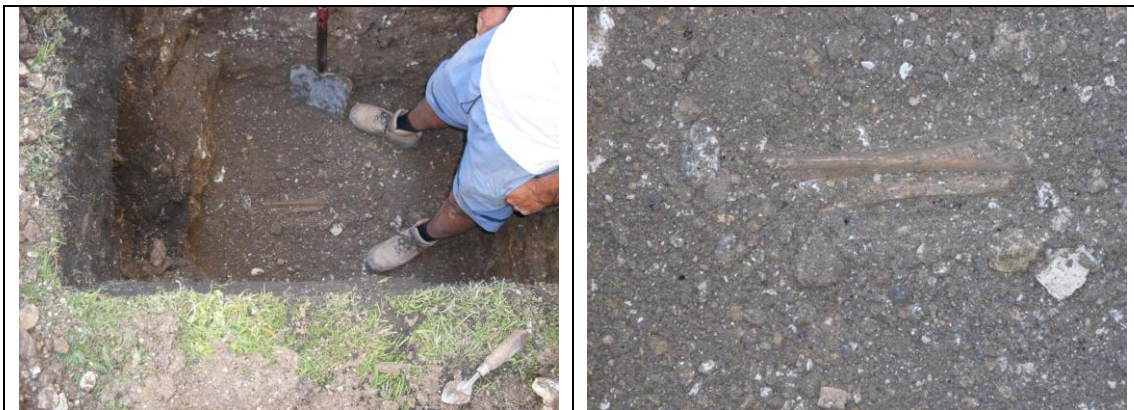
Chalk bedrock was found in the centre and on the north edge at the base of the pit. At least four features had been cut into the chalk. These all appeared to be graves, on the basis of disarticulated human skeletal remains noted in the fill of grave 1, and an articulated lower leg (tibia and fibula) in grave 4. The latter were in the correct east-west orientation and appeared to be *in situ*. The disarticulated bones appeared to be those of a child or young teenager, and consisted of mandible (jaw) and skull fragments with a few foot or hand bones. The skull and jaw fragments had old breaks, showing that they had been disturbed from their original positions in the past. Unfortunately the bones could not be left in place, and so were removed.<sup>2</sup> Graves 1 and 4 both cut grave 2, while grave 1 also cut grave 3. Only a very small part of the latter was within the pit, and its interpretation is therefore not certain. The other features, however, are regarded as graves with some confidence. They were not excavated, but the foundations of Deanery Gate House clearly cut grave 1. Therefore all the graves are considered to pre-date the house.

Figure 5: The foundation pit during excavation showing the human bone in grave 4. Note the brick rubble in the left-hand photograph.

<sup>2</sup> The bones were reburied in the side of the pit before the foundation was cast. A note of this is included in the cathedral burial register.

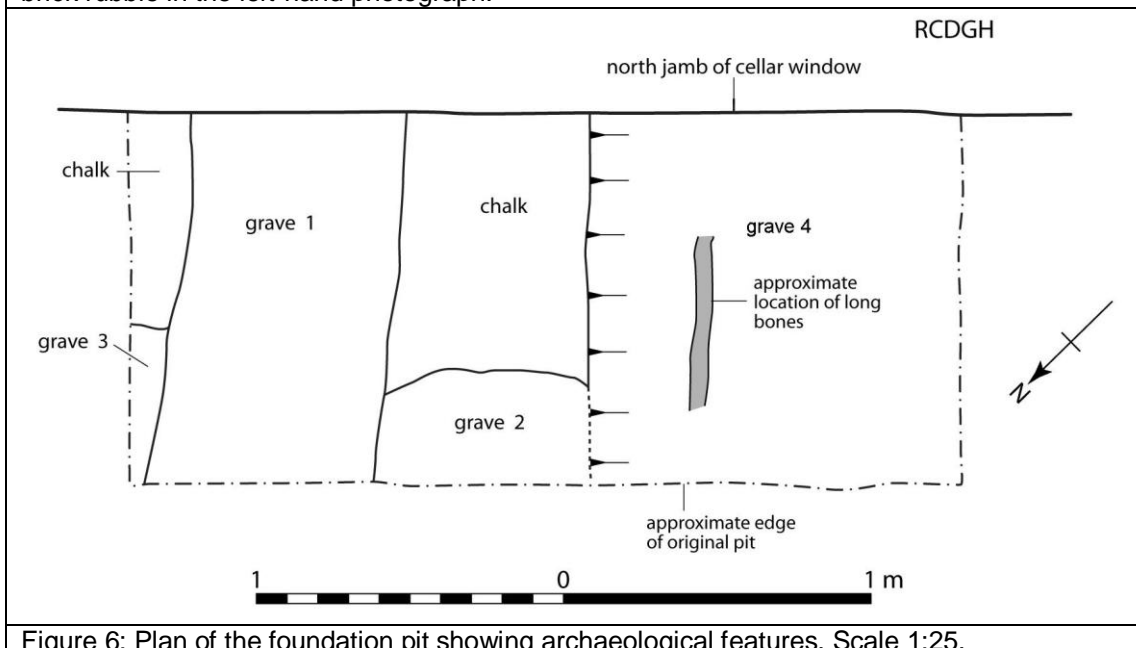
Figure 6: Plan of the foundation pit showing archaeological features. Scale 1:25.

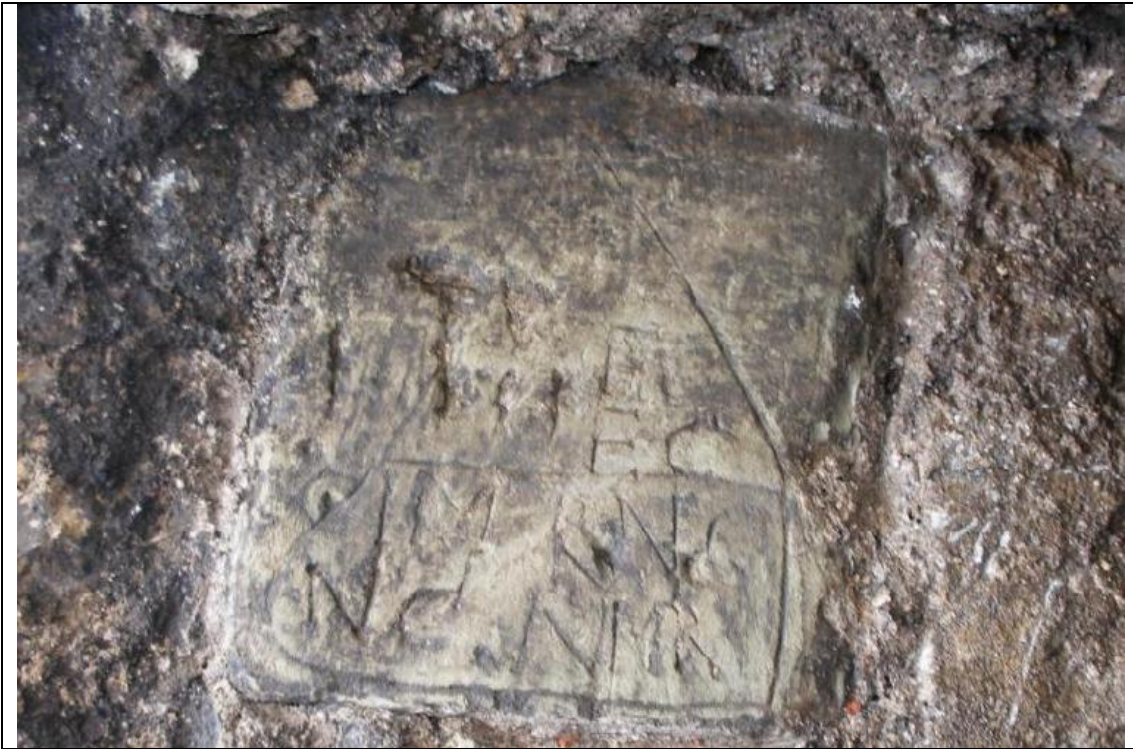
One further item of interest was noted during excavation of the foundation pit. The external face of the basement for the house was found to include a stone with an incised inscription. This does not quite fit within a roughly triangular border, also incised. It is difficult to decipher any meaningful text within the script, and the lettering is crude. Opinion as to its date ranged from Roman to post-medieval, with no definitive conclusion reached. The stone was protected and left in place.

Figure 7: The inscribed stone in the basement wall of Deanery Gate House. This photograph has been rotated through 90 degrees anticlockwise compared to the stone's true position.

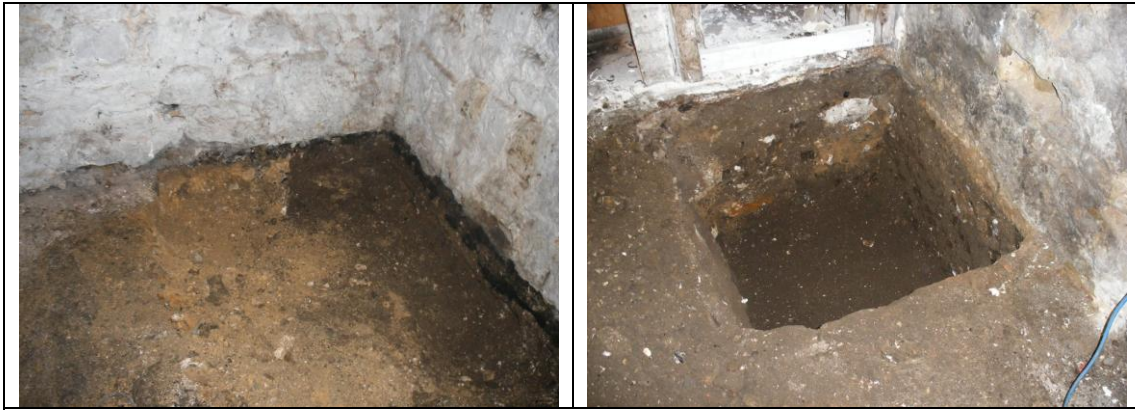
Two trial pits were excavated in the basement that underlies the two-storey part of the house. These investigated the depth of the foundations, as the ceiling height of the basement was uncomfortably low. It was hoped that the floor could be reduced in height to compensate for this. Unfortunately the basement walls only continued for one or two courses below the packed earth floor, meaning that the floor could not be reduced at all. The south wall rested on the compacted gravel foundation of the Deanery Gate itself, with soil to the west of this where the house extends forward slightly from the gate (Figure 8, left; the relationship between the gateway and the house is shown in Figure 4, top). The east wall had been cut into poorly defined layers of archaeological strata (Figure 8, right). These may have been cemetery soils similar to the grave fills noted in the external foundation pit, but the excavation was too limited for this to be regarded as a definitive interpretation.

Figure 8: The basement test pits – left, pit 3, showing the gravel foundation of Deanery Gate and soil to the west (right) of it where the house extends beyond the gate; right, pit 2, with poorly differentiated soils under the east wall and floor.

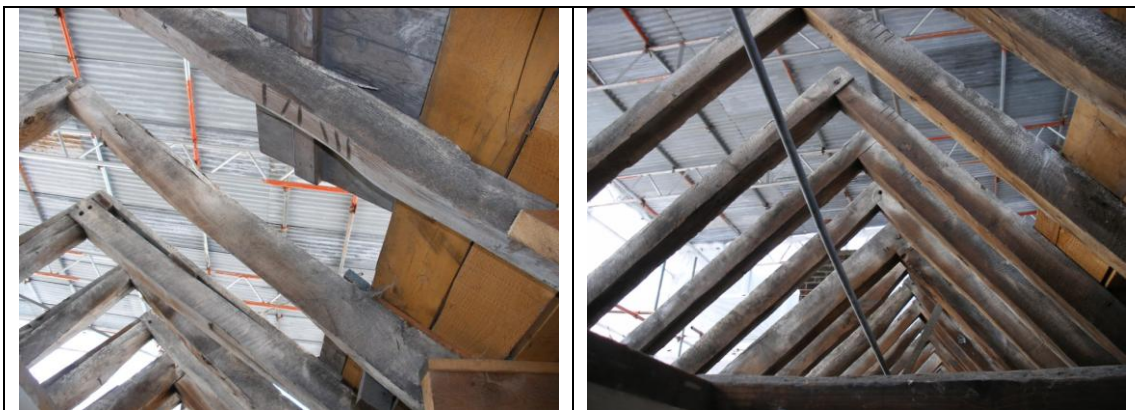
Figure 9: The west roof seen from the east (left) with the IIIIII tally on the underside, and from the west with the II-III tallies on the side. The timbers marked IIIIII and IIII are the same pair.

Several of the rafters displayed tally marks cut into the timbers as part of the pre-fabrication and erection process. Interestingly, several of the timbers had two different sets of tallies, one very deeply incised on the bottom surface, and a second shallower set cut into the south side. Only the lower of these matched the current position of the rafters. The sixth one in from the south on the western roof, for instance, was correctly marked IIIIII on the underside but IIII on the west face (of both timbers). The next two sets of rafters (ie seven and eight from the south) were marked III and II on their west faces, so that all three were in their correct sequence, but reversed and displaced from their original positions. Either the roof was re-used from another building or (more probably) it had been taken down and re-erected at some time in the past

(perhaps when the dormers were inserted). A similar situation was noted on the eastern roof as well.

English Heritage agreed to fund dendrochronology dating of the roof, and commissioned Dr Martin Bridge of the Institute of Archaeology, University College London, to carry out this work. Several timbers that had already been removed from the roof of the house were examined. Unfortunately they were all rather small scantling softwood common rafters of very limited potential for dendrochronological dating. The principal rafters that were still in place were also unpromising. Dr Bridge commented that the small sizes of the timbers and the fact that they were softwood meant that they were unlikely to be older than the early 18<sup>th</sup> century, ie of about the accepted age for Deanery Gate House.

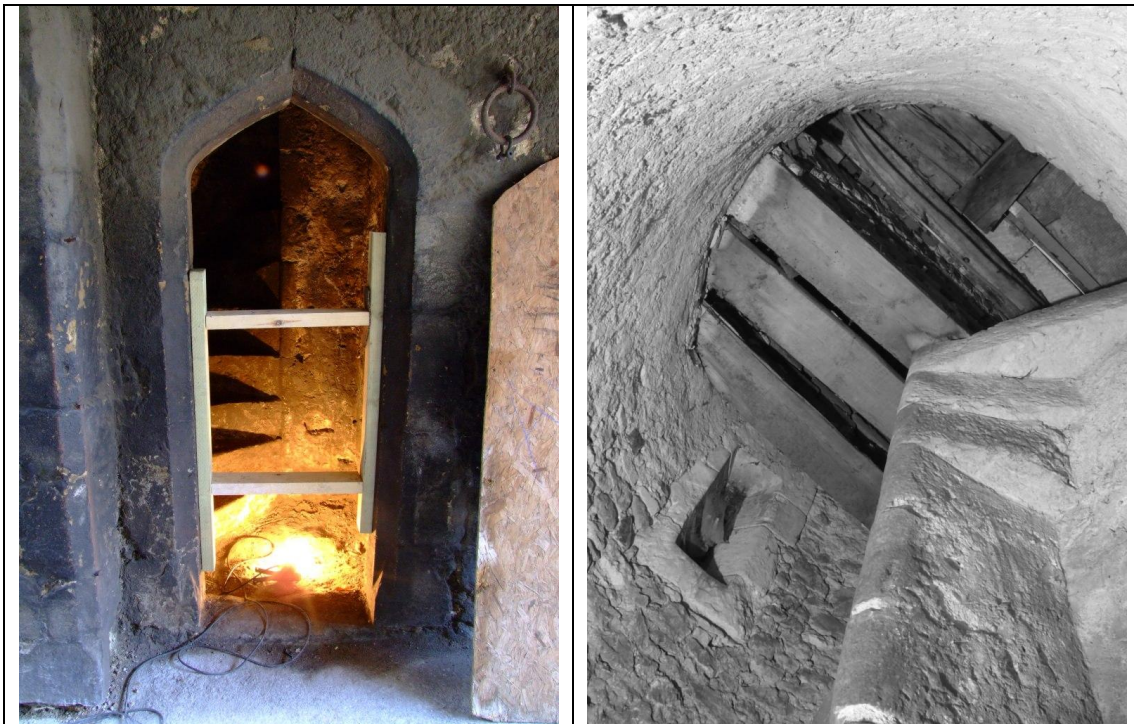
Figure 10: The newly unblocked door to the spiral staircase (left), with the slit window and the boarding under the fireplace in the upper chamber (right).

The conversion involved superficial work in the medieval chamber over the gateway itself. There are actually two rooms here: a larger one over the gate arch, and a smaller one over the area to its south. The larger chamber has a fireplace in its east wall. When the floorboards were lifted, this fireplace was seen to rest on timbers running across the bore of a spiral staircase. One clear implication is that the fireplace could only have been built once the spiral stair had gone out of use. The stair was already known, as its blocked doorway lies on the south side of the gate archway. The opportunity was therefore taken to unblock the door and examine the staircase from ground level up to the point at which the fireplace truncates it. A full photographic record of the structure was made as part of this work. There is a narrow slit

window on its south side, ie facing out away from the gate. This implies that there was an open area between the gate and the cathedral, and that this was used to light the staircase.

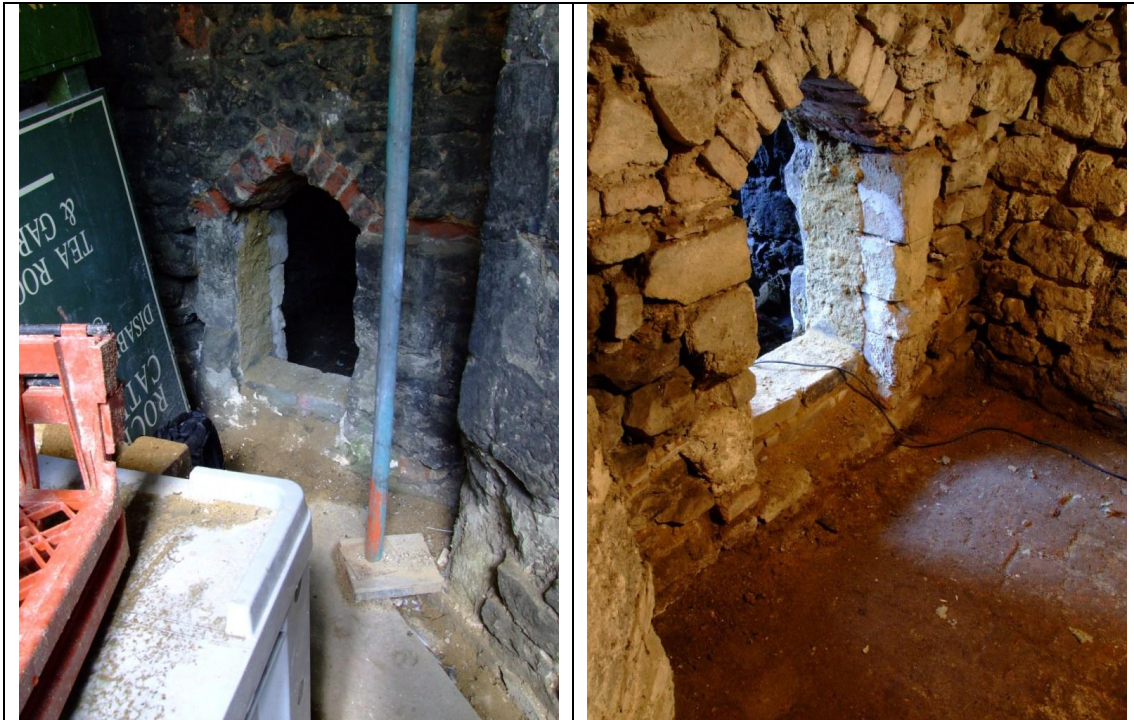
It was soon realised that there were other implications leading from the existence, position and apparently early date of the spiral staircase. Existing plans of the Deanery Gate, for instance, showed a small square block extending east from the spiral staircase. In fact the south-east corner of this block is polygonal. Furthermore it has a wall running between it and the north-west corner buttress of Gundulf's Tower, butting against (and so post-dating) both of them. The cross-wall also had a low, pointed arch in its centre, and this was also blocked (with brick). Given that the polygonal back to the spiral stair clearly continued beyond the cross-wall, it was agreed that this door also should be unblocked so that whatever lay beyond it could be recorded. Once this had been done the area behind it was drawn and photographed in detail.

Figure 11: The unblocked door in the cross-wall from the outside (east) on the left, and inside on the right. Note the brick paving in the right-hand photograph.

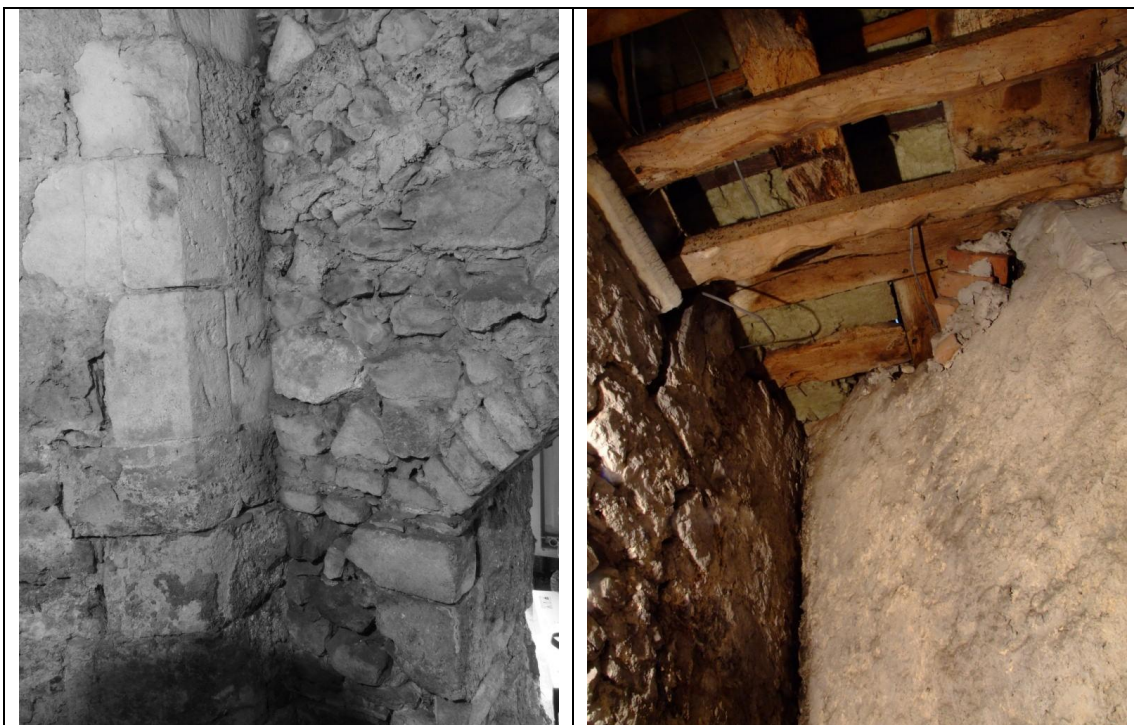
The opening is not obviously visible in the outer face of the west wall, and indeed the corner with the south wall seems to be reasonably well bonded. The character of the external masonry of the west wall is quite different from the inner face, with generally much smaller rubble having been used. Significant cracks are also evident on the inner face but much less so on the exterior (compare Figure 4, top, with Figure 14). It seems that the west wall had been completely re-faced (thus blocking the opening). Presumably the west wall was re-built at the same time in a position to the north of its original location (though this is unknown at present).

Figure 13: The polygonal turret, with the cross-wall abutting it (left) and the front wall of the Deanery Gate cutting across it (right). The window cill can just be seen towards the top left of the right-hand photograph.

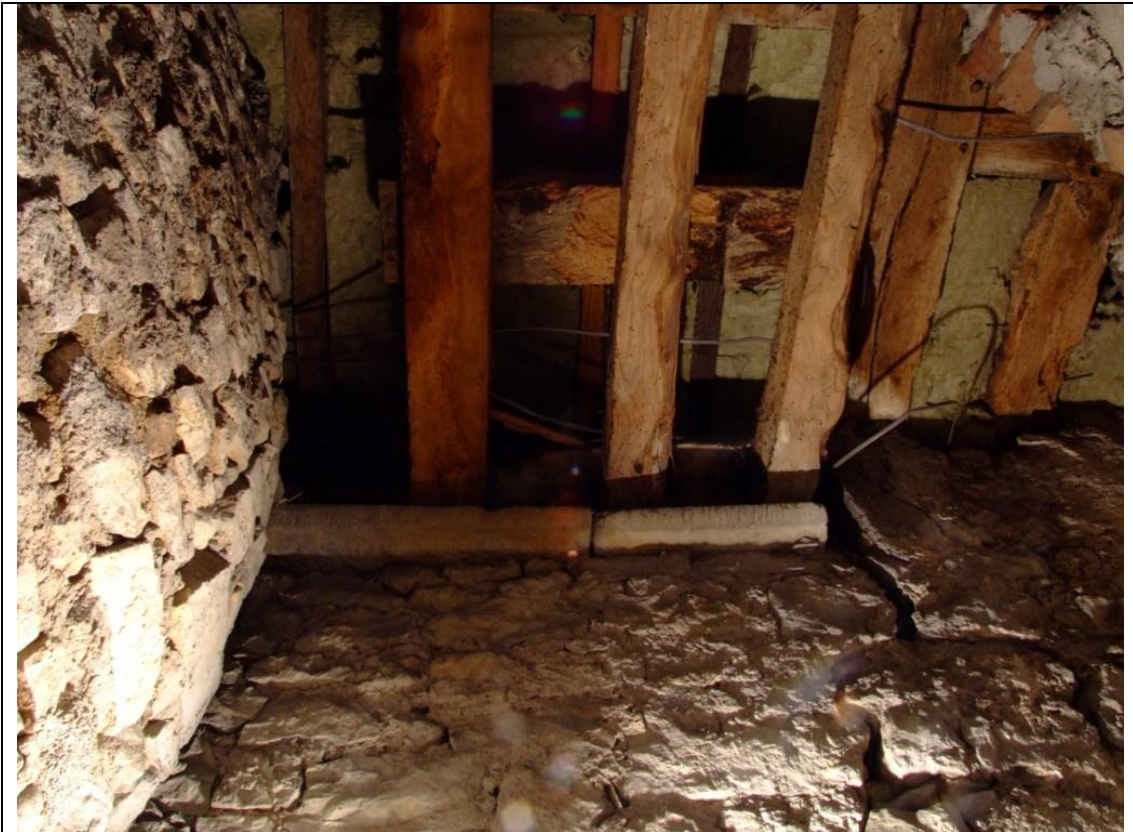
The relationship between the inner face of the Deanery Gate wall (3 on Figure 12) and its south wall (2) was difficult to understand. The two did not appear to be bonded in, as contemporary structures would be, but wall 2 appeared to abut (and so post-date) wall 3. Further, it was apparent that wall 3 included the cill and the lower part of a northern jamb for a substantial opening about

2.8m above ground level, probably a window (see Figure 14; the position of the cill and jamb are also indicated on Figure 12). The cill clearly continued behind wall 2, which confirms that the south wall is indeed later than the west one.

Figure 14: The west wall (3) of Deanery Gate, with the cill and jamb of a window, re-used as the seating for floor joists. Note the structural crack running down from the jamb.

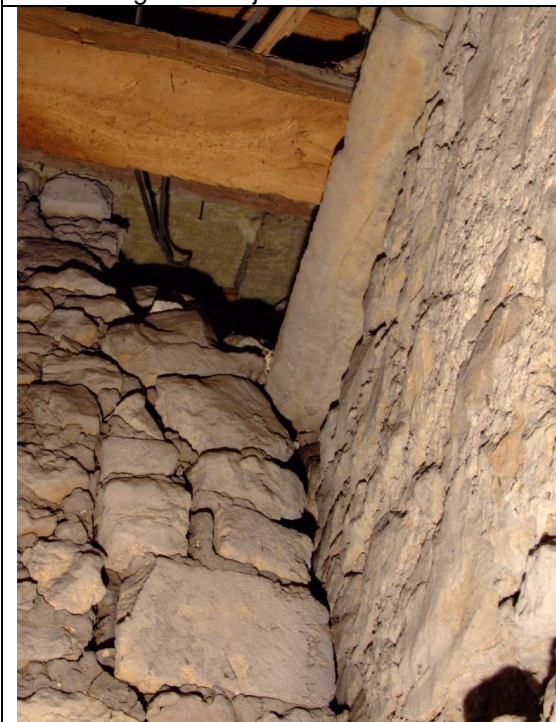
Figure 15 (left): Wall 2 butting against wall 3 and the cill within it.
