ROCHESTER CATHEDRAL, MEDWAY, KENT

REPORT ON ARCHAEOLOGICAL RECORDING BEFORE AND DURING THE CONSTRUCTION OF NEW GLAZED PORCHES AT THE NORTH AND WEST DOORS (PROJECT CODE RCNWD 10) – NGR TQ 742 685

Graham Keevill
2 December 2010
Keevill Heritage Consultancy
For the Dean and Chapter of Rochester

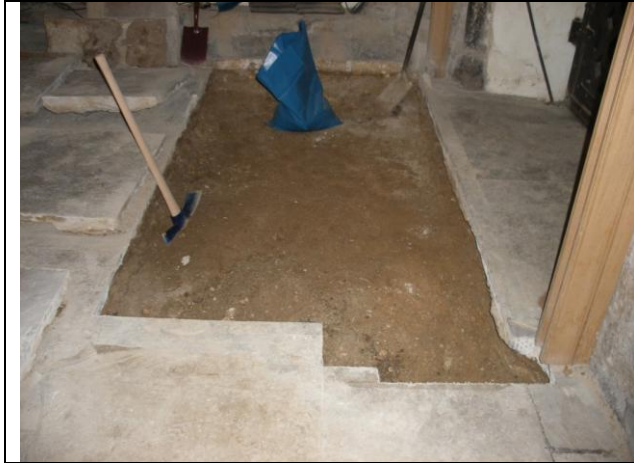
The bottom 0.14m of the excavation area was covered with mid-brown silty clay (1004) containing pieces of stone rubble. None of this was datable, and none was retained. It was notable that the top of this layer lay at about the same level as the top of offset foundation 1006.

Figure 5: The North Door porch foundation pit as excavated, with layer 1004 visible across the base of the pit.

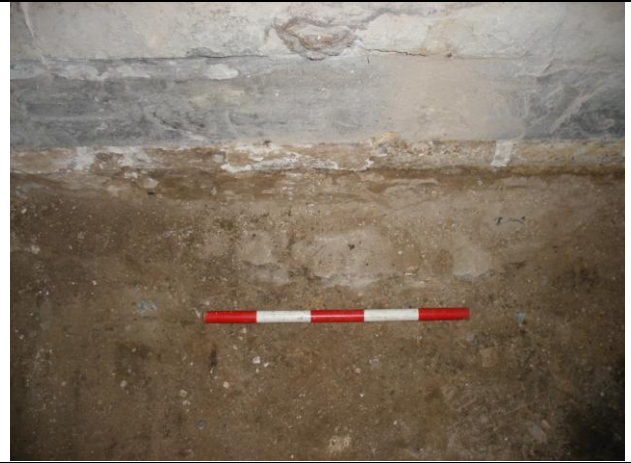
Six contexts were recorded in the test pit at the North Door. Structure 1006 was the offset foundation for the plinth-wall in the northern arcade-niche of the transept's west wall. The Kentish Rag masonry lay 0.18m below the existing paving and was up to 0.15m wide. Its edge was somewhat irregular, suggesting that the foundation consisted of rubble. Its northern extent could not be traced with certainty, but it appeared to turn east as it approached the western jamb of the North Door.

Figure 6: Detail of offset foundation 1006.

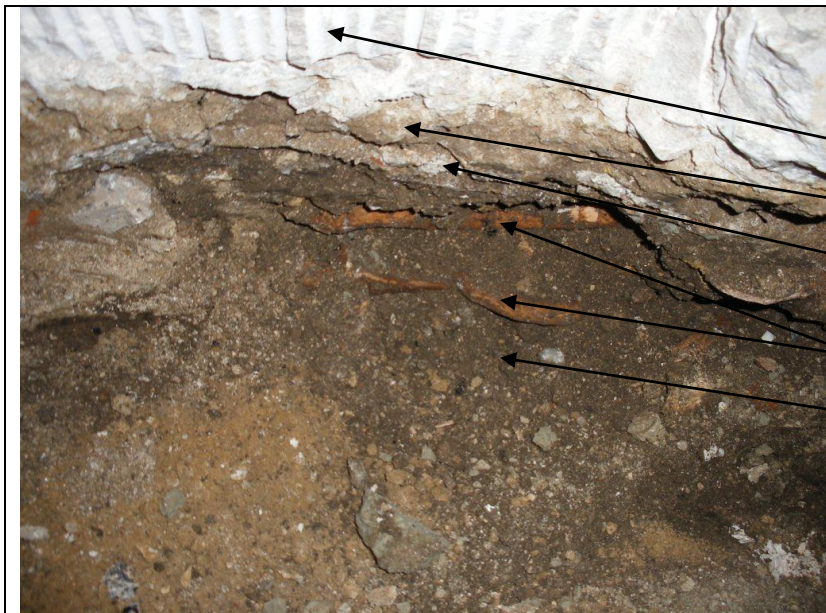
Approximately 15 fragments of human bone (context 1005) were found within layer 1004, all in the north-east corner of the pit. The bones were mostly from the lower leg (tibia and fibula), but a few vertebrae, ribs and toe or finger bones were also present. The long bones were all oriented north-south, ie at 90 degrees to the expected orientation for an *in situ* skeleton. The bones had clearly been re-deposited here. Fortunately it proved possible to leave them all in place and pour the foundation concrete around them (with a separating membrane and sand between them to protect the bones).

Figure 7: Long bones visible in the east section of the foundation pit.

Paving slabs, 1001.

Bedding 1002.

Mortar 1003, probably bedding for an earlier floor.

Human bones, 1005.

Rubble layer 1004.
