ROCHESTER CATHEDRAL, MEDWAY, KENT

NEW MEMORIAL FOR THE ROYAL ENGINEERS IN THE NAVE SOUTH AISLE.
PROJECT CODE RCREM 10, NGR TQ 7424 6853

REPORT ON AN ARCHAEOLOGICAL WATCHING BRIEF

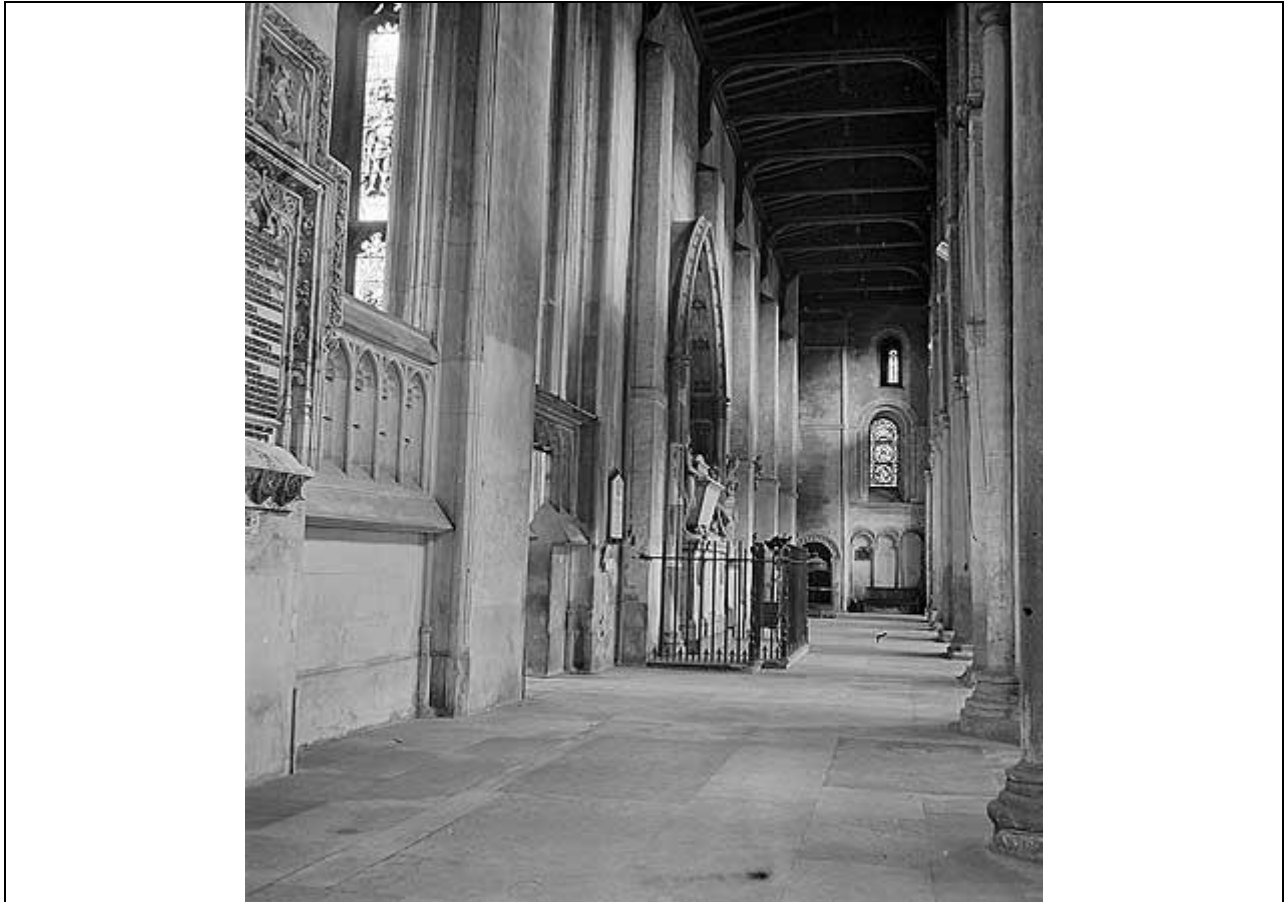
Figure 3: The Nave south aisle looking west – note the Gurney stove in the background behind the railings. Photograph by Bill Brandt, 1942. National Monuments Record ref AA43/00169.

Associated improvements included the removal of a modern flue rising up to the roof. This had serviced a long-since removed Gurney stove (Figure 3). The flue interrupted a finely decorated Romanesque string course, the only part of it to be so decorated on this side of the nave (the rest is of plain rectangular profile). It was not clear whether construction of the flue had cut away part of the decoration, or whether it had stopped at this point already. The existing rendering on the wall face to the west of the flue was also in poor condition, and was thus replaced as part of the project. Demolition of the flue also exposed the wall face fully to roof height, as well as the west face of the pilaster buttress against which the flue had been built. This was the westernmost of five such buttresses, identified by St John Hope as being early 12th century additions to the late 11th-century south wall of the Nave. He also suggested that the western bay of the south aisle was also part of the early 12th-century work to build the Cathedral's magnificent West Front. The work thus offered an opportunity to examine and record several areas of potentially early fabric, and so an archaeological watching brief was maintained. The area had also been recorded photographically in advance of the project to ensure that its existing condition was documented.

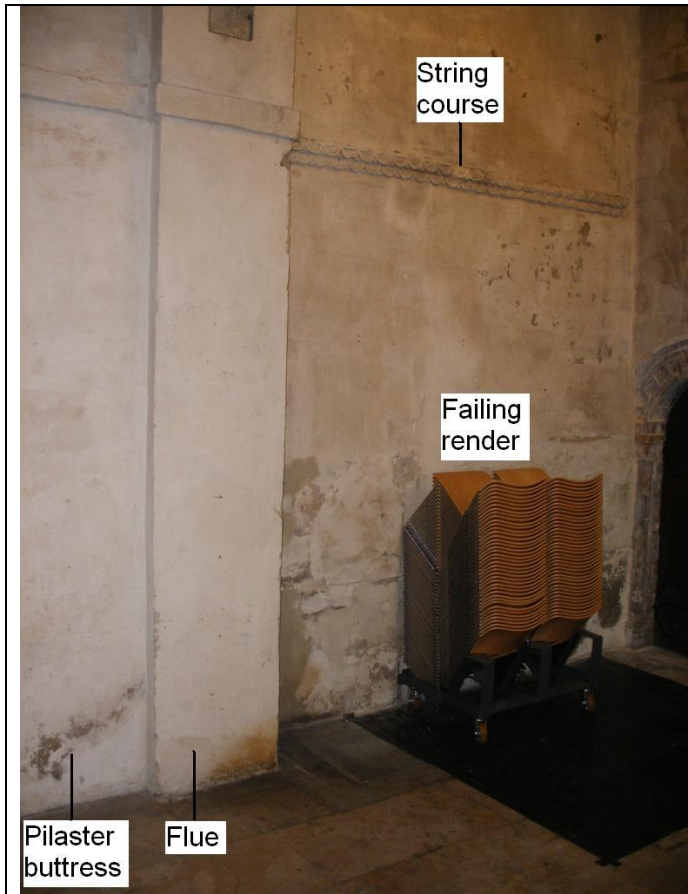
Pilaster buttress
Flue

String course

Failing render

Figure 4: The westernmost bay of the south aisle in October 2009, before work started. Note the string course.

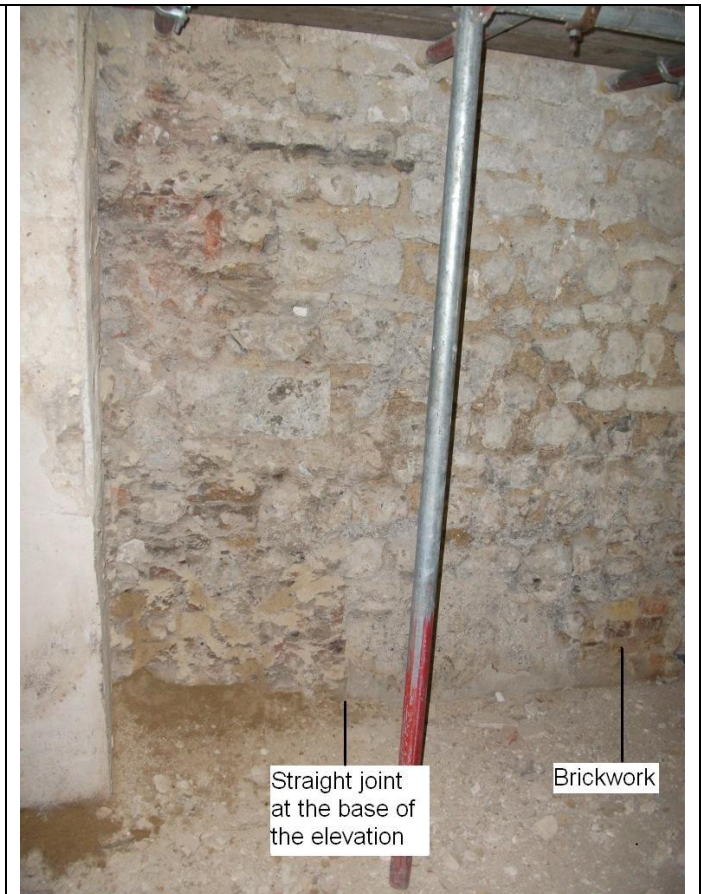
Straight joint at the base of the elevation

Brickwork

Figure 5: The same bay in March 2010 with the failed render removed to reveal the masonry behind it. Note the straight joint, highlighted.

Stripping the render exposed the lower part of the Nave's south wall internally, allowing an invaluable opportunity to examine the fabric at this important location. As noted above St John Hope considered that there was a junction between two phases of Norman work here (see Figure 2). This is an over-simplification, and the fabric is more complex than this. Halsey (2006, 65) points out that the Nave foundations are Gundulf's work of the late 11th century, so the overall form of the structure was devised in his time. The inside was refaced with new masonry in the mid-12th century, however, probably working from west to east. The south wall of the nave was completely rebuilt in the late 17th century, but the north wall, despite much later repair, still retains some internal and external carved decoration of the mid-12th century. Despite the 17th-century rebuilding of the south wall, the westernmost bay appears to retain some original fabric. It is difficult to account for the survival of the Romanesque string course otherwise. Observation during the watching brief appeared to confirm that this is *in situ* within the fabric around it.

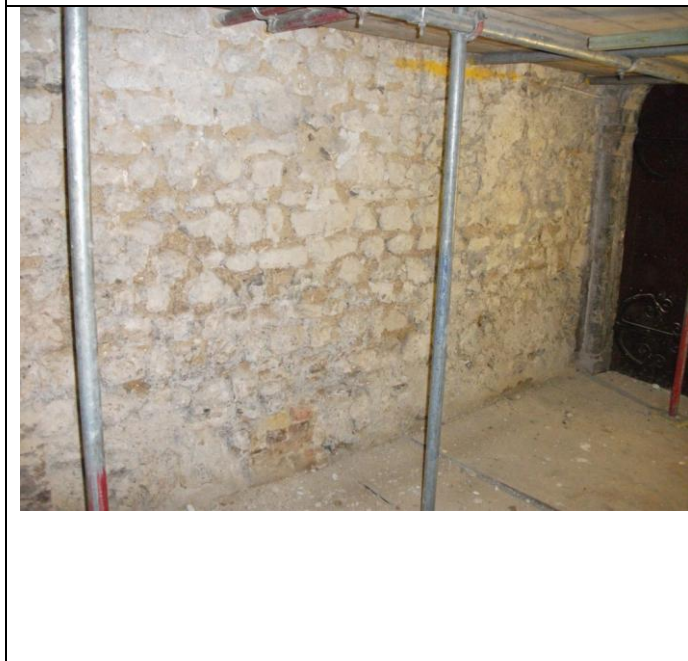
Figure 6: The remainder of the westernmost bay of the Nave south aisle. Most of this is 12th-century fabric.

Once the render had been fully stripped, it was clear that there were indeed differences in the masonry behind it. Most of it was of coursed rubble (Figure 6) and is probably 12th-century fabric, but the section adjacent to the flue was mostly of more random character, and appears to belong to the 17th-century rebuild. The same mixture of roughly laid and poorly (if at all) coursed stone and brick was also observed behind the flue once it had been removed, for its full height (Figure 8). The junction between the early and later stonework was mostly quite ragged and indistinct, but there was a clear straight joint between them at the base of the wall (Figure 5). It is possible that this represents the junction (as suggested by St John Hope) between Gundulf's work and the early/mid-12th-century rebuilding of the West End, but fossilised by the 17th-century fabric, which seems to have replaced the earlier Norman work here. It is also notable that this point is a little to the west of the termination of the string course, which was found when the flue was demolished. The Romanesque string course only continued for c 100mm east behind the flue (Figure 9), but even so this places its end about 0.5m to the east of the straight joint. The 12th-century masonry also abutted the jamb of the door into the south-west turret of the West Front (Figure 7). These should be contemporary, so the abutment probably represents nothing more than a constructional relationship: it would make sense to work up the high-quality ashlar of the door frame before building the rubble walling up to it.

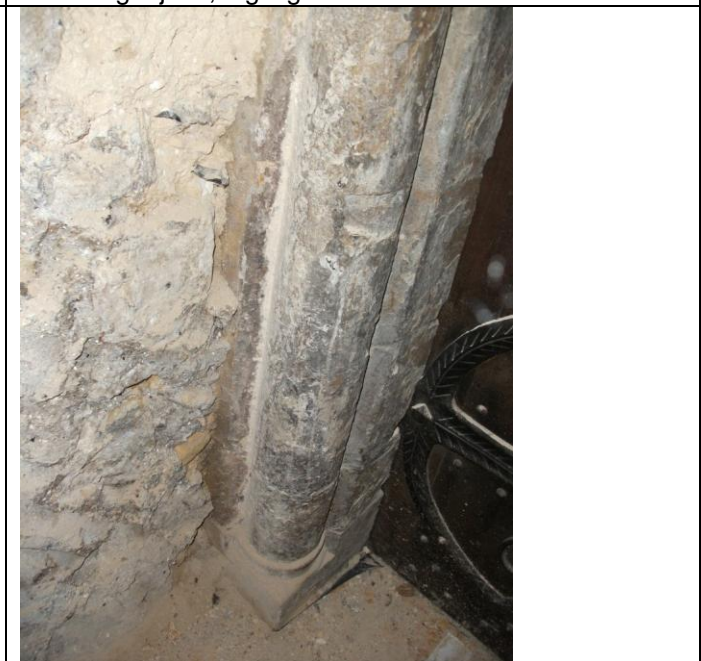
Figure 7: Abutment of the south wall with the door jamb of the West Front's south-west turret.

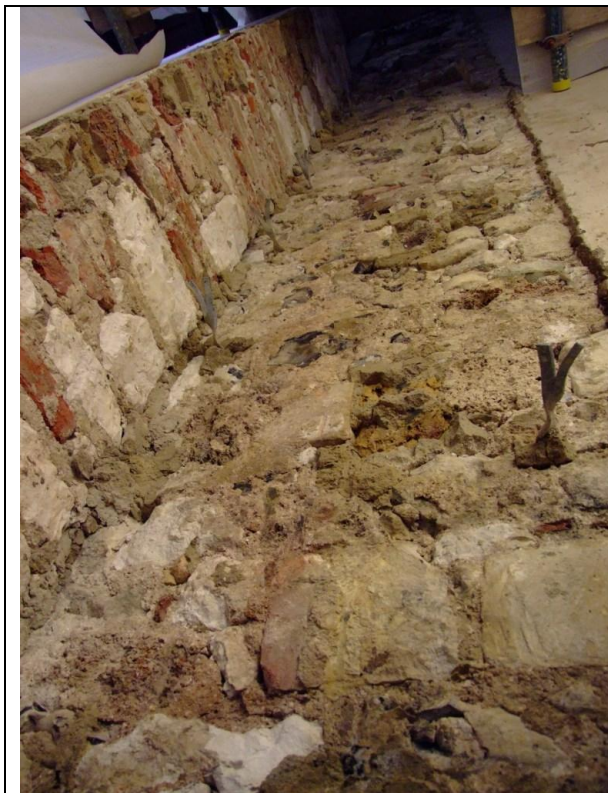
Figure 8: The pilaster buttress (left) abutting the masonry of the south wall. Note the frequent use of brick in both, but especially in the buttress.

The final piece of evidence uncovered during the watching brief relates to the pilaster buttress. The stove flue had been built hard into the corner between this and the rebuilt south wall of the aisle. St John Hope showed the buttresses as cutting back slightly into what he perceived as Norman fabric (Figure 2). The watching brief demonstrated that the western buttress actually abuts the south wall, but in this case it is butting against the 17th-century rebuild. Large quantities of brick had been used both in the aisle wall and the buttress. Most of the bricks were of hard-fired types that became standard after London's Great Fire in 1666. Perhaps the buttresses had been forgotten when the south wall of the nave was rebuilt, and had to be added soon afterwards to balance up with the north wall.

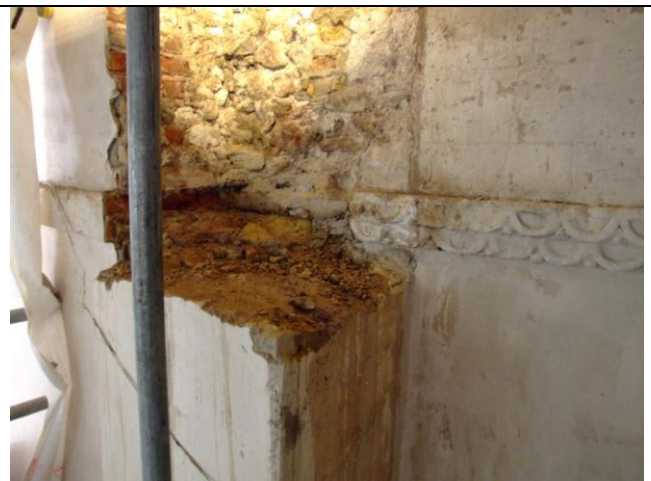
Figure 9: Demolition of the stove flue revealed a short extra length of the Romanesque sting course on the south wall of the aisle.
