ROCHESTER CATHEDRAL, MEDWAY, KENT

REPORT OF A MINOR ARCHAEOLOGICAL EXCAVATION ON THE NORTH SIDE OF
THE CATHEDRAL (PROJECT CODE RCD RP 10), NGR TQ 74312 68514

Graham Keevill (main text) and Catherine Underwood (finds report)
30 November 2010
Keevill Heritage Consultancy
For the Dean and Chapter of Rochester

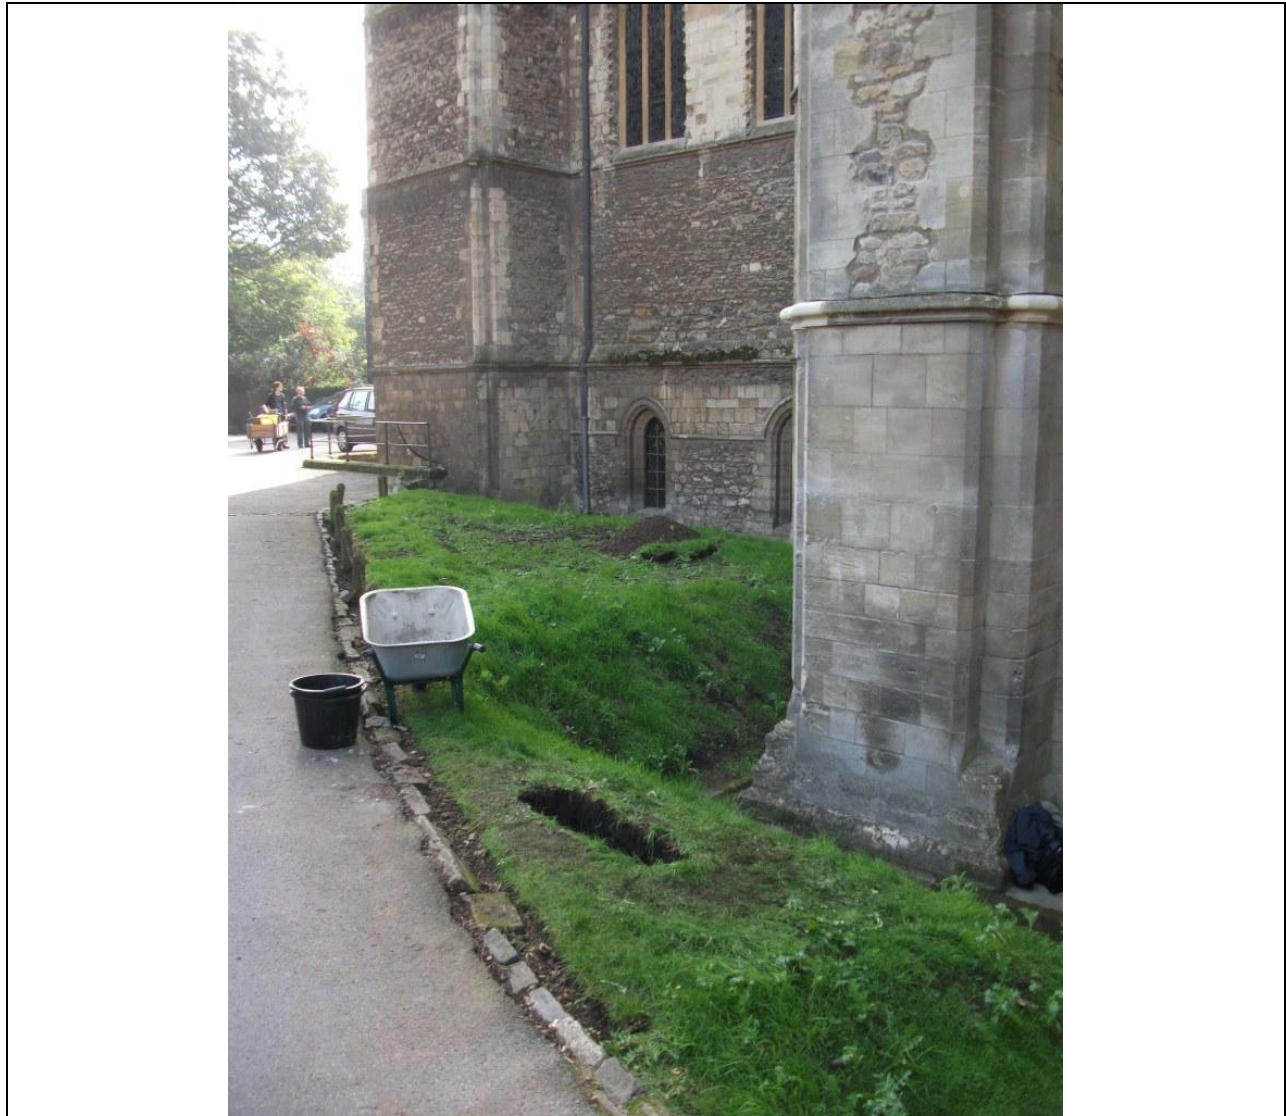
The excavated pit looking south-east toward the East End of the Cathedral.

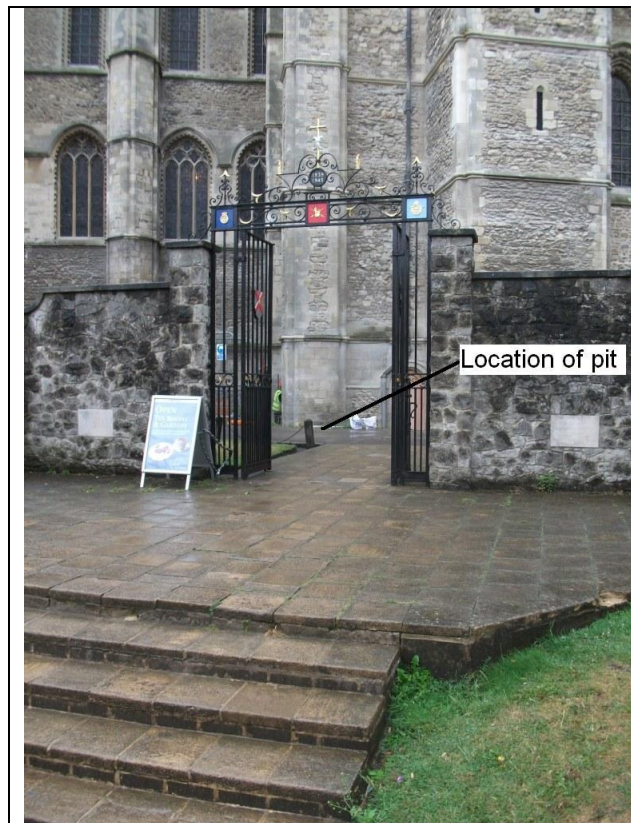
Figure 2: Location of the foundation pit seen through the gates from the Memorial Garden, with the Cathedral's east end in the background.

The excavation took place on 8 October 2010,² and was carried out by hand. The foundation pit was 0.86m long, 0.3m wide, and up to 0.85m deep. It was located on ground which slopes down from the roadside towards the Cathedral, and so the pit was deeper on its north side (ie away from the building).
