## Rochester Cathedral, Medway, Kent

### Report on archaeological test pits on the east side of the Tudor Gate (Project Code RCTG 11)

Graham Keevill  
Archaeological Consultant to the Dean and Chapter of Rochester  
7 March 2011

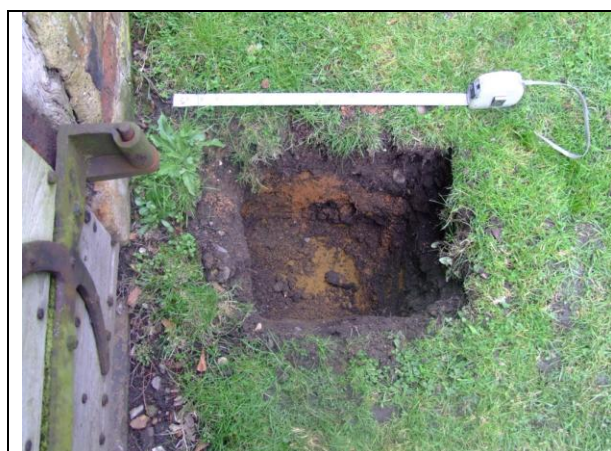
Figure 4a: Test Pit 1 viewed from the south, 0.5m scale.

The topsoil was essentially uniform across all four pits, being a very dark grey-brown silty clay loam (context 101, 201, 301, 401). This was 100mm thick in pits 1 and 2, but slightly thicker (150mm) in pits 3 and 4. The two pits immediately behind the gate otherwise encountered mixed rubble in a grey-brown silty clay incorporating much yellow sand (context 102, 202) for their full depth. The sand was part of the protection for an electric cable running through pit 2 (203), with a ceramic cable cover (204) to the east side of (but not covering) it. The cable is believed to be the feed for the floodlighting on this side of the cathedral, with the feeder pillar for this being located just to the south of pit 2.

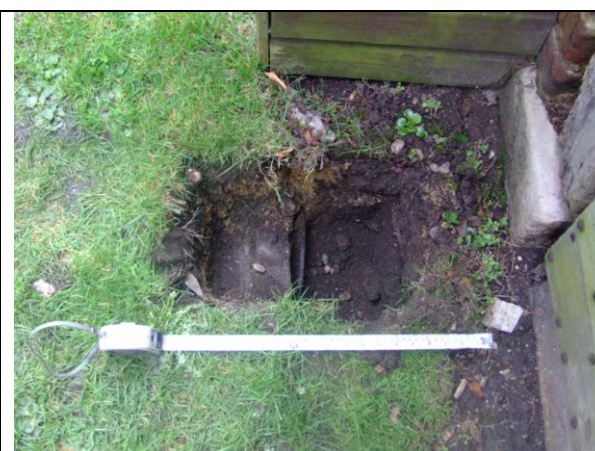
Figure 4b: Test pit 2 from the north with the feeder pillar behind it, 0.5m scale.

The location and direction of the cable found in pit 2 may mean that the foundation has to be re-positioned slightly to avoid this. Any further work here would still be in modern disturbance layers, and is thus unlikely to require any further archaeological input.

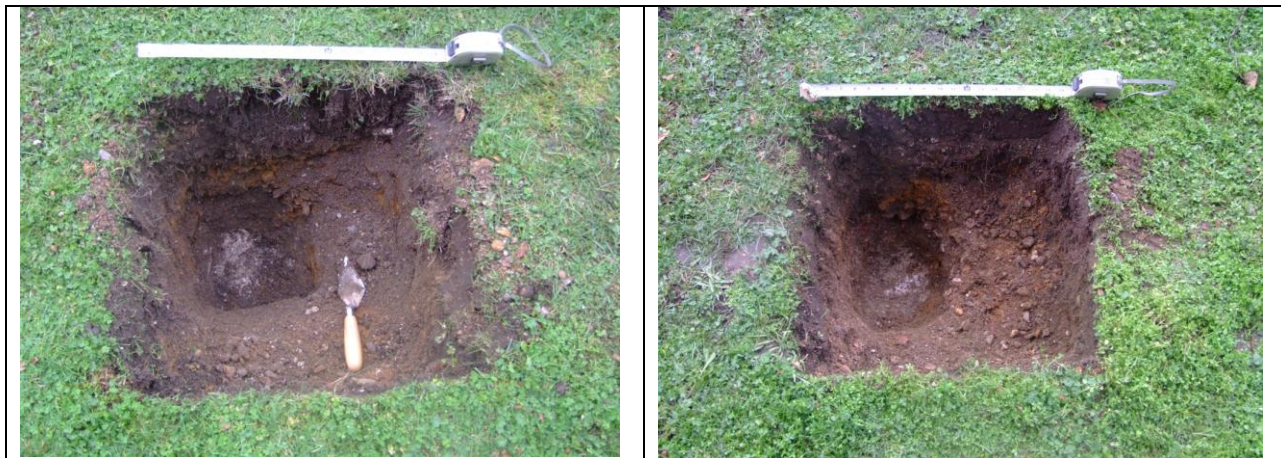
Figure 5a (left) and b: Test Pits 3 (a) and 4 (b) from the north, showing the 'ballast' layers and the ashy mortar at the bottom of the sondages, 0.5m scales.

Test pits 3 and 4 were similar in sequence, but not identical. In both pits the topsoil sealed an extremely compact and hard orange sandy gravel 'ballast' (302, 150mm thick, and 402, 130mm thick). This was excavated over the full extent of each pit, after which a smaller sondage was dug into the north-west quadrants. Layer 302 in pit 3 sealed a similarly hard and compact 180mm-thick 'ballast' layer, but here the gravel was in a mid-brown sandy clay (303). In pit 4, layer 402 sealed a 170mm-thick layer of mixed brick, chalk and stone rubble (403). This was somewhat less heavily compacted than the 'ballast' layers, but was still hard. Layers 303 and 403 sealed a pale grey mixed layer of ash, lime mortar (possibly burnt limestone) and chalk (304, 404). This lay at the base of the pit, and was not excavated as it appeared to be a potentially significant deposit. Its upper surface lay at about the same level once the slight slope from south to north was taken into account.

The two pits next to the Tudor Gate do not require any further comment here. As far as pits 3 and 4 are concerned, the ashy mortar layer (304, 404) appeared to be demolition and/or stone robbing rubble. There are only two known buildings from which this might have derived: the west range of the medieval cloister, adapted after the Dissolution and in use until the beginning of the 19<sup>th</sup> century; and the Prebendal House which succeeded it, demolished in turn in 1937-8. The house was a red brick structure, and parts of its foundations were exposed in the cloister watching brief during 2009-10 (project code RCCL0 09-10). The bonding mortar was hard and apparently cement-

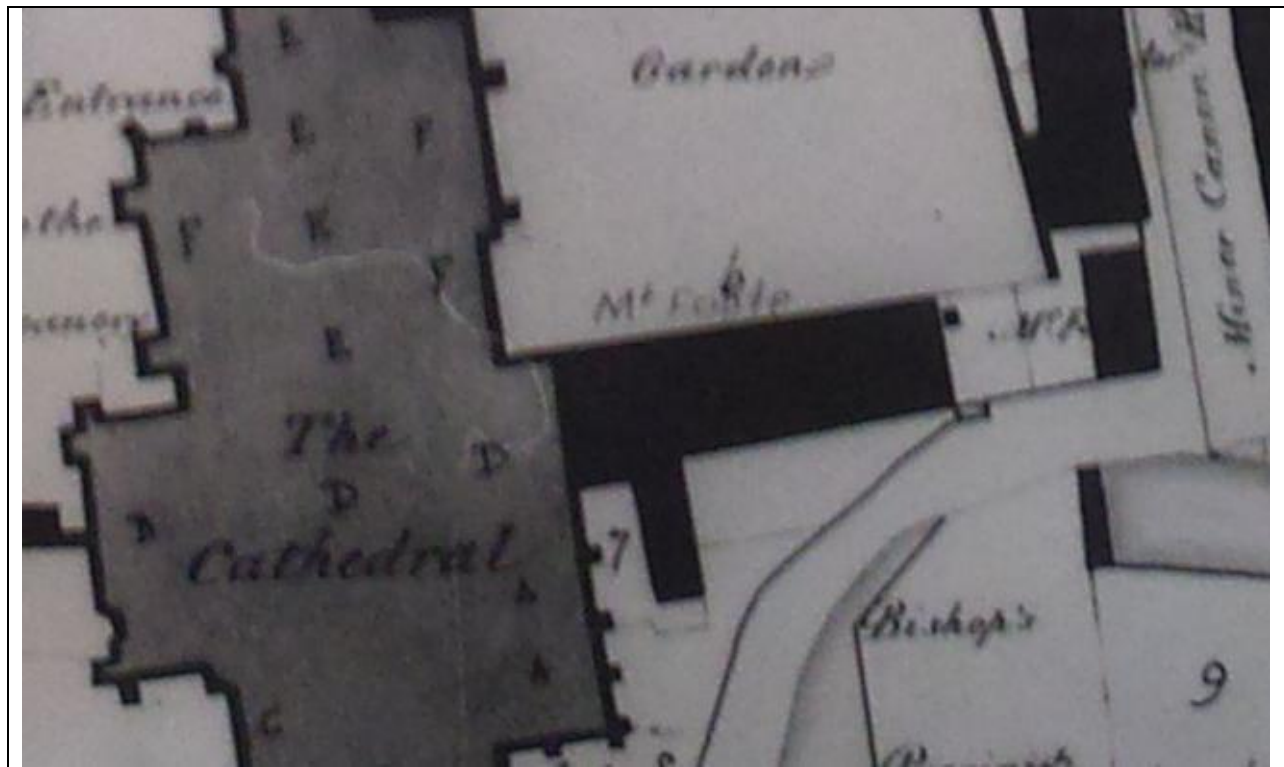
Figure 6: Extract from D Alexander's plan of the cathedral and precinct c 1801, showing the west range and the extension from it (to the right of the number 7).

based. The materials present in layer 304/404 do not seem to be consistent with this. Notwithstanding the lack of excavation, therefore, the mortar layer is interpreted as being derived from the demolition of the west cloister range. The test pits lie just to the west of the anticipated line of the west wall of this range (for which evidence was found in 2007 – project code RCSTLC 07), and so should be just beyond it. D Alexander's plan of 1801, however, shows a second (added?) structure running west from the range (see Figure 6). The demolition material could have come from either building.
