Rochester Cathedral, Medway, Kent

Trial pit excavations in the Chapter House, and a watching brief in former Dorter, 2019

Graham and Cathy Keevill
Keevill Heritage Ltd
For the Dean and Chapter of Rochester
August 2019

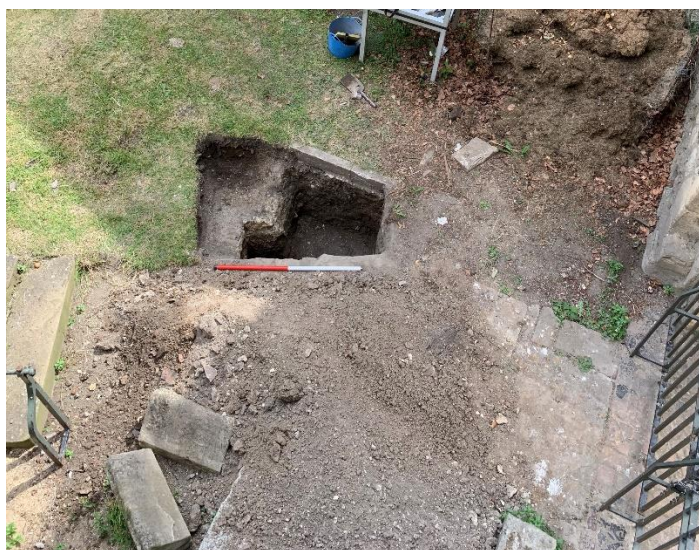
Figure 4: Excavation of pit 3 in July 2019, with the Chapter House door to the right.

Pit 3 was excavated to 0.85m deep (from 8.35m above Ordnance Datum, aOD) without any significant remains being found. Excavation (and more particularly removal of the soil) became difficult at this depth. A smaller area was therefore chosen on its north side, and excavation continued here. This strategy quickly paid dividends when a skull was revealed at 0.98m below ground. Excavation continued for a further 0.19m below this, ie to 7.18m aOD).

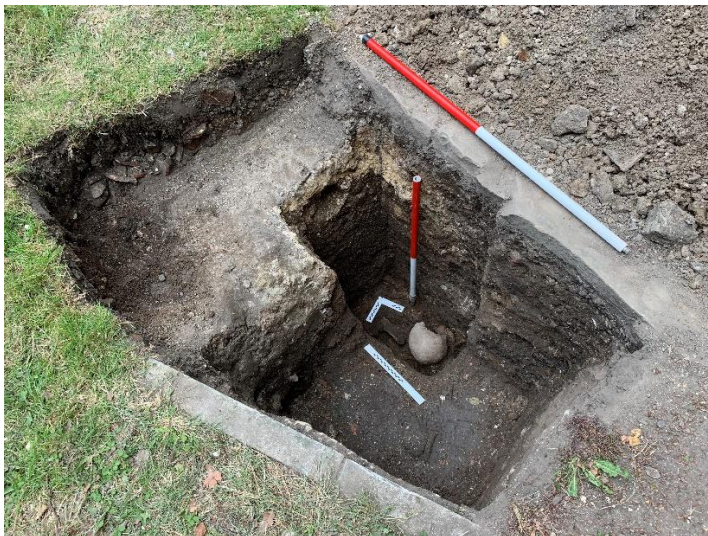
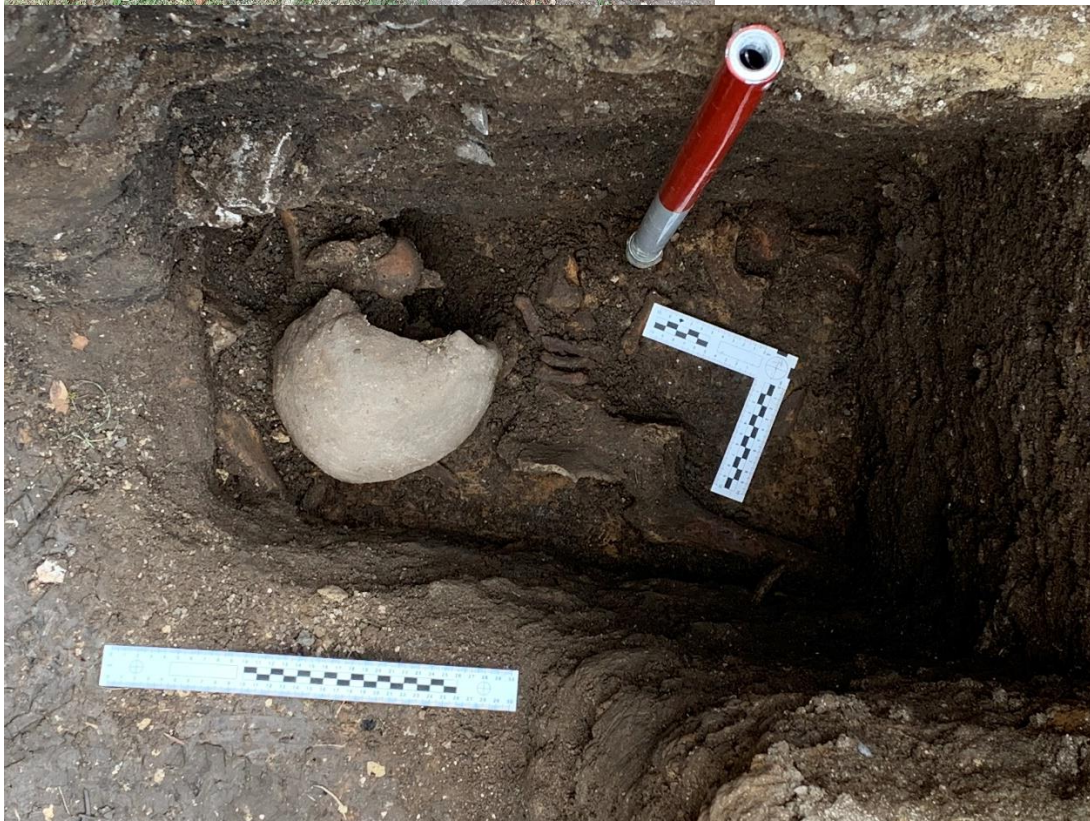
Figure 5: General view of pit 3 looking north-west with skeleton 28 exposed, and a detailed view of the grave. Note the placement of the skull directly over the abdomen area.

A clean layer of clay (**29**) was found at the very bottom of the pit. The clay could not be excavated, so its thickness and character are unknown. It is most unlikely that it was a natural deposit at this depth. Its presence immediately under an articulated skeleton (**28**) might be coincidental, or the clay might have been laid deliberately as a floor at the base of the grave. Excavation of a 2m-deep pit at the north-east corner of the Cloister in 2012 for the Hidden Treasures-Fresh Expressions project did not encounter a clean clay layer of this type (Keevill 2012, 2-3), nor did the few deeper excavations in the Cloister for the main HTFE project in 2015-16 (Keevill and Ward forthcoming). This might lend some support to the floor interpretation, but only further excavation could prove this either way. Skeleton **28** was obviously that of an adult, and appeared to be male (as one would expect in this location). The pelvis, both femora, the lower vertebrae and finger bones (probably of both hands) were found in the restricted area. The bones were generally in good condition, the body being supine, extended, and laid directly on clay **29**. The abdomen/chest area, however, was obscured by the skull already referred to (with at least part of a mandible, presumably associated), along with several other long bones.

The skeleton was found at the bottom of a homogenous, 0.8m-thick layer of mid-brown silty clay (**26**). This contained some rubble (stone, flint and tile). A sherd of early/mid 17th-century pottery was found just above the skeleton, and was given a separate context number (**27**) for identification; the soil itself was not notably different at this point. Later post-medieval pottery was found in the upper part of the layer. Stratigraphically, layer **26** appeared to seal skeleton **28** but should probably be regarded as a 'graveyard soil' within the Chapter House, thus 'containing' the burial. The finds do not help much as dating evidence, given that this area was used as a private garden for the Deanery from the middle of the 17th century onwards; horticultural disturbance of the soil will have occurred throughout this time. For reasons discussed below, the nature of the stratigraphy and finds here may be misleading anyway.

Skeleton **28** was an articulated burial, but with parts of what may have been a second body in the grave. The disarticulated skull and other bones over the abdomen were either from an earlier burial which had been disturbed by this one, or were from the same body and had been displaced at an unknown time in history. Either way, the bones had been placed in this grave with a degree of care. It seems highly unlikely that the disturbance was caused by the excavations of 1936. A note in The Times for 2 April of that year stated that “the bones were not removed, and were covered up again within half an hour of their having been discovered”. It seems very unlikely that bones would have been moved around to this extent within half an hour, and the disturbance evident in the burial is therefore assumed to have happened in antiquity. The grave itself is most likely to be of medieval date given its location immediately inside the Chapter House’s entrance, and its orientation on the long axis of the building. An Anglo-Saxon date is felt to be much less likely, while a Roman date can be ruled out because of the location within the area of the town.

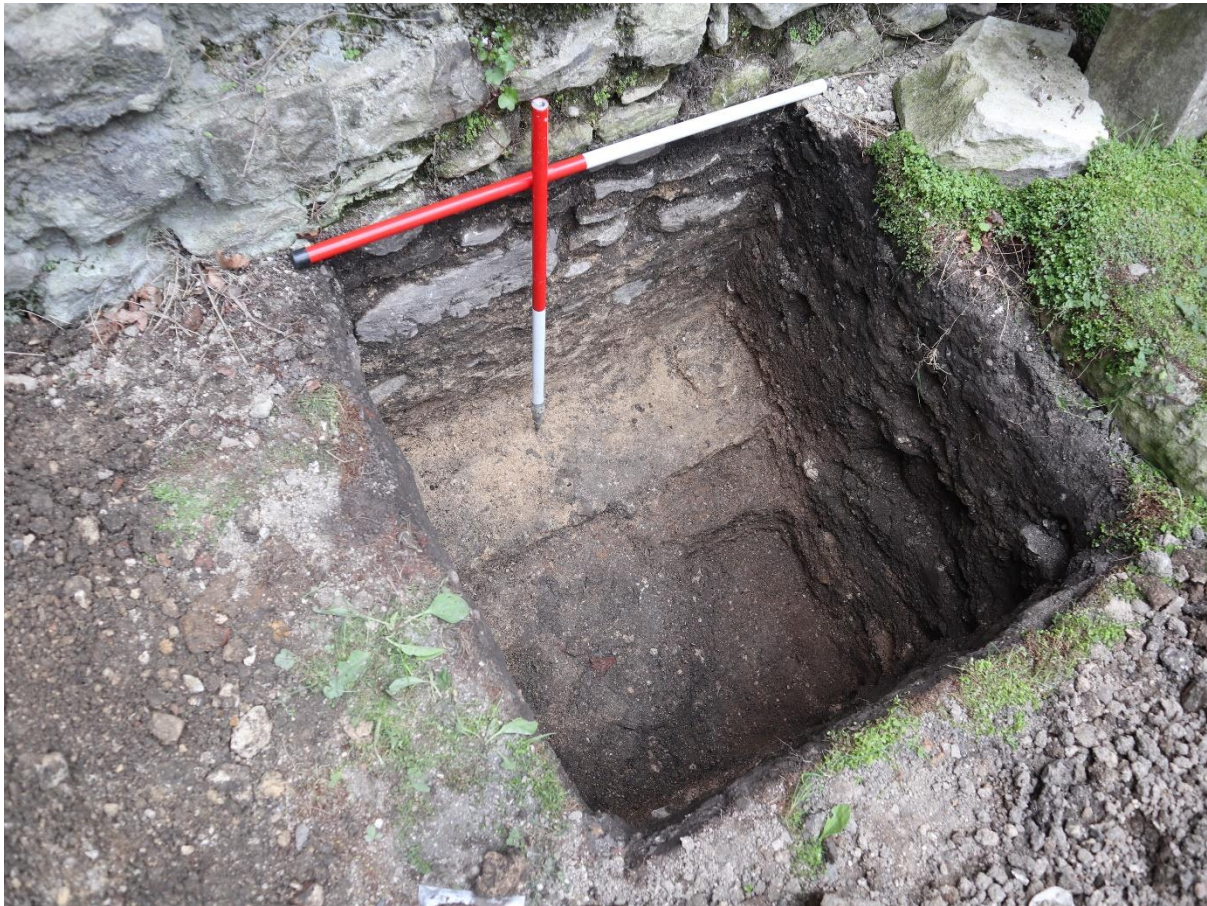
Figure 6: Pit 4 looking south-west, with the offset foundation plainly visible – note the slight upstand at its west (right) end. This image also shows the sondage dug in context **38/39**, in the lower right corner of the pit.

Foundation offset **36** was 0.3m wide, and notably even along its length. A compact mortar spread was evident in places, and may have been a remnant floor bedding. A slight thickening in the offset was noted at its west end, directly under one of the eroded angel corbels at high level in the wall above. While this might have been related to the corbel in some way (the base for a wall-shaft?) it could simply have been part of the floor bedding. The wall itself (**37**) rose vertically off the foundation, with 0.84m being exposed within the pit. Not surprisingly the masonry was in good condition, with traces of a possible lime render in places: the stonework was certainly not of a high-quality (ashlar or similar) finish in its own right.

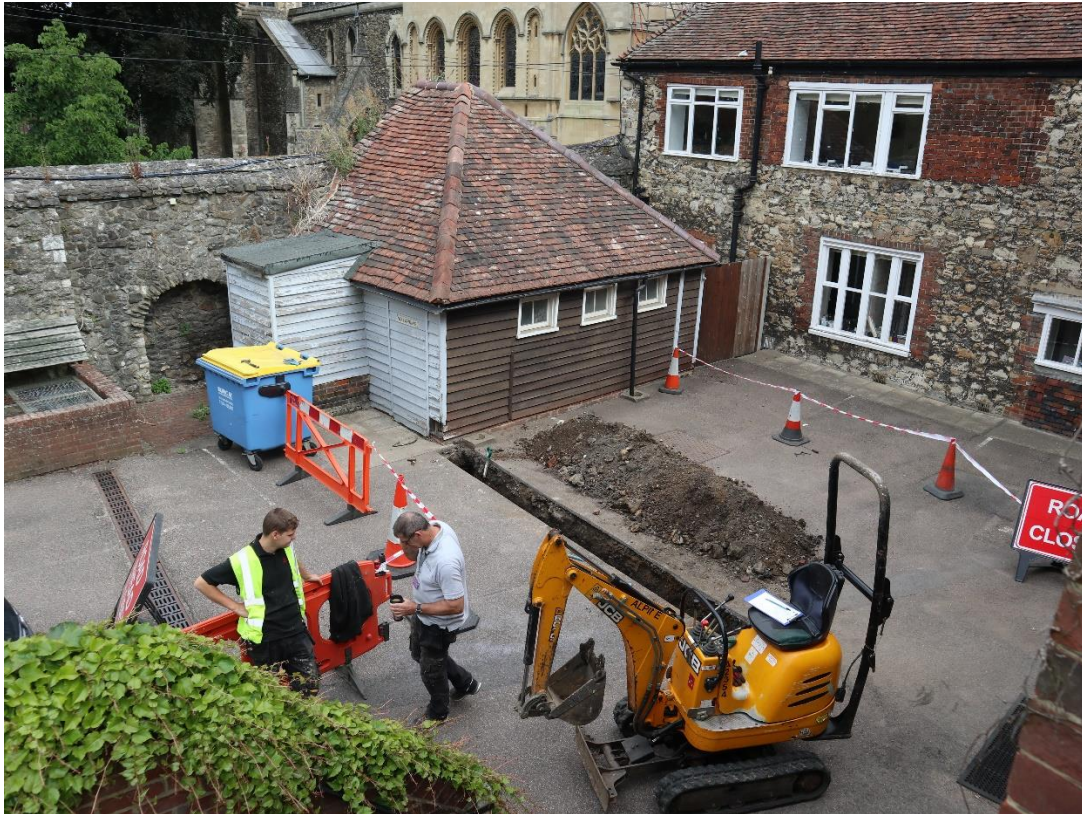
Figure 7: The new water trench in the former Dorter area, looking north-west. The stone range to the right is described as having 16th-century rectangular brick dressed window openings in the listing, which would suggest a potential medieval date for the surrounding masonry (see footnote 1).

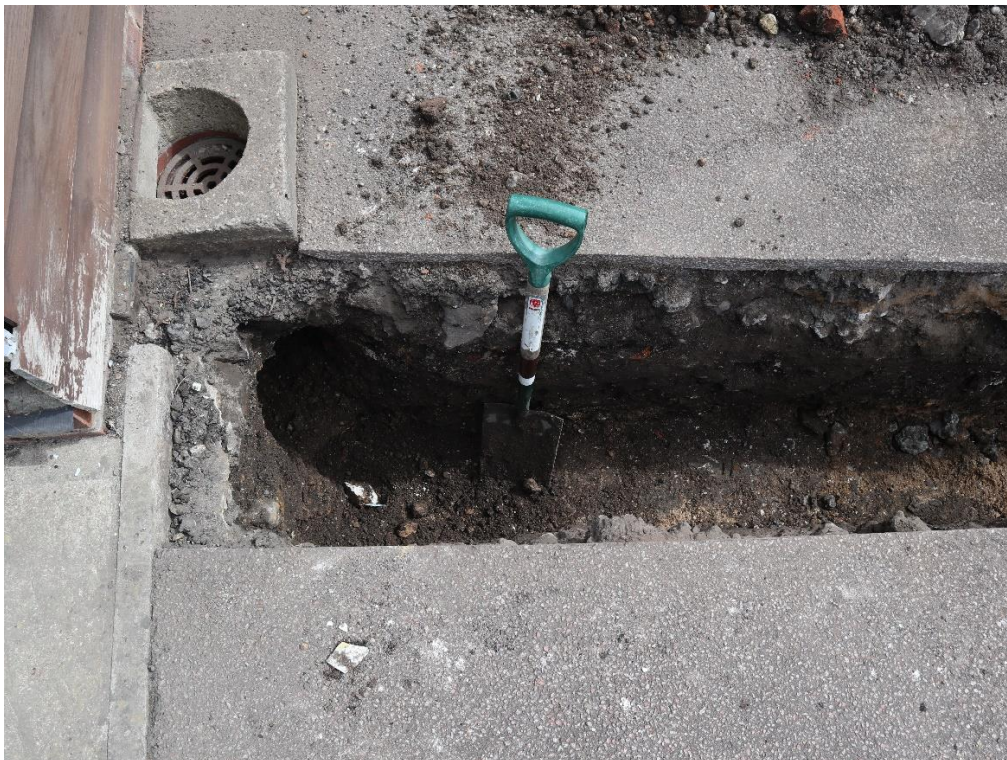
Figure 8: Sample section of the water main trench with rubble layer 18 at the base.

The upper few centimetres of a pale brown to buff layer of loose chalk, flint and stone rubble in sandy mortar (**18**) were found at the base of the trench, ie around 0.7m-0.75m below ground. No pottery or other artefacts were found. The same layer had also been revealed in 2018's pit 1, where it was at least 0.75m thick from 0.65m down (layer **9**); given the gradual slope of the ground here from south to north, this is the same depth as in the water trench. The rubble was sealed by a 0.6m-thick layer of coarse mid-brown silty clay (**17**) mixed with brick, stone and tile rubble. Though again no pottery (or clay pipe) was present, the character of the bricks suggested that this was a later post-medieval layer, probably of early/mid 18th-century date. A pair of services (not numbered) had cut the rubble in the east half of the trench: one, in blue plastic, was obviously very modern but the other (an iron gas pipe) was most likely of later 19th-century date. The remaining three layers comprised a 20mm lens of sand

(16) over the rubble, forming a bed for 80mm of Type 1 roadstone (15) acting as the sub-base or the present tarmac courtyard surface (14), which is 50mm thick.
