Hidden Treasures, Fresh Expressions

Archaeological Surveys, Excavations and Watching Briefs at Rochester Cathedral 2011-2017

Graham Keevill and Alan Ward, with contributions by Cathy Keevill
On behalf of the Dean and Chapter of Rochester
March 2019

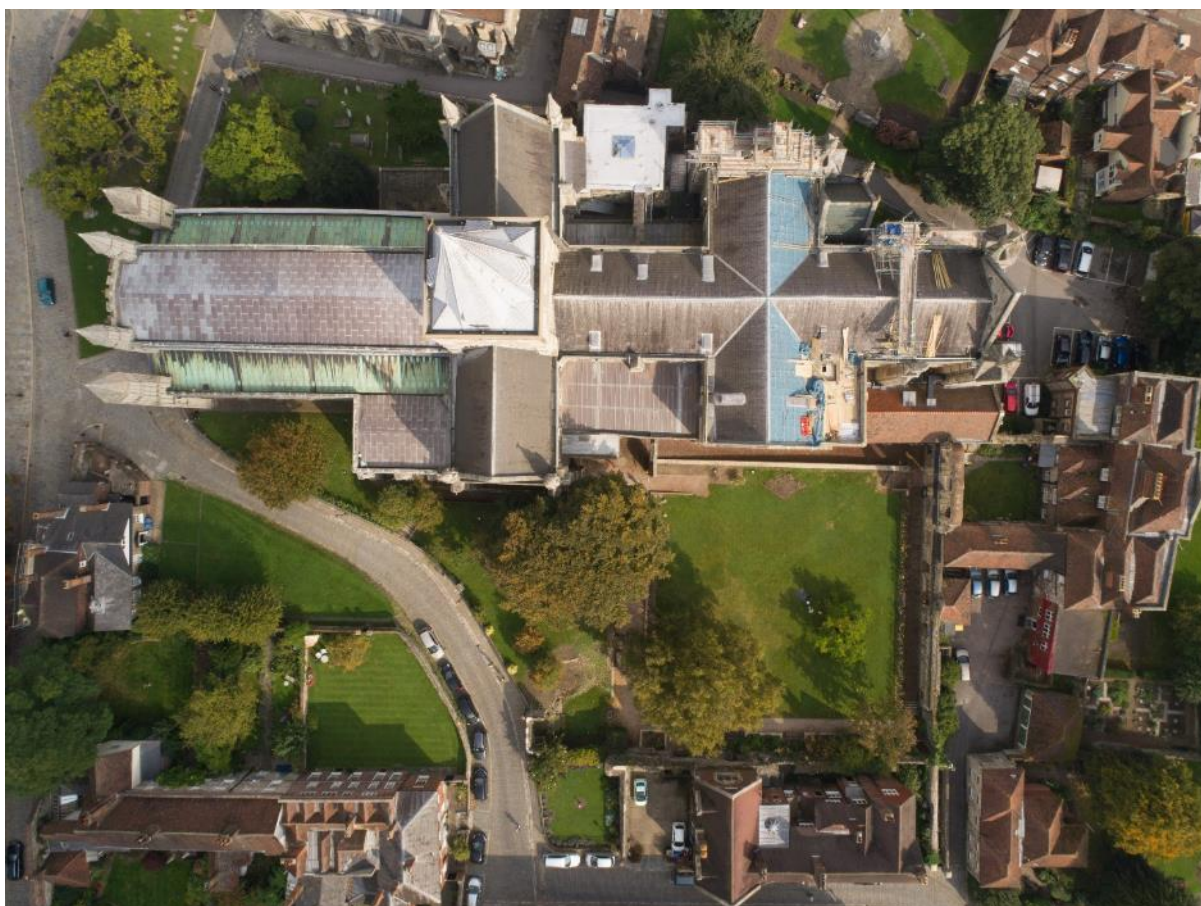
Aerial photograph of Rochester Cathedral. The cloister is to the right of centre, with the Chapter House and Old Deanery (now the St Andrew's Centre, partly used by the King's School) to its right. The current Deanery, College Green and Southgate – formerly the Bishop's Palace – are at bottom left. Photograph by kind permission of Adam Stanford.

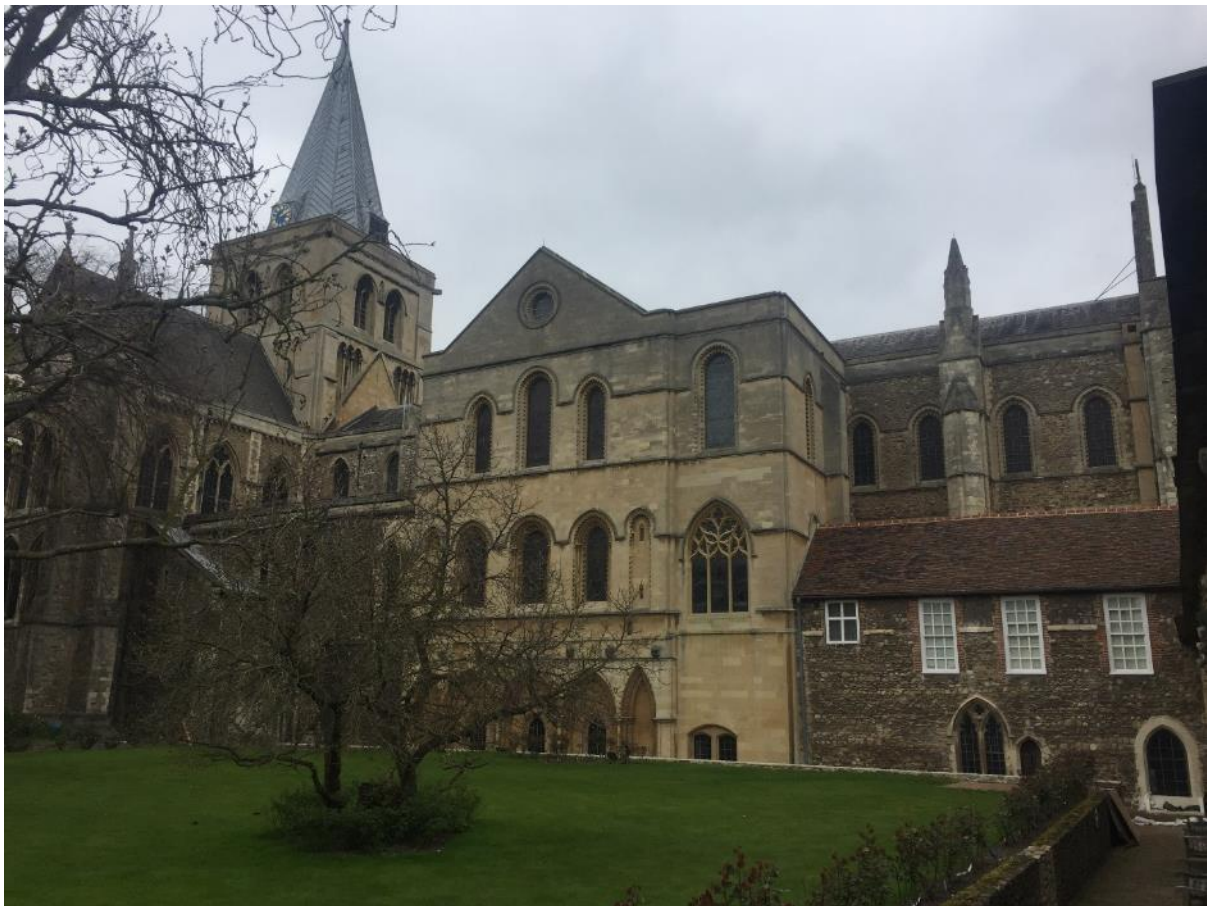
Plate 2: The cloister and eastern arm of Rochester Cathedral looking north-west. The two-storey building at bottom right is the Chapter Library (on the first floor), with the vestry beneath.

Rochester was established at a crossing point over the River Medway (Figures 1 and 2; Plate 2). This crossing point was in use from at least the Late Iron Age, but was, probably, at that date by ferry rather than a ford. Even with a lower water table the depth, tides and currents would have been too great to cross by foot or animal. Supposedly the nearest ford was four miles further to the south at Lower Halling, although one at Upnor has been suggested (Thornhill 1976, 126).

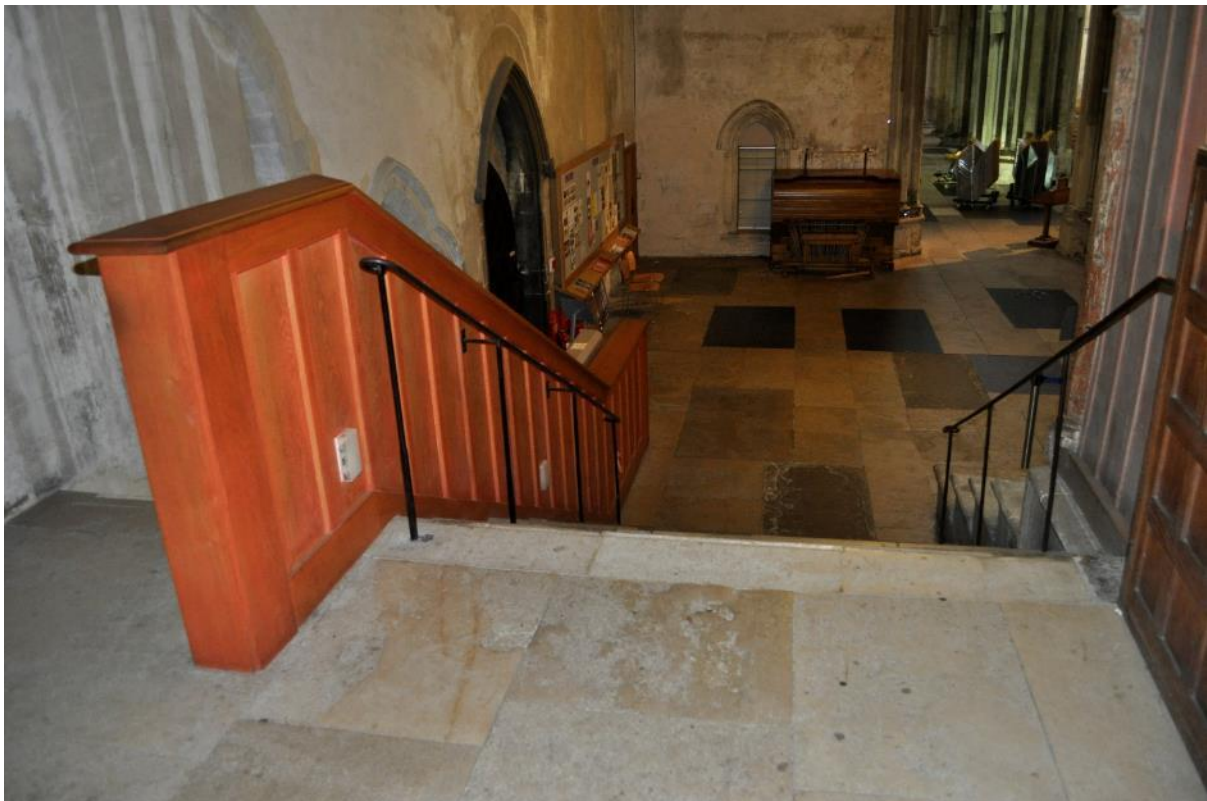
Plate 3: The South Quire Aisle and the Kent Steps looking east in 2014, before the main contract began, showing the change in floor levels. The timber structure to the left hid the wheelchair lift.

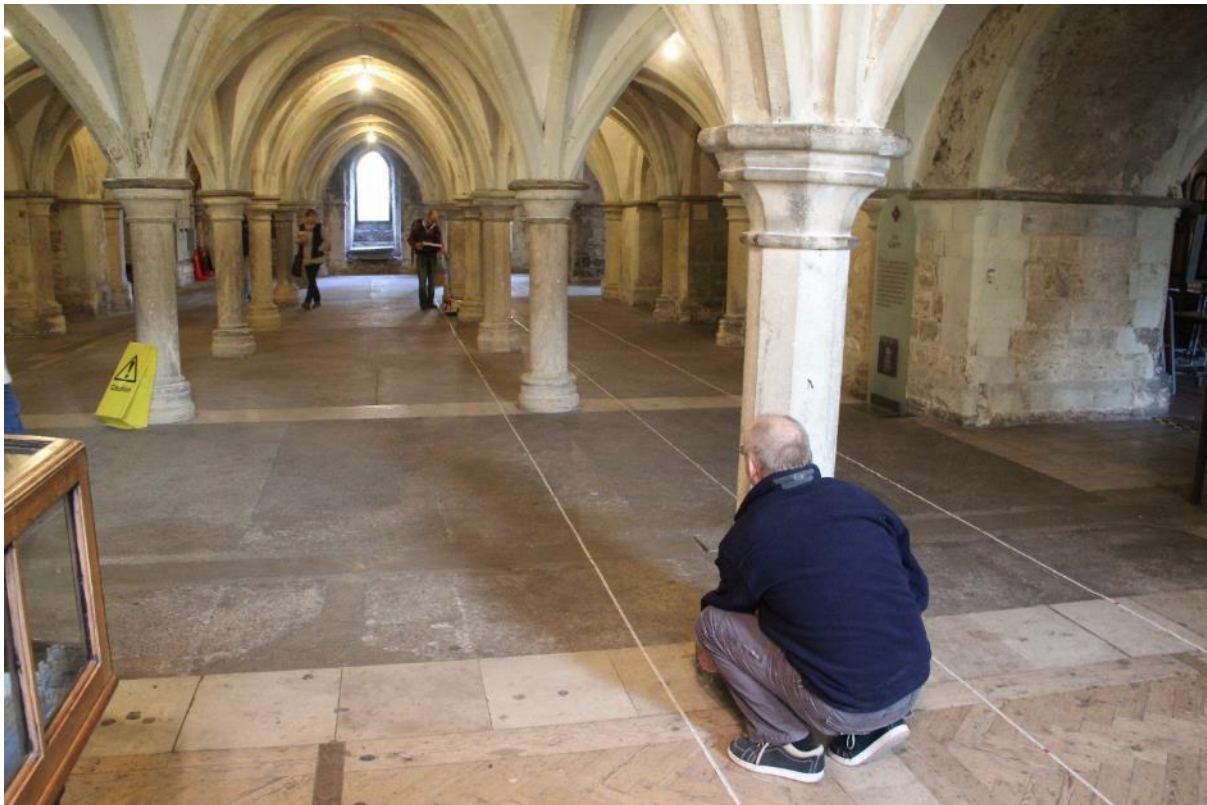
Plate 4: The GSB team carrying out a GPR survey in the main crypt in 2011, looking north. Note the varied floor finishes and poor lighting.

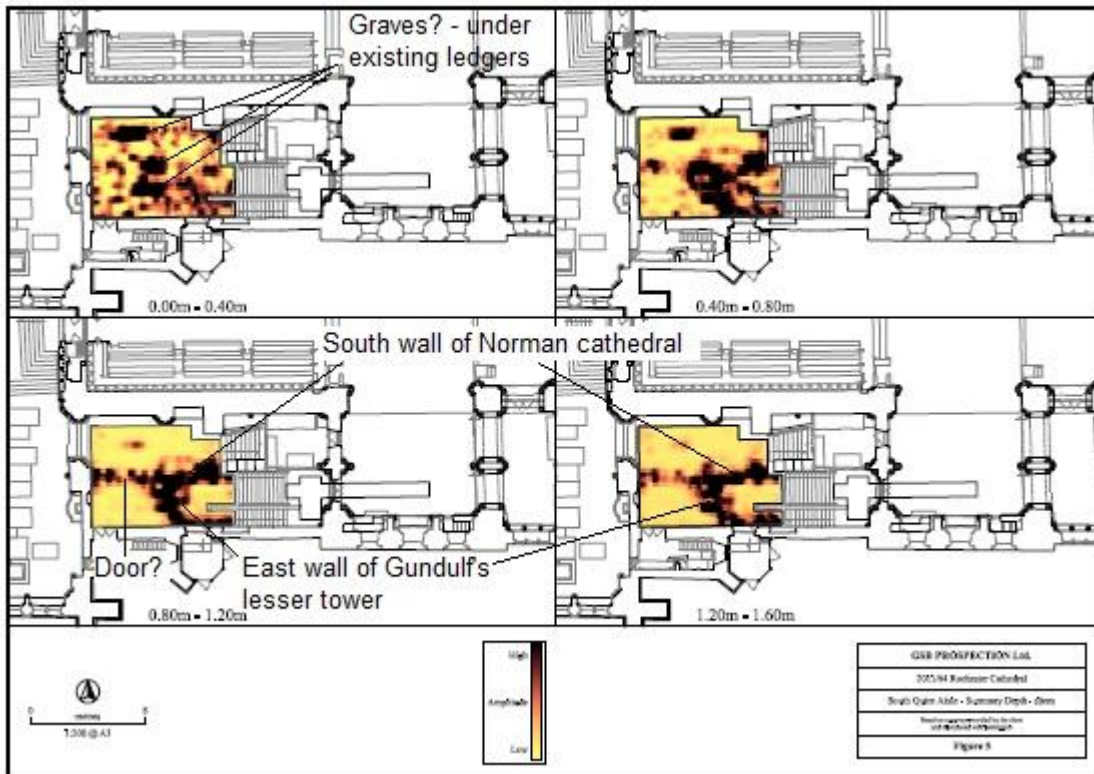
Plate 5: Time slice images of the GPR results from the South Quire Aisle, with provisional interpretation of features added in 2012. The anomaly identified as ‘Gundulf’s lesser tower’ probably relates to the Norman masonry found under the Kent Steps in 2014 - see Chapter 4.

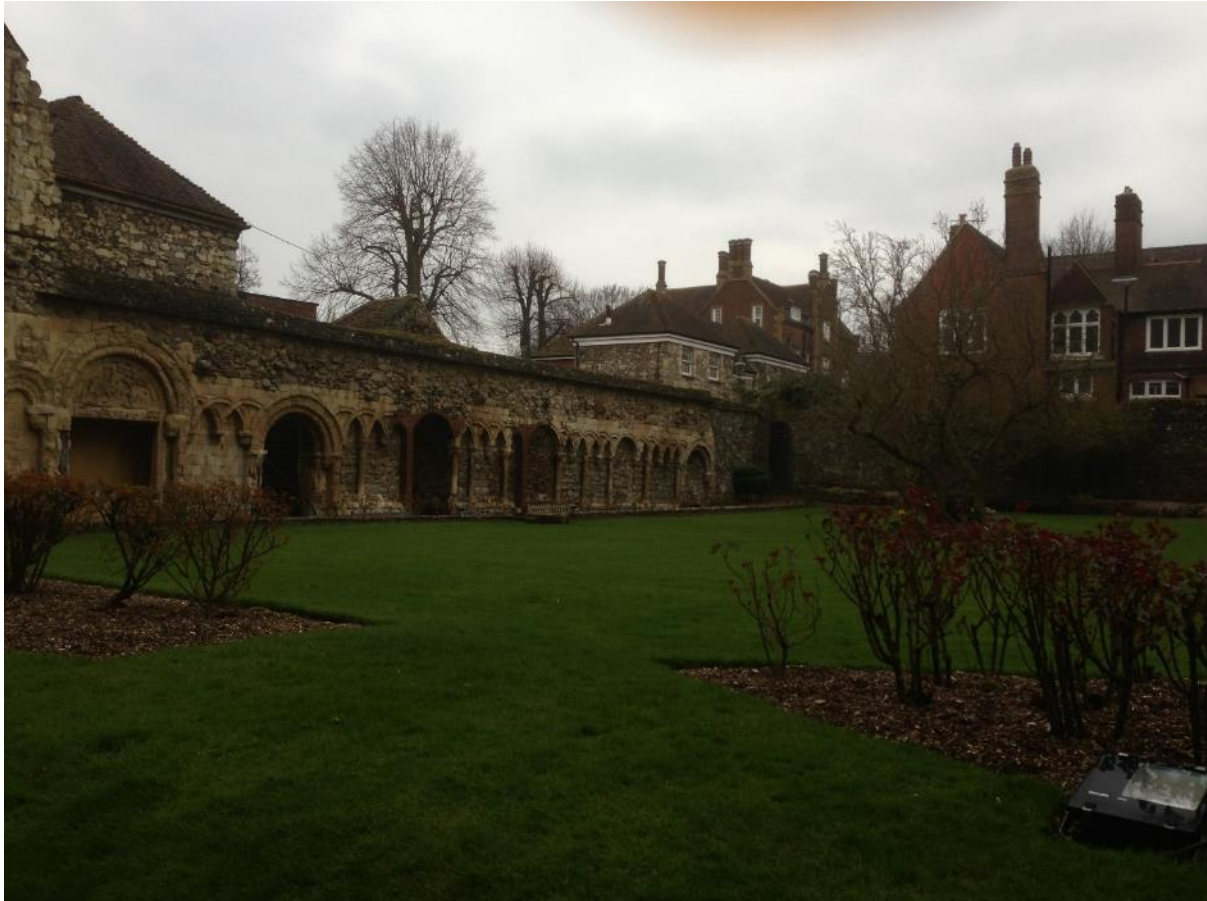
Plate 6: The East Range of the cloister. The red brick structure to the right, Garth House, stands on the site of the former Fraternity (refectory) range on the south side of the cloister, behind the Roman town wall.

by Ernulf c.1120. These are usually considered to be the remains that we see today on the east and south of the cloister garth (Plate 6), replacing the ranges constructed by Gundulf to the west. It has been suggested that the West Range is also of the time of Ernulf (McAleer 1993, 20). Up until the date he was writing McAleer had been the only dissenter regarding the position of Gundulf's cloister, placing them in the area of the existing garth (ibid, 13).

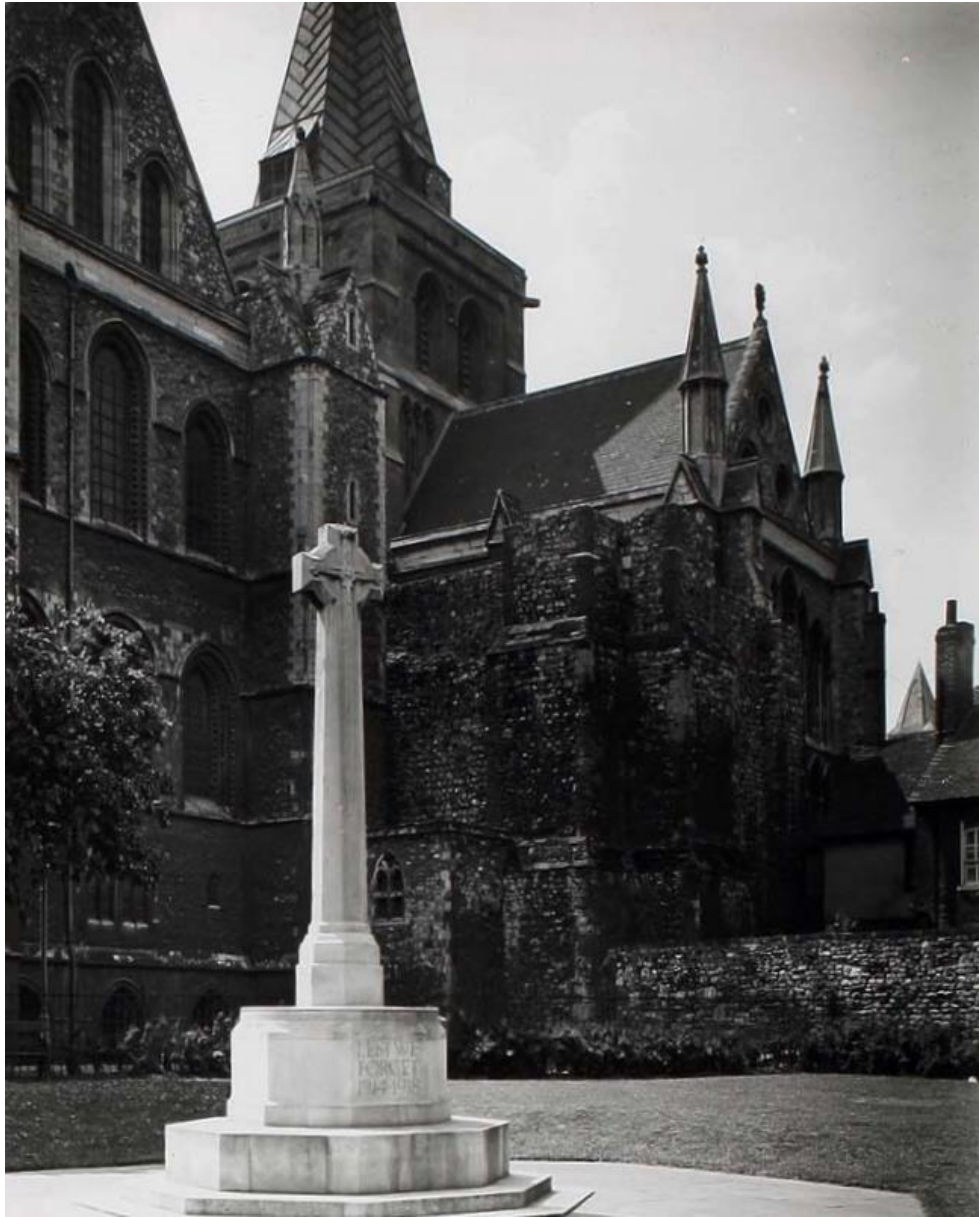
Plate 7: Gundulf's Tower with its massive clamping buttresses, to the right of the War Memorial, in 1936. Historic England Archive image AA52/5142.

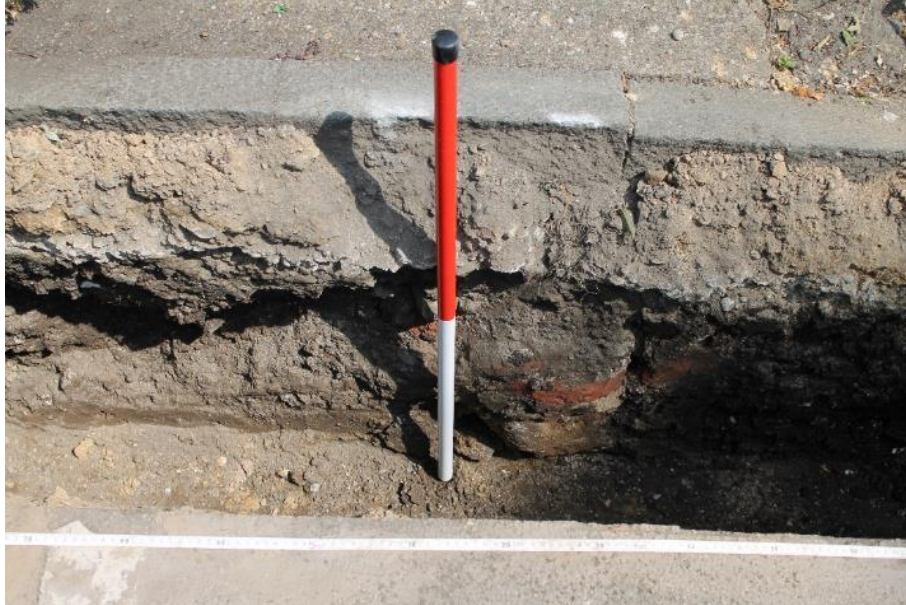
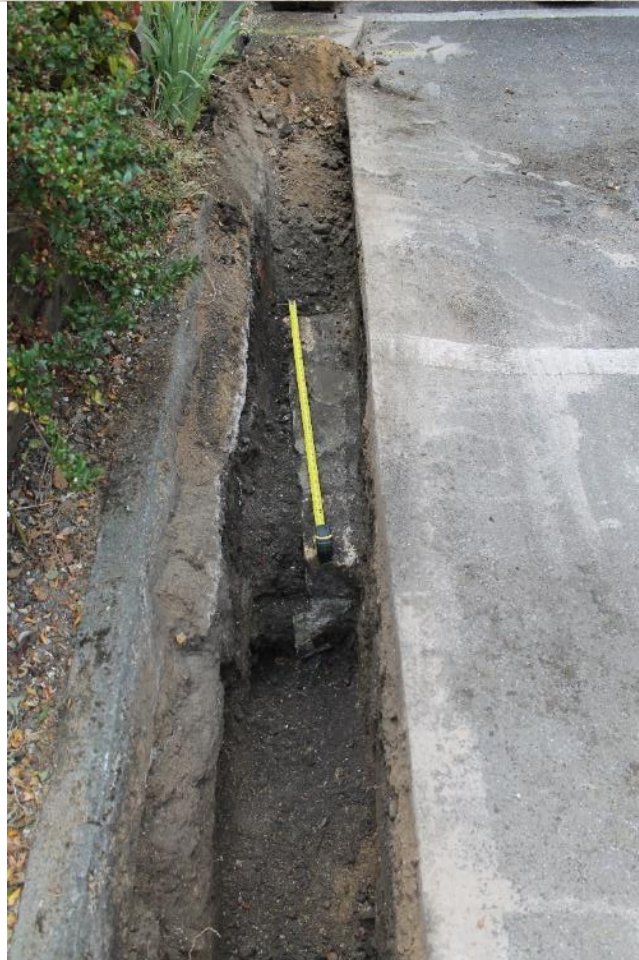
Plate 8: Top, wall 4 looking north (note that the kerb has moved slightly on its east edge). Bottom, wall 7 looking east.

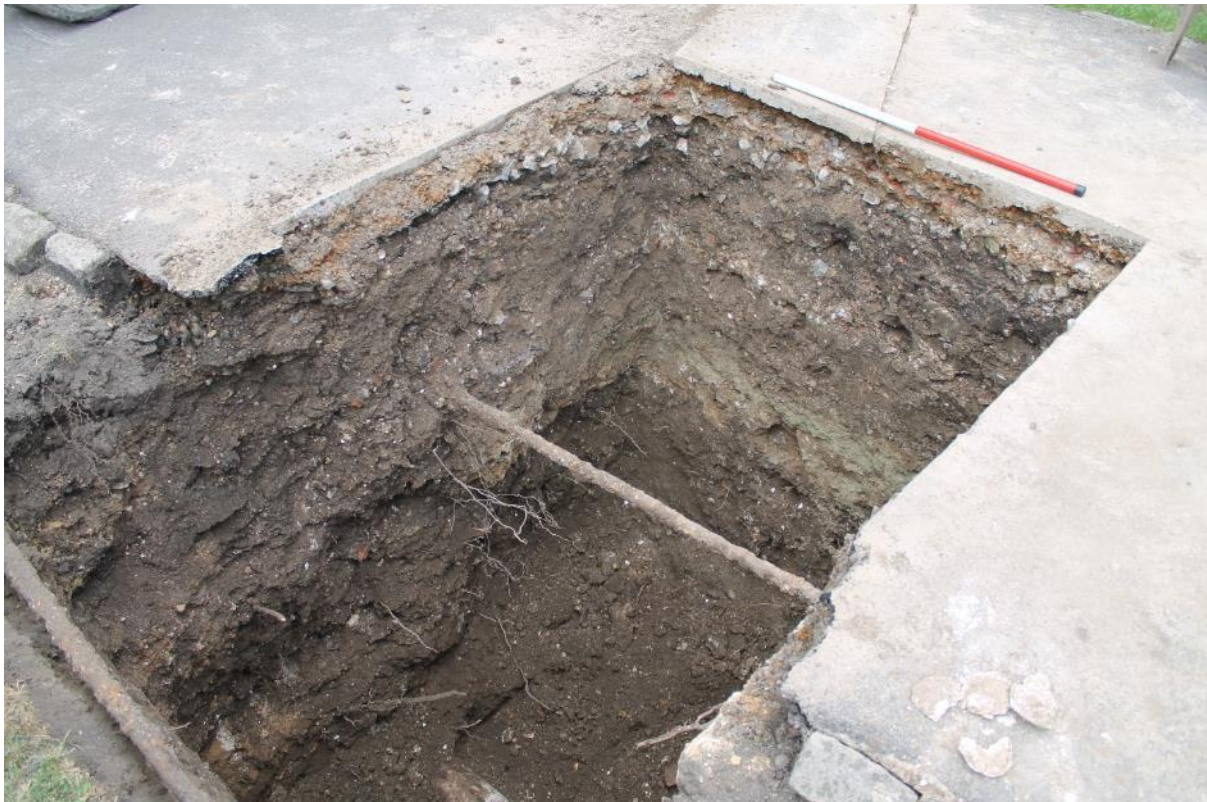
Plate 9: The excavation for a new manhole in the roadway, with the existing sewer just visible at the bottom, looking north-west. The edge of the pipe trench can be seen quite clearly in the long section, cutting through all the layers except for the tarmac and its bedding.

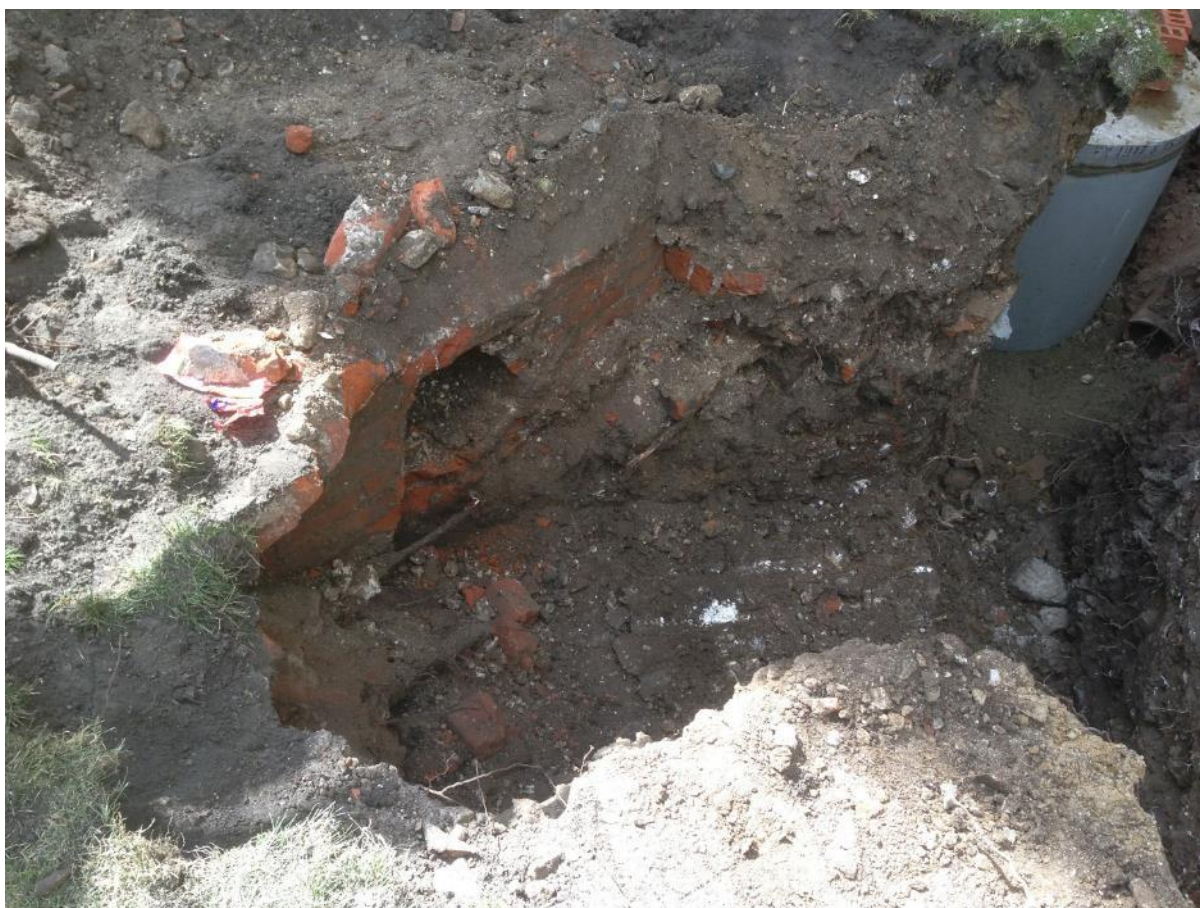
Plate 10: The remnants of culvert 27, with the opening for the adjoining culvert 28 visible.

The trench between the two new manholes had to be expanded when parts of it collapsed where a brick culvert (27) was found running at an angle to it. The culvert was about 0.6m wide, with a similar height to the crown of its arched roof. The floor was flat. It was aligned on the corner between the lesser north-east transept and the presbytery, suggesting that it had taken rainwater from the high roofs over these structures away from the building. A second culvert (28) joined it from the south-east, perhaps having emanated from the north-east corner of the presbytery/Ithamar Chapel (where it too could have collected rainwater). This culvert was completely clogged with earth, and both had been broken in antiquity. Evidently they pre-dated the Victorian drainage system: the brickwork suggested an 18th-century date for them.

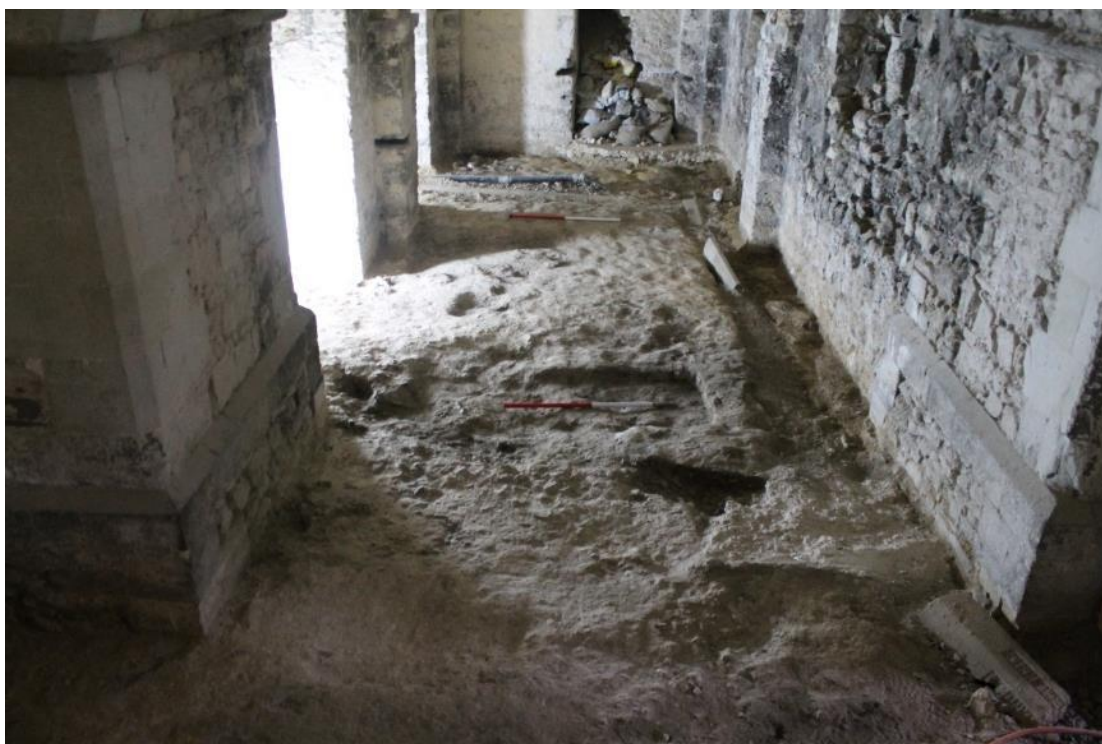
Plate 11: Roman pits in the north aisle of the Norman crypt. The nearer scale is in pit 1002, with pit 1005 just in front of it.

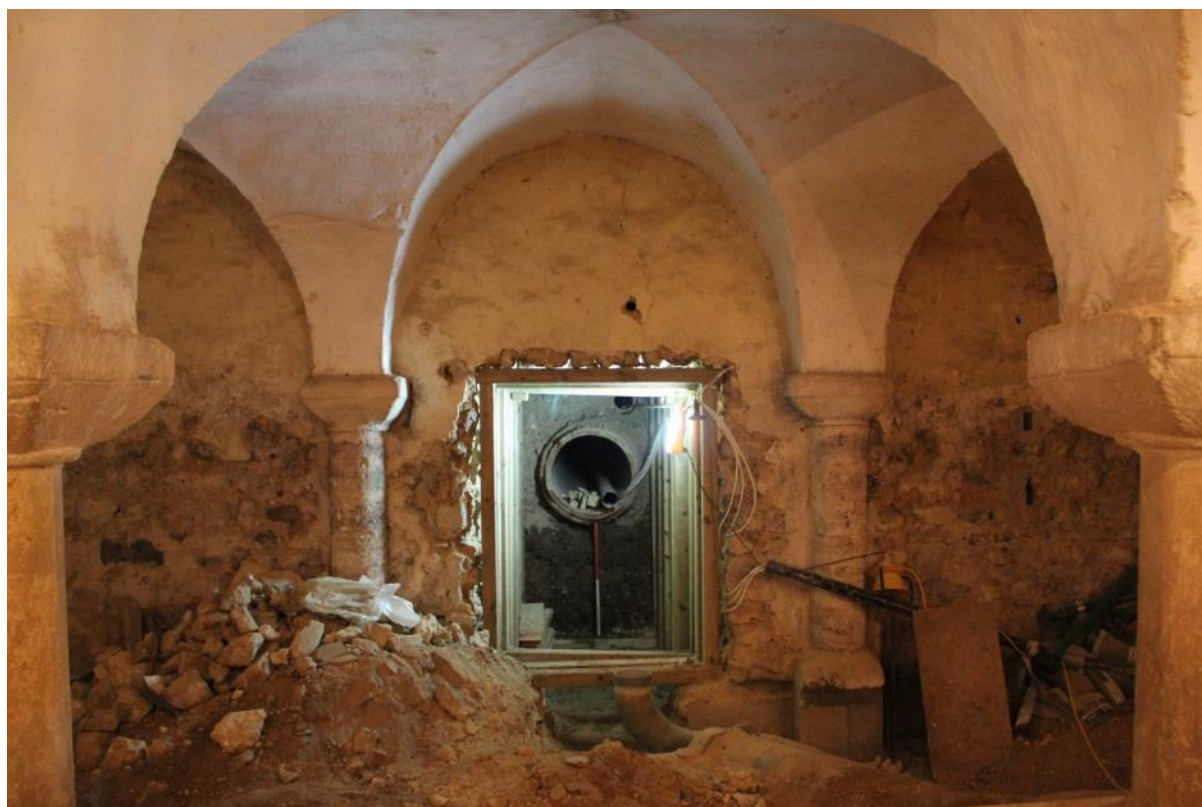
Plate 12: Irvine's tunnel being re-excavated, January 2016. The 1m scale rests against Roman layer 1226, which Irvine had left largely in situ - the grey backfill of his trench is clearly visible above it.

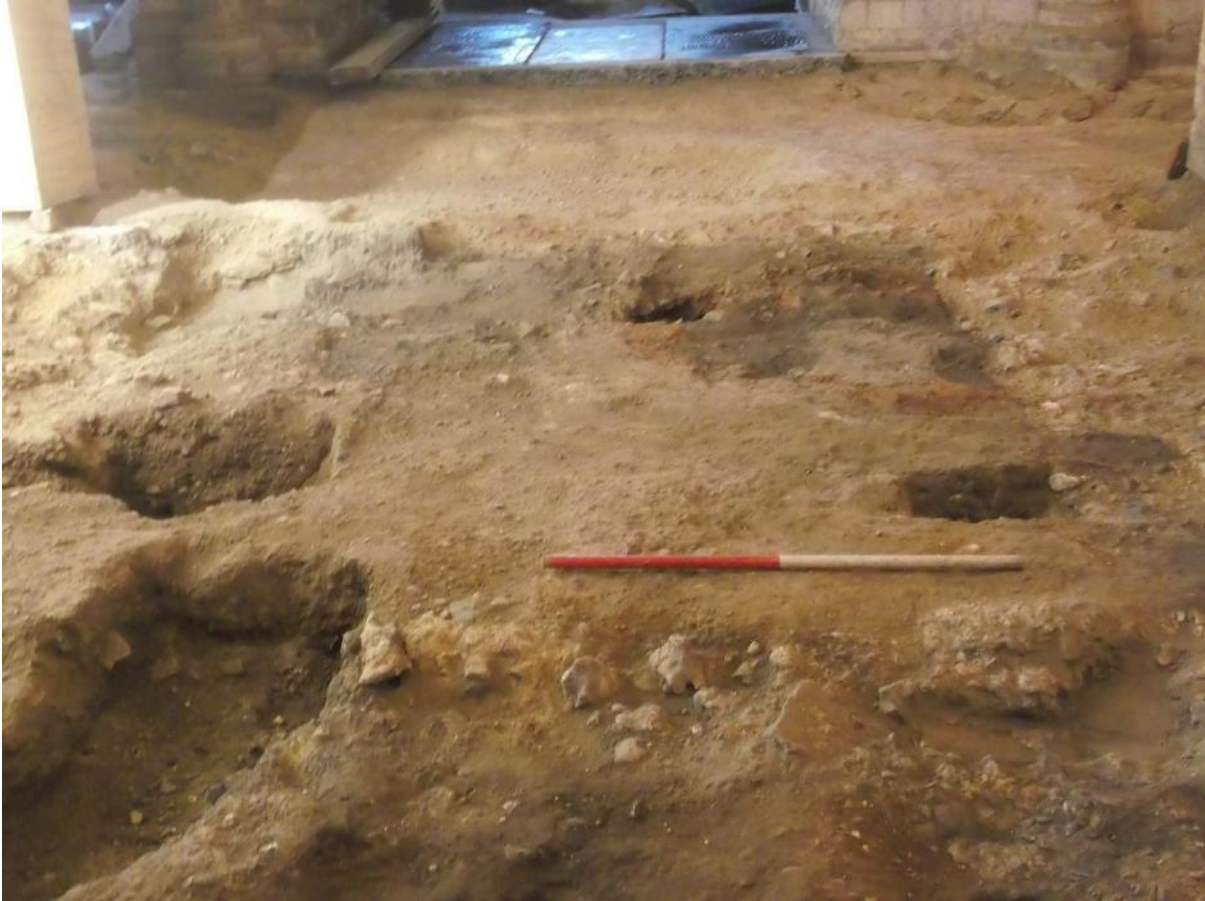
Plate 13: The Roman building in the main crypt space looking east. The 1m scale rests on the clay floor, 775. The flints in front of it are part of the thickened wall/possible threshold, 809. The floor had been cut by a pit - the darker area in its upper right corner here; the building was also cut to the south (right) by the sleeper foundation for the late 12th-century piers of the crypt.

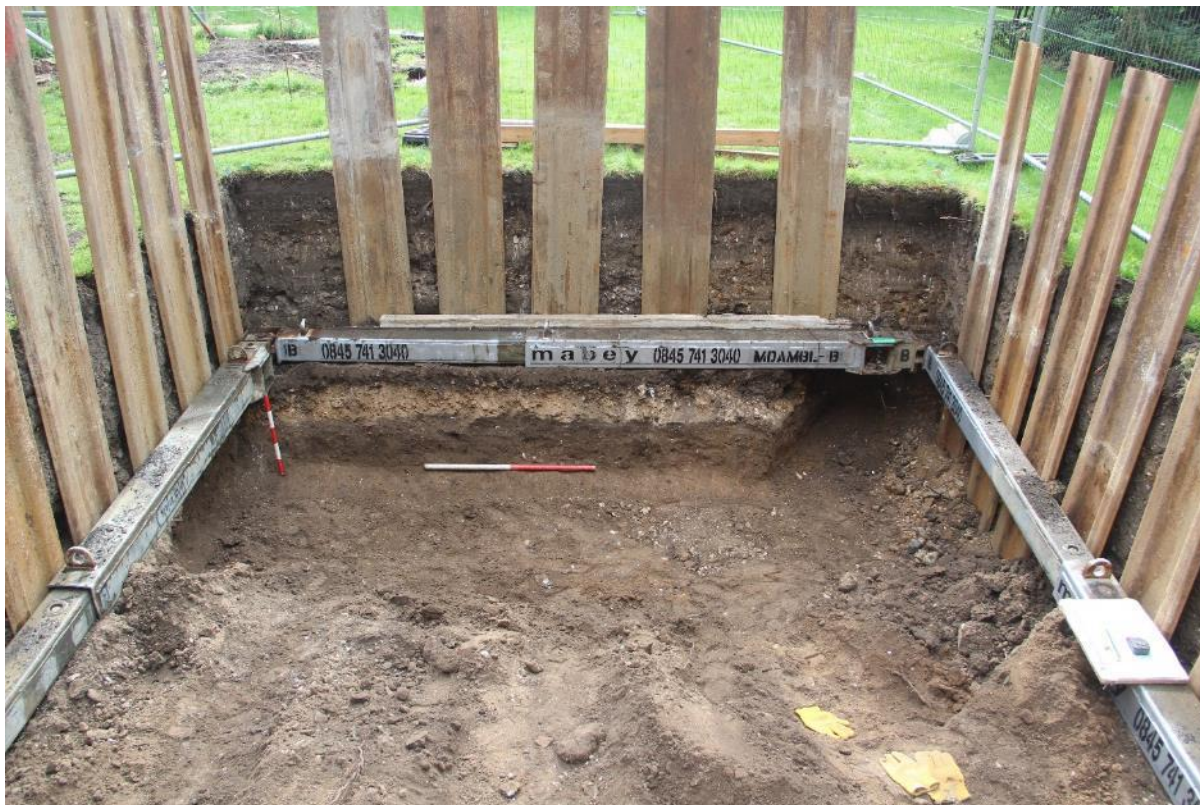
Plate 14: Rubble and mortar foundation 1590 on the east edge of the soakaway pit in the Cloister Garth. A modern feature in the south-east corner of the excavation had removed the south end of the foundation.

the Garth (see below). The materials used were different to the Norman work, however, and varied within the foundation trench: loose mortar fragments with a few flints were found to the north, with loose chalk fragments and areas of sandy mortar to the south. These factors cast doubt on that interpretation, but did not disprove it. The available evidence cannot prove either a Roman or Norman date for 1590.

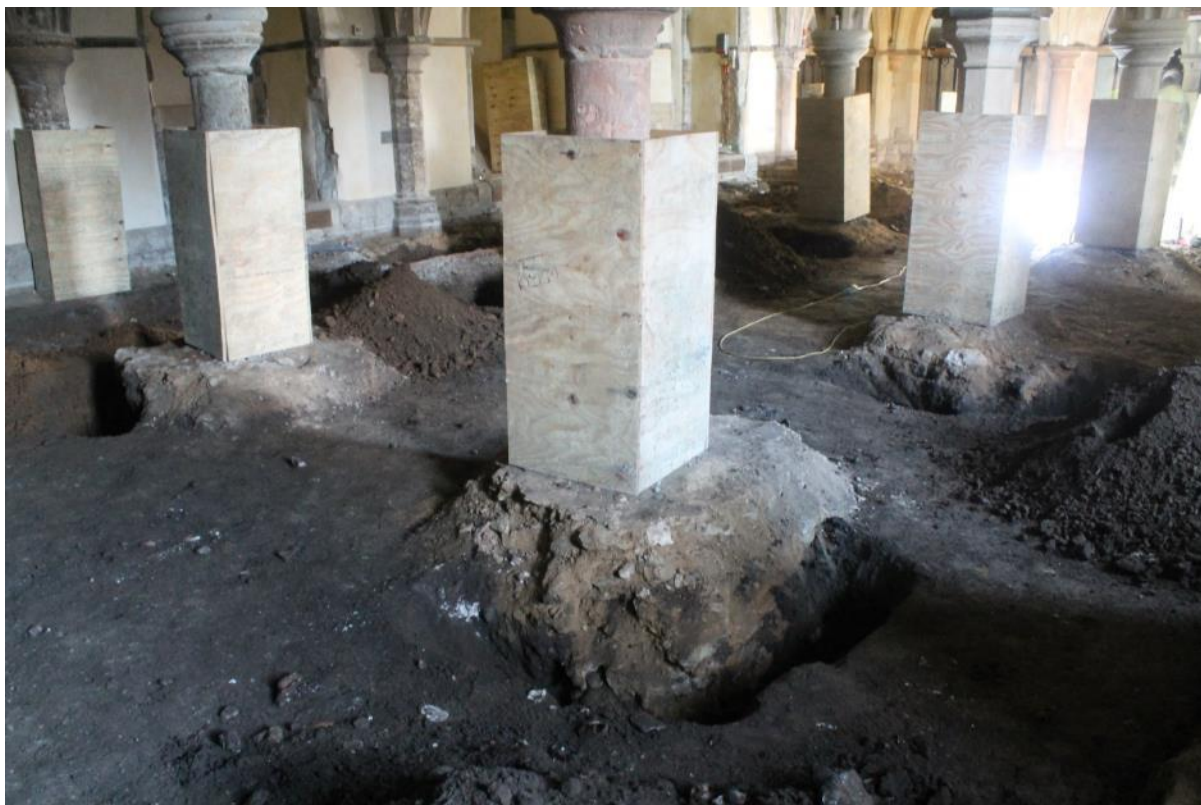
Plate 16: Excavation within St Ithamar's Chapel looking south-west, with the dark brown clayey loam exposed between (and cut by) the late 12th-century foundations for the chapel vault.

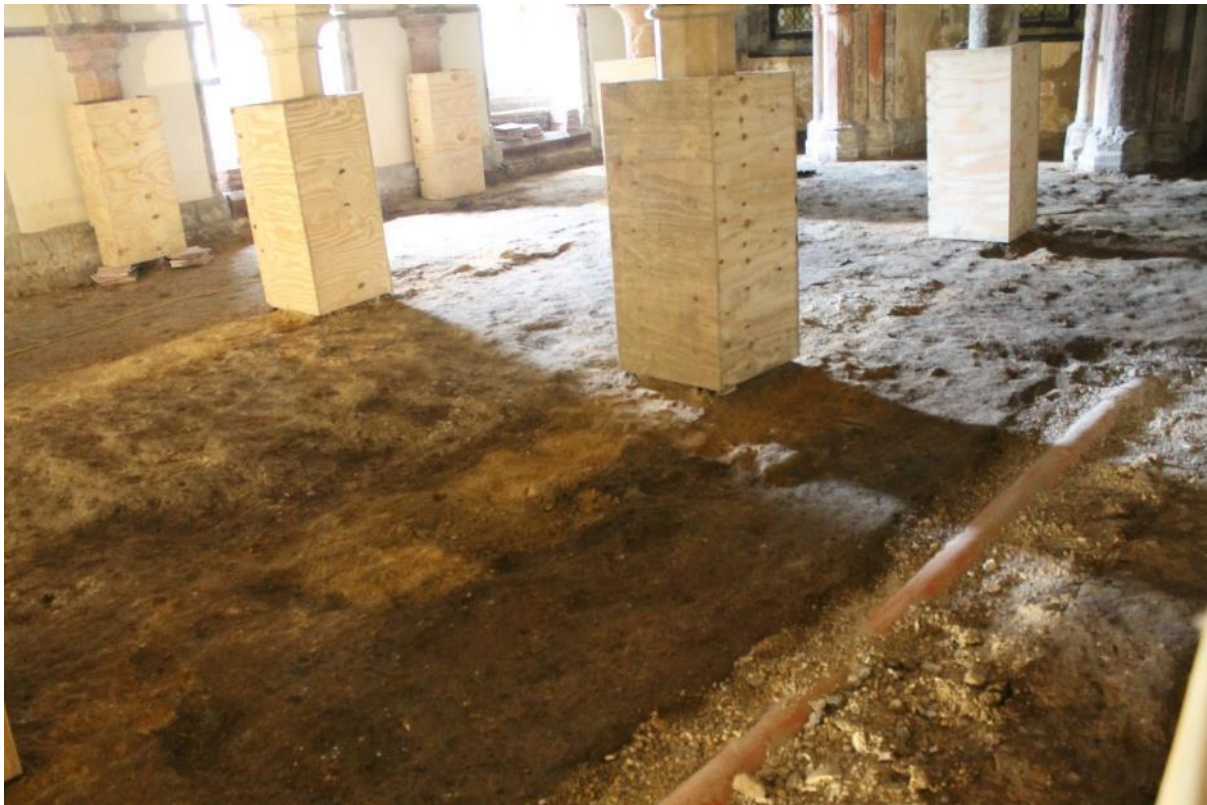
Plate 17: Excavations in St Ithamar's Chapel at an early stage, with the foundations for the High Altar support walls (615) and patches of mortar floor/bedding (605) exposed.

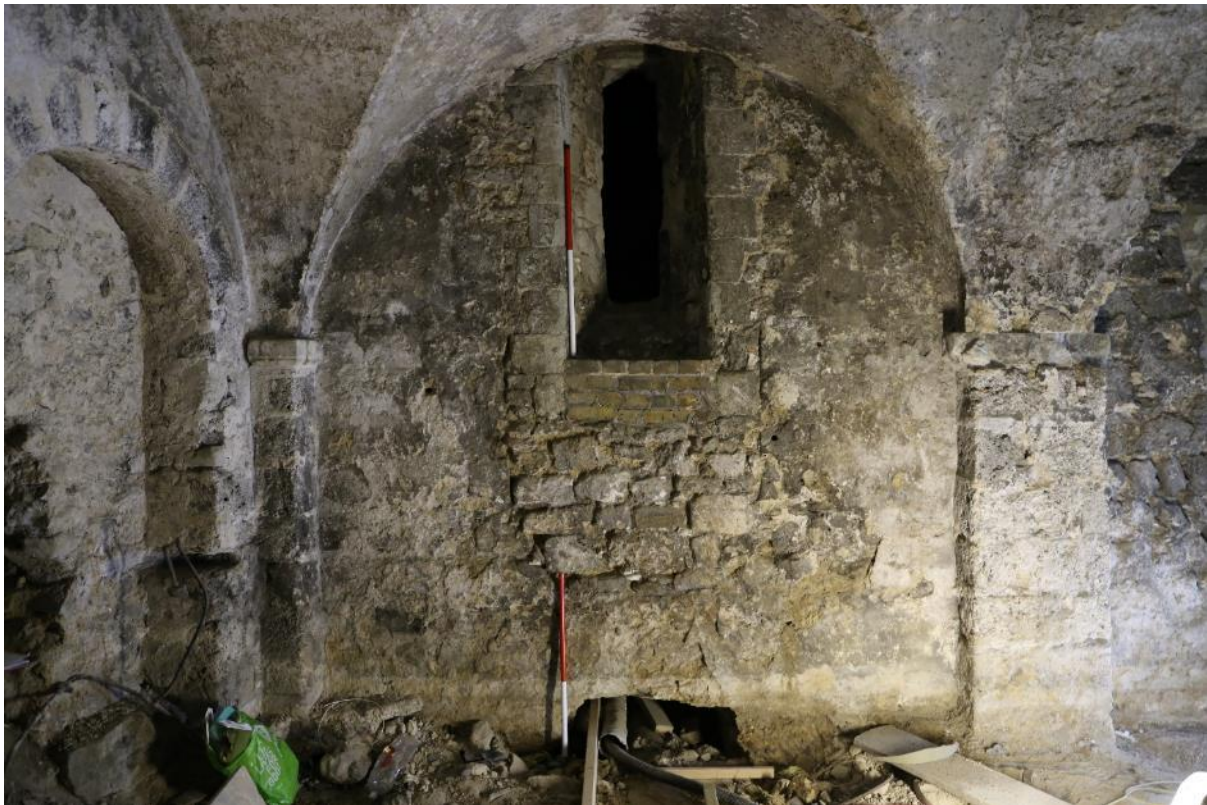
Plate 18: The partially blocked arch in the outer wall of Norman crypt's north aisle was used as the route to get the new heating ducts from under the crypt floors into the 'Gundulf Shaft' behind the arch. The area of blocking between the two 1m scales is easily recognisable on the left (west) side of the arch in this photograph, taken just before work started in June 2017.

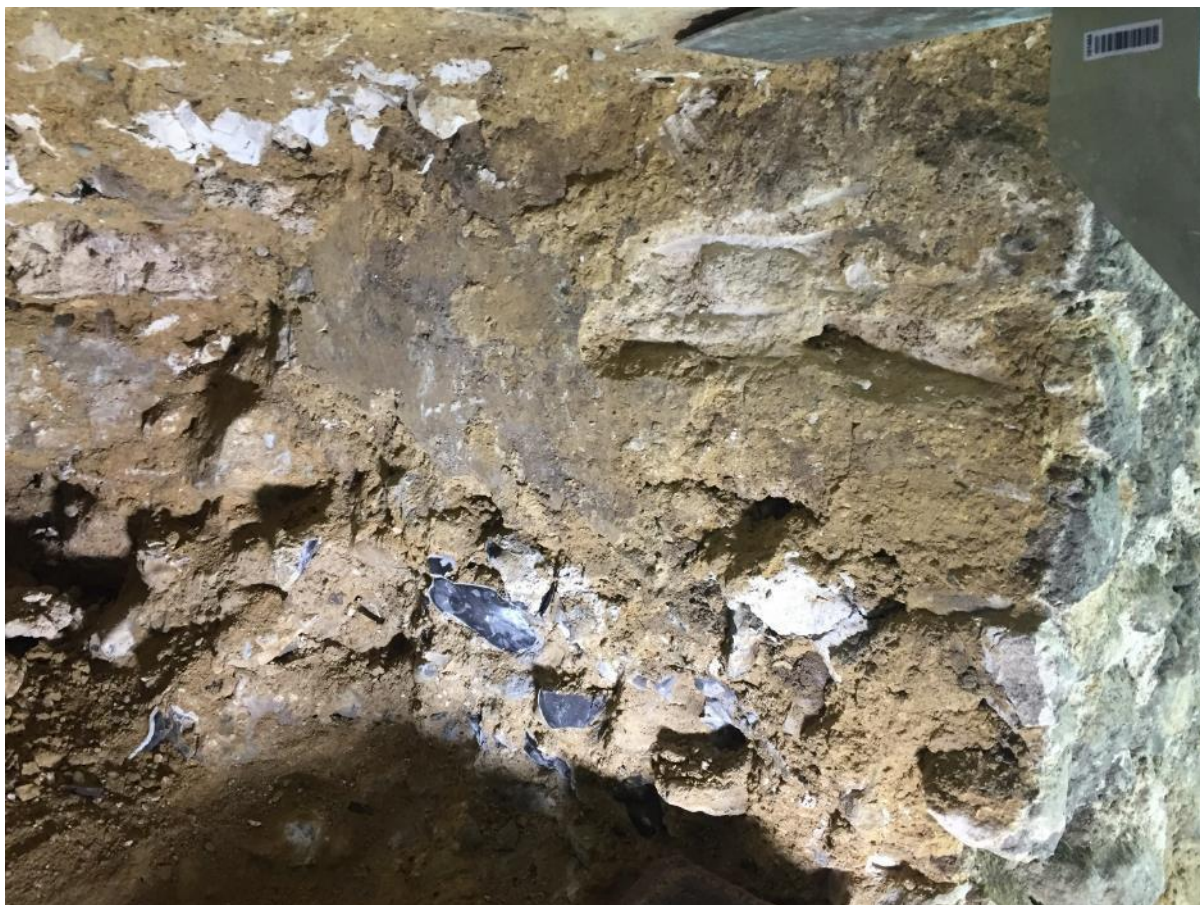
Plate 19: The tufa jamb stones on the east side of the arch were exposed during the work. The area of render in the centre of this photograph is original, ie Norman. The blocking of the arch, though all but solid, peeled away from the render surprisingly easily.

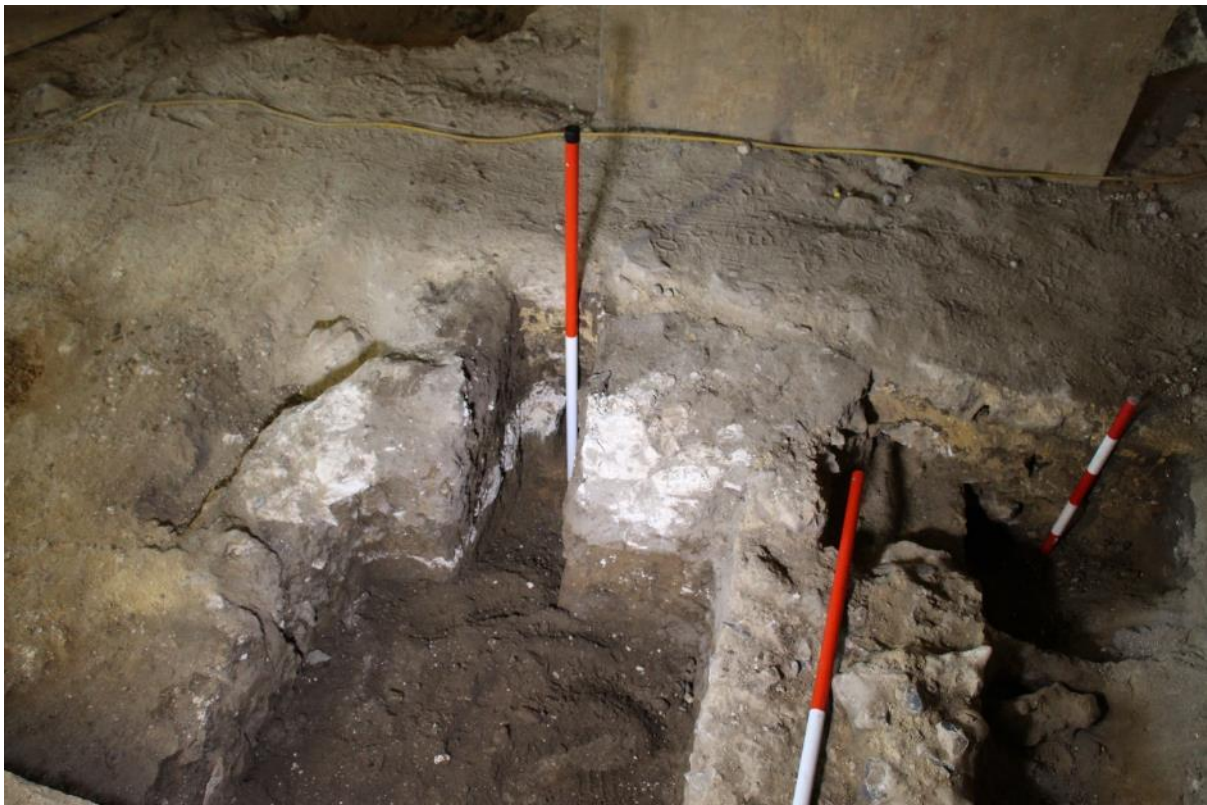
Plate 20: The north wall foundation of the Norman crypt was re-used as the sleeper footing for the piers of its late 12th-century replacement (the timber protection for one of the piers can be seen here). The two vertical scales (1m and 50cm) rest against the face of the Norman foundation (684). The chalk (785) in front of the foundation is a remnant of a medieval (possibly late 12th-century) floor butting against 684.

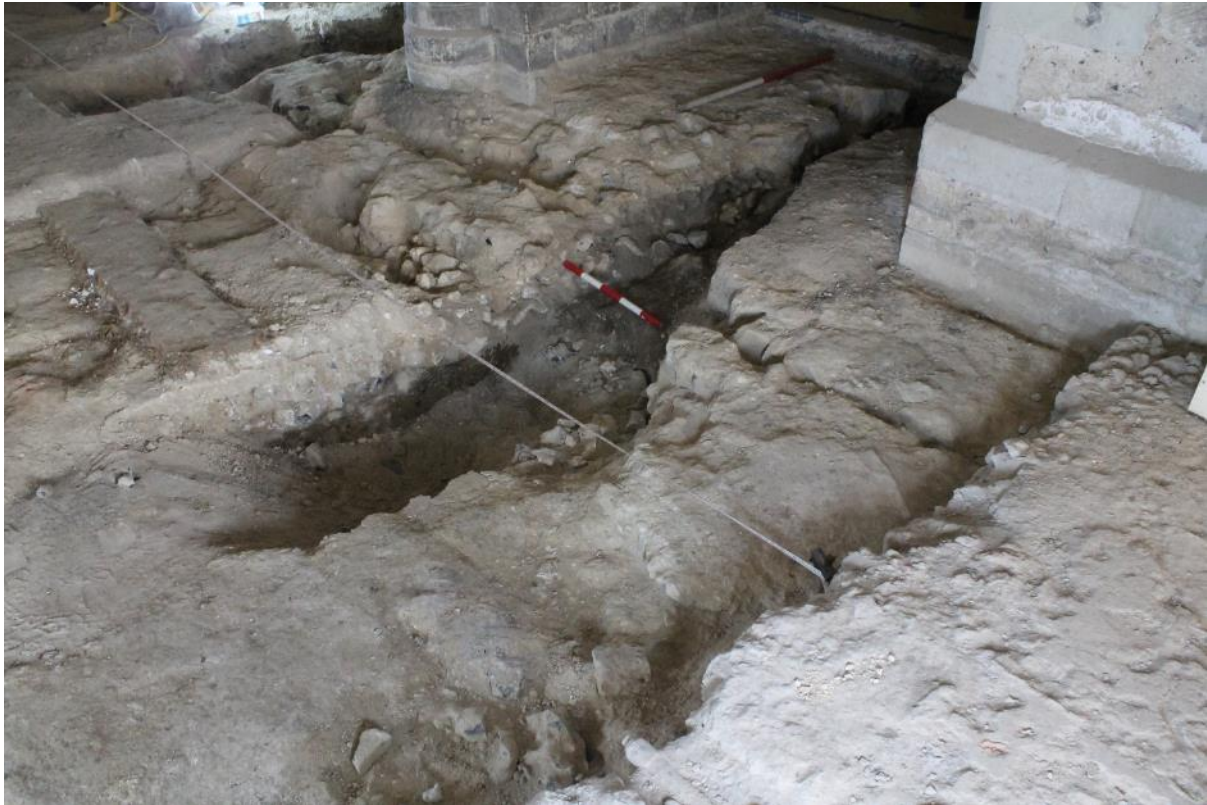
Plate 21: The east foundation of the Norman crypt, looking north-east with the piers at the entrance to the late 12th-century Ithamar Chapel beyond. The 50cm scale is on the east edge of the Norman foundations: the footings for the late 12th-century piers had been built close up to the earlier ones. The 1m scale rests on the south wall of the small chamber on the east side of the Norman east wall. The 'cut' through the east wall evident here must be one of Hope's trial trenches.
