Hidden Treasures, Fresh Expressions

Archaeological Surveys, Excavations and Watching Briefs at Rochester Cathedral 2011-2017

Graham Keevill and Alan Ward, with contributions by Cathy Keevill
On behalf of the Dean and Chapter of Rochester
March 2019

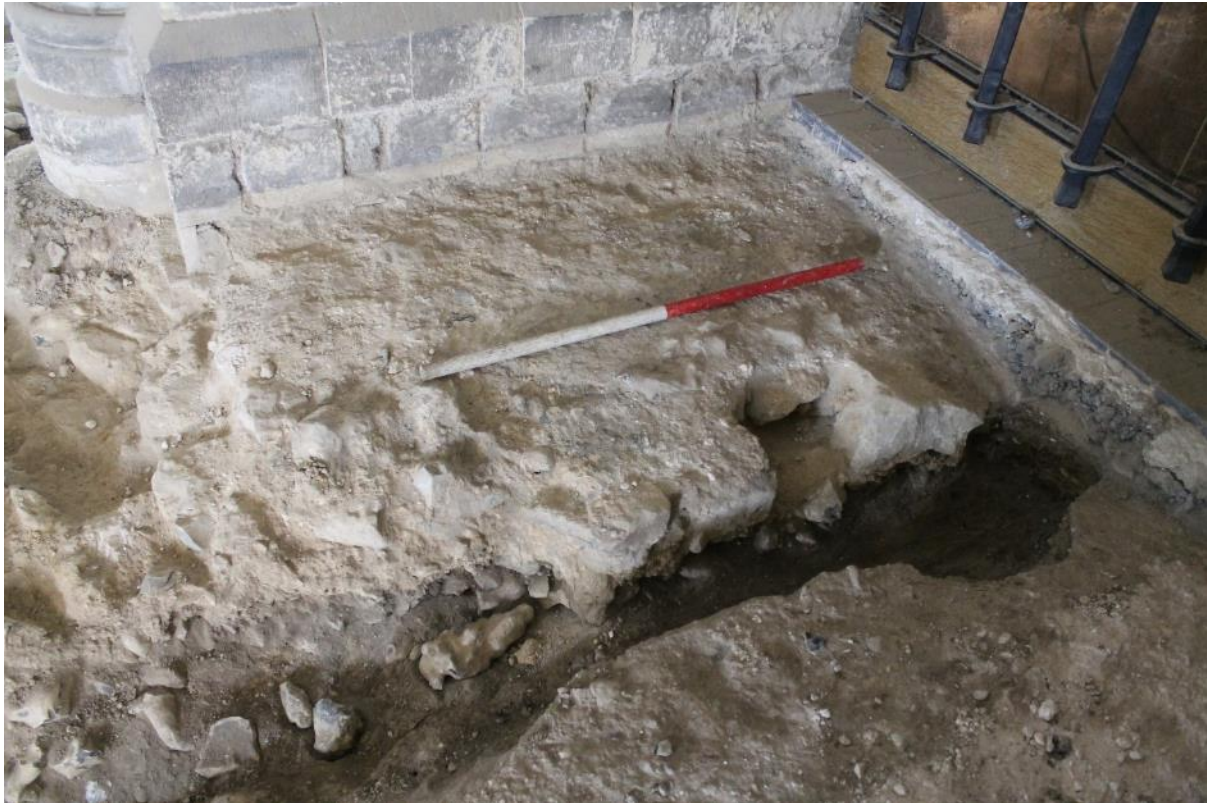
Plate 22: The south face of wall 724, with the dressed blocks showing that this was originally standing fabric. The foundations can be seen where one stone had been removed in antiquity. One of the late 12th-century piers at the entrance to the Ithamar Chapel had been built directly onto the Norman wall, though a small area of new footing was needed on its north side.

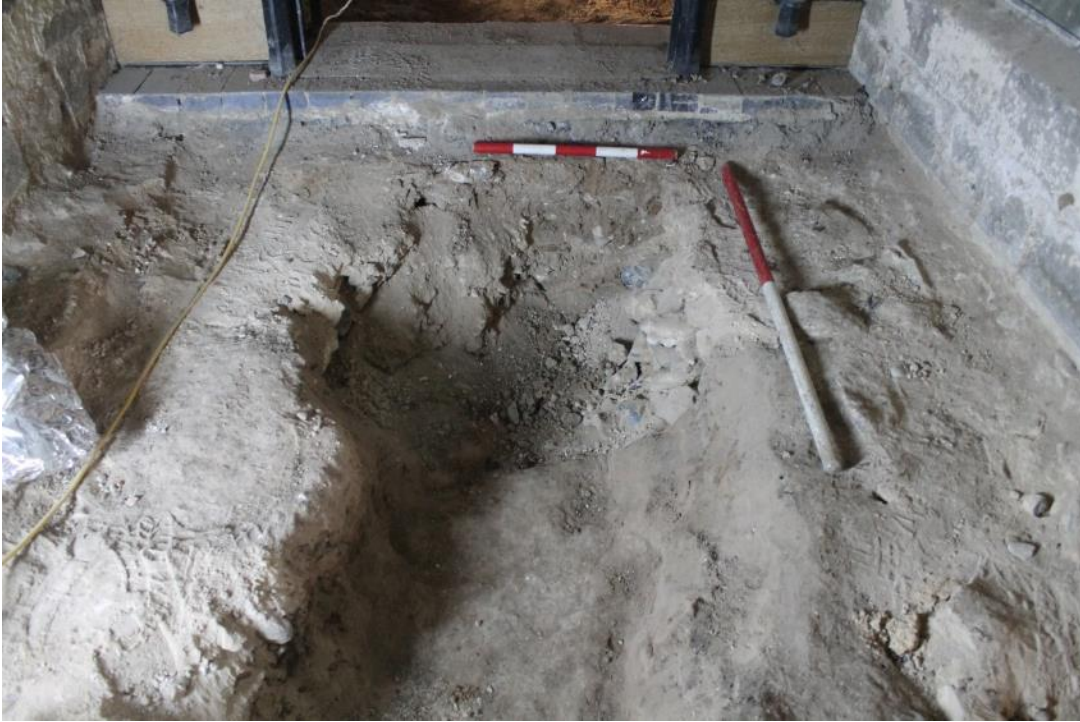
Plate 23: Hope's trial trench through the centre of the eastern annex re-excavated in December 2014. The long bones and skull were recovered later, when the area under the modern threshold at the entrance to St Ithamar's Chapel was excavated.

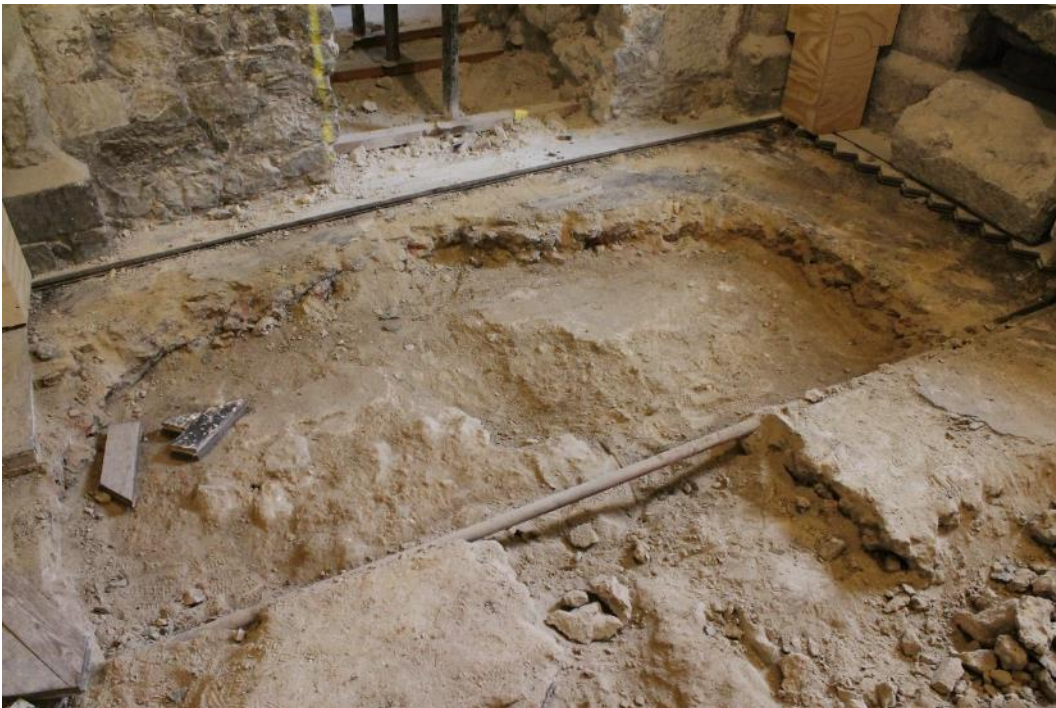
Plate 24: The south-east corner of the Norman foundations and buttress 1803 during initial cleaning. The straight edge of the south wall can be seen passing under the modern pipe.

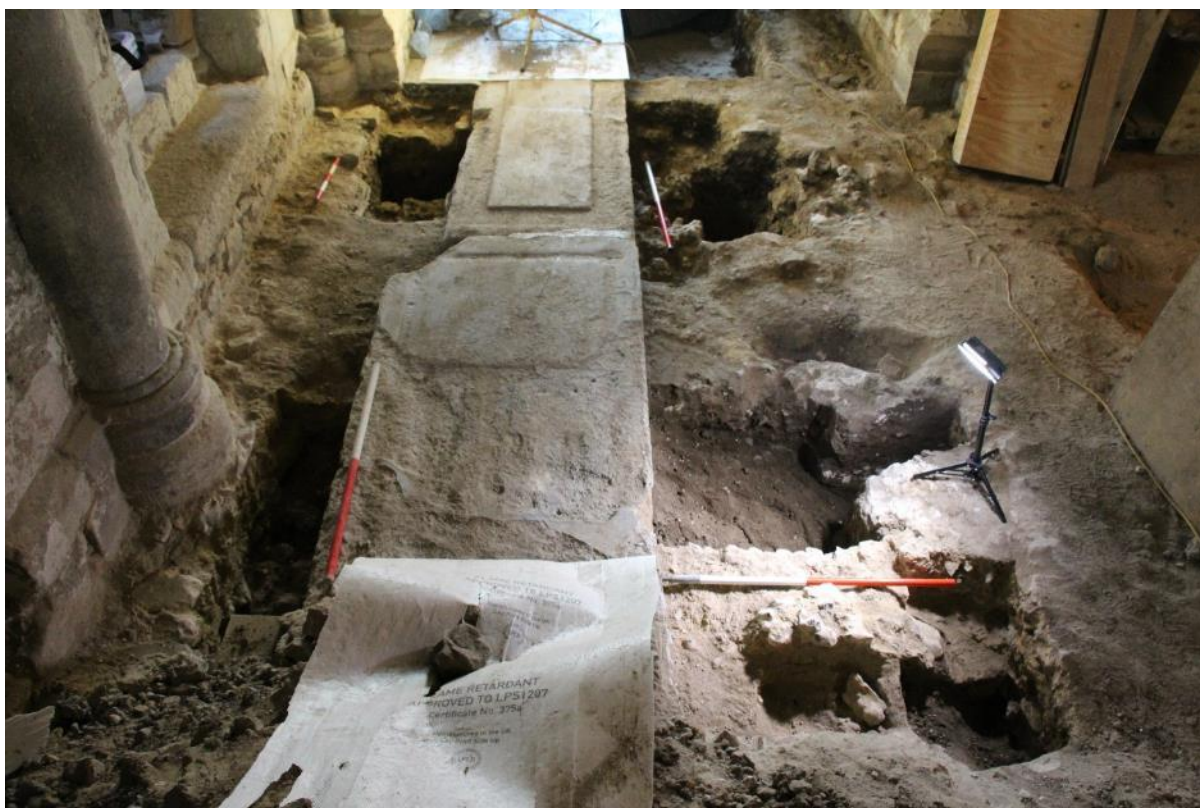
Plate 25: Walls 840 (in the foreground) and 842 (under the rear right scale), with the path of re-set ledger stones separating them. The north foundation of the Norman crypt is to the right, thickened at the east end (ie the north-east corner), perhaps to support a pilaster buttress. View looking east.

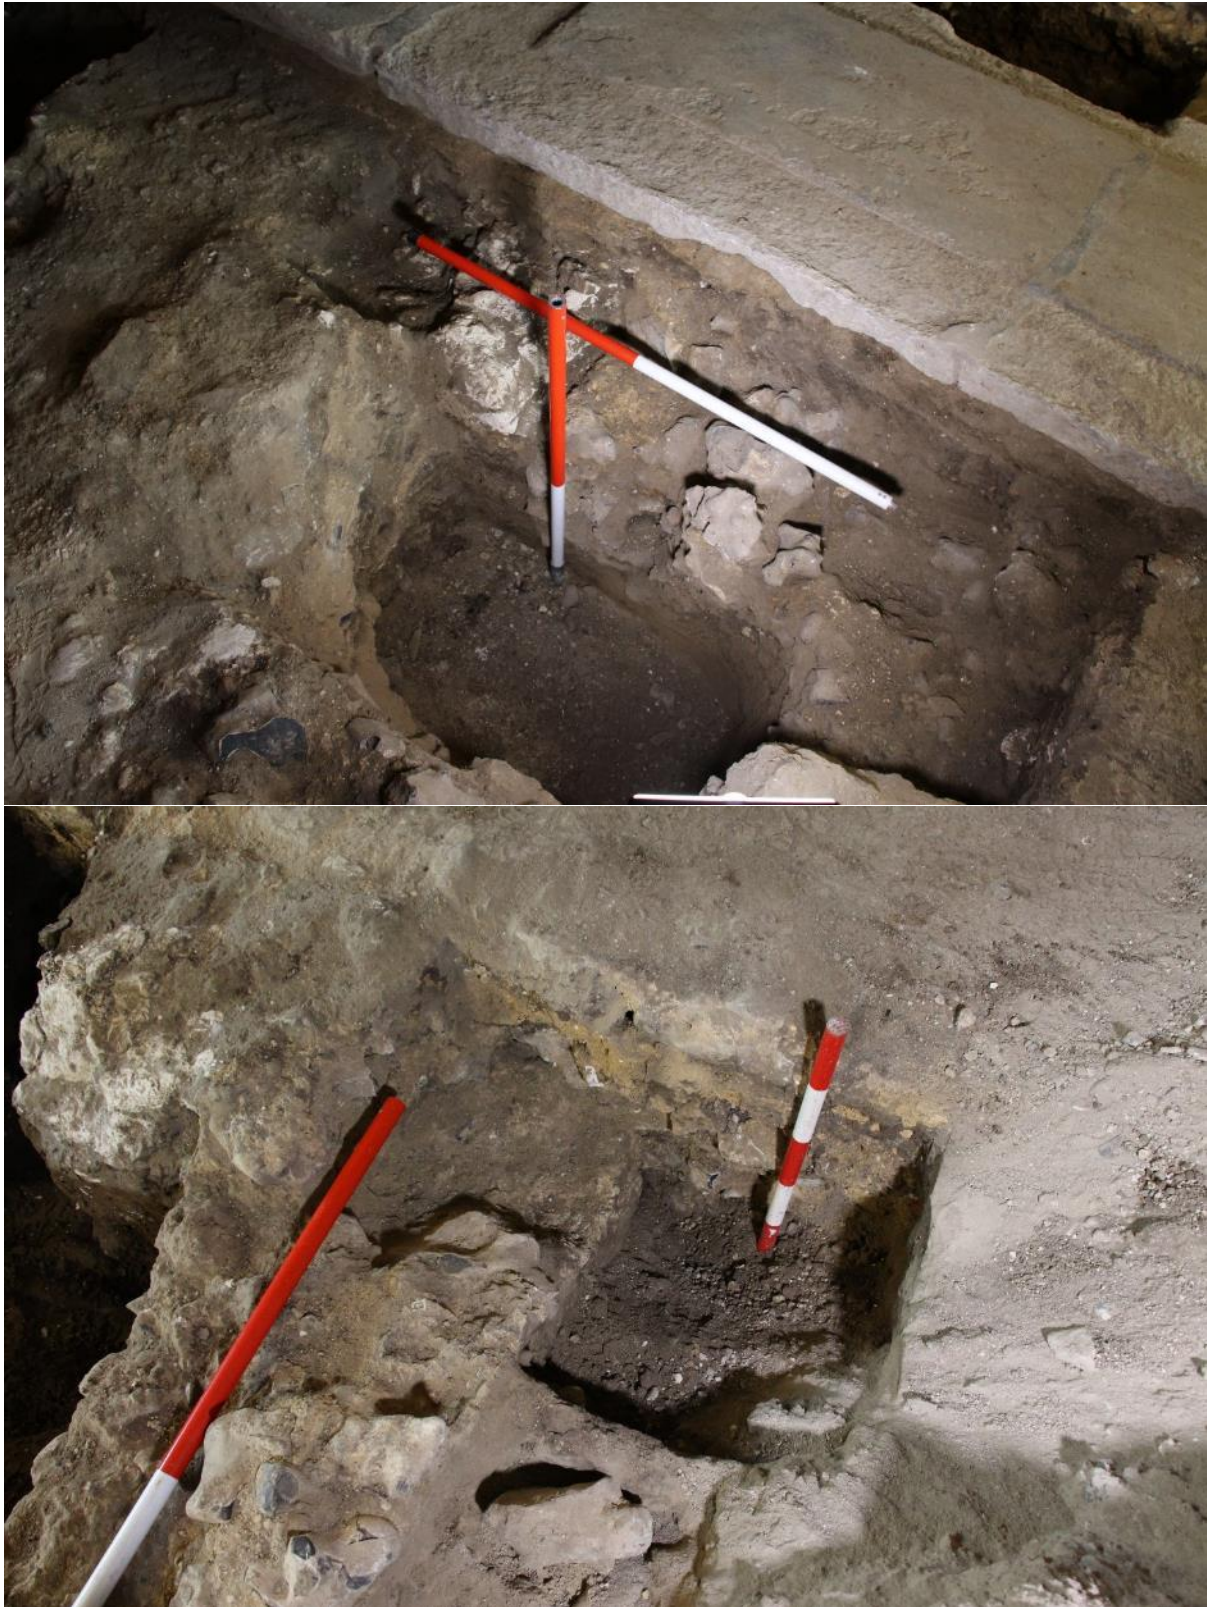
Plate 26: Top - wall 842 cut by grave 825, with part of raft 829/830 to the north (left). Bottom – wall 840, clearly bonded to the north wall foundation 684.

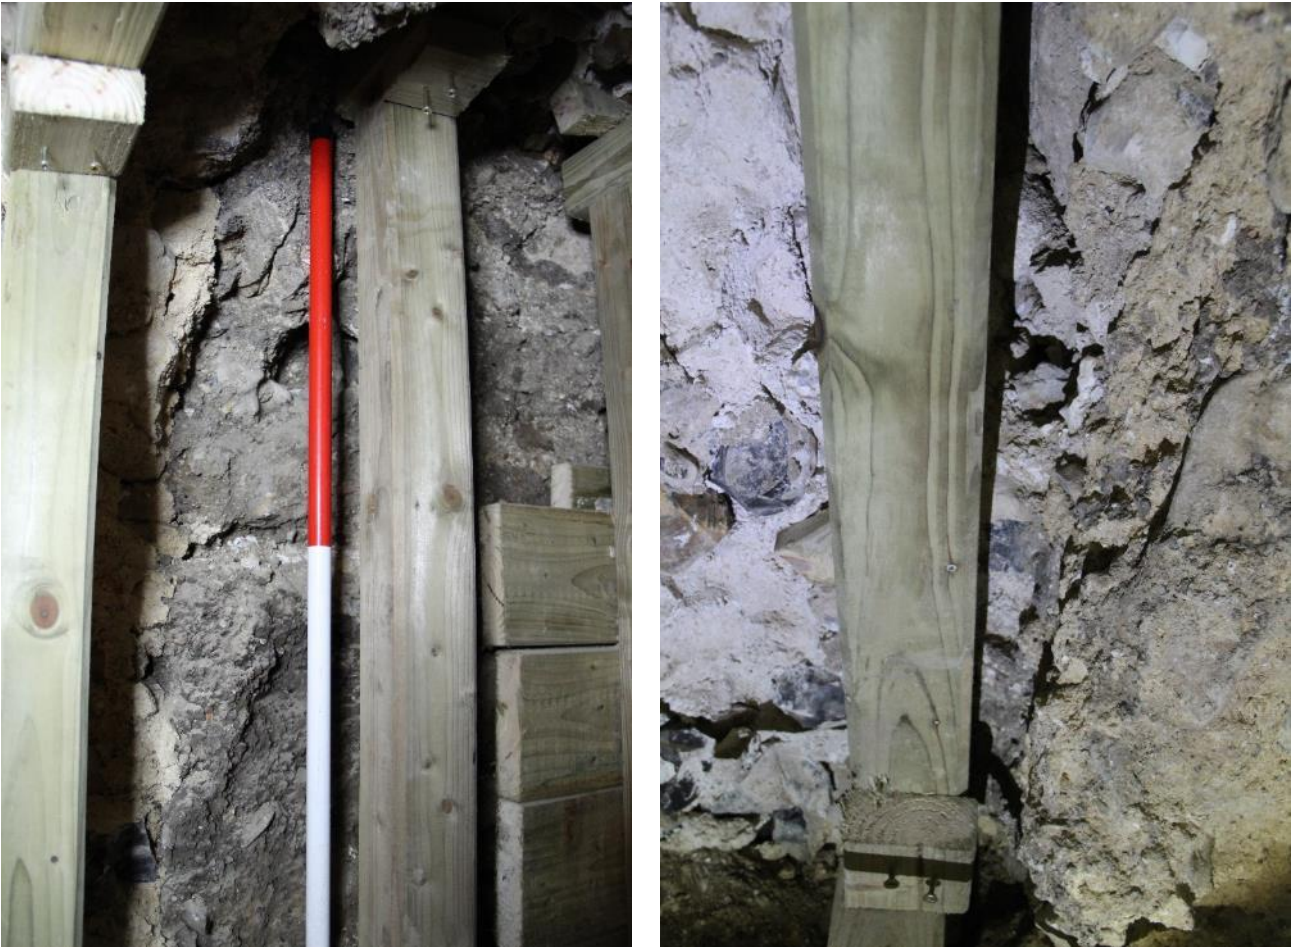
Plate 27: Left – the south face of Irvine’s tunnel re-opened. The dark earth and Roman soils can be seen behind the lower (white) portion of the 1m scale, with the made ground behind the red upper part – the sloping tip lines can be seen to the right. Note the rough rear (west) face of the crypt wall to the left. Right – the north side of the tunnel with mortar and flint floor 1221, and the crypt wall to the right. The shadows cast by the arc light clearly show that the floor both abuts and slightly overlaps with the wall.

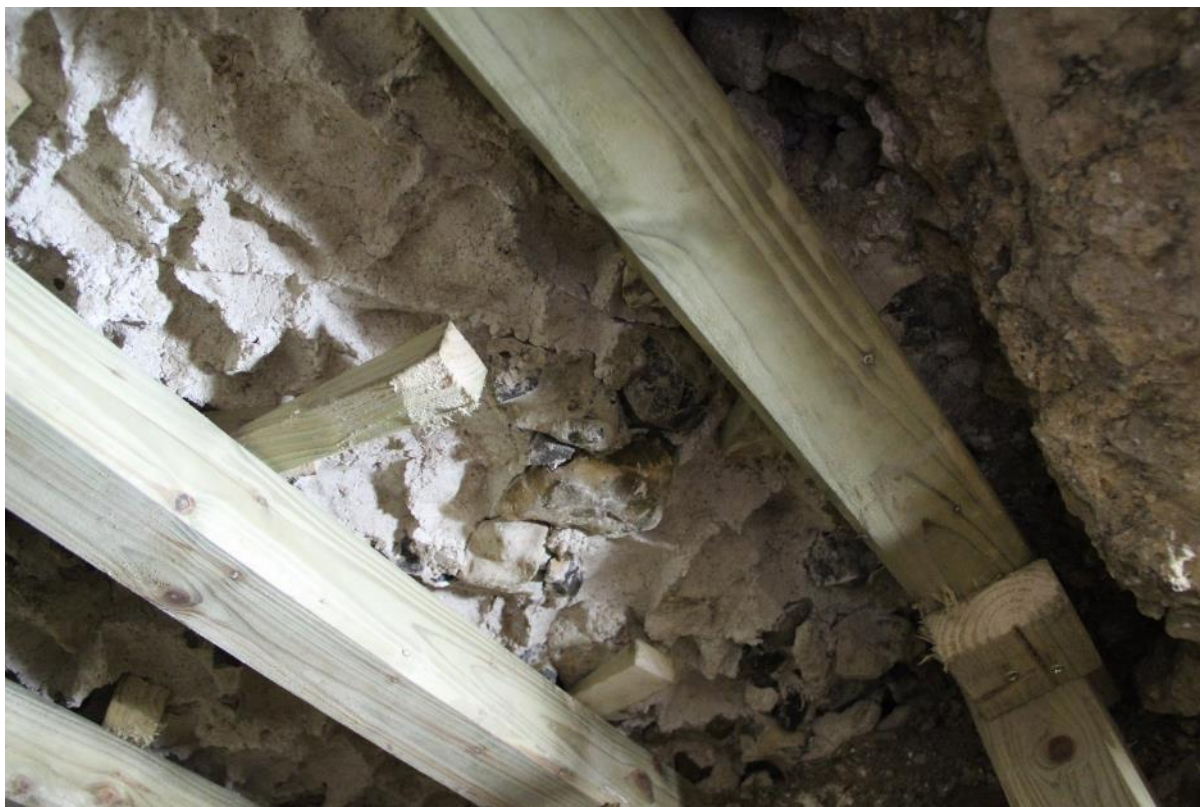
Plate 28: Mortar and flint floor 1221 formed the roof of Irvine's tunnel. The rough underside of the poured surface is very evident here. The small hole referred to in the following paragraph can be seen starting to open up to the right of the trench shore closest to the crypt wall.

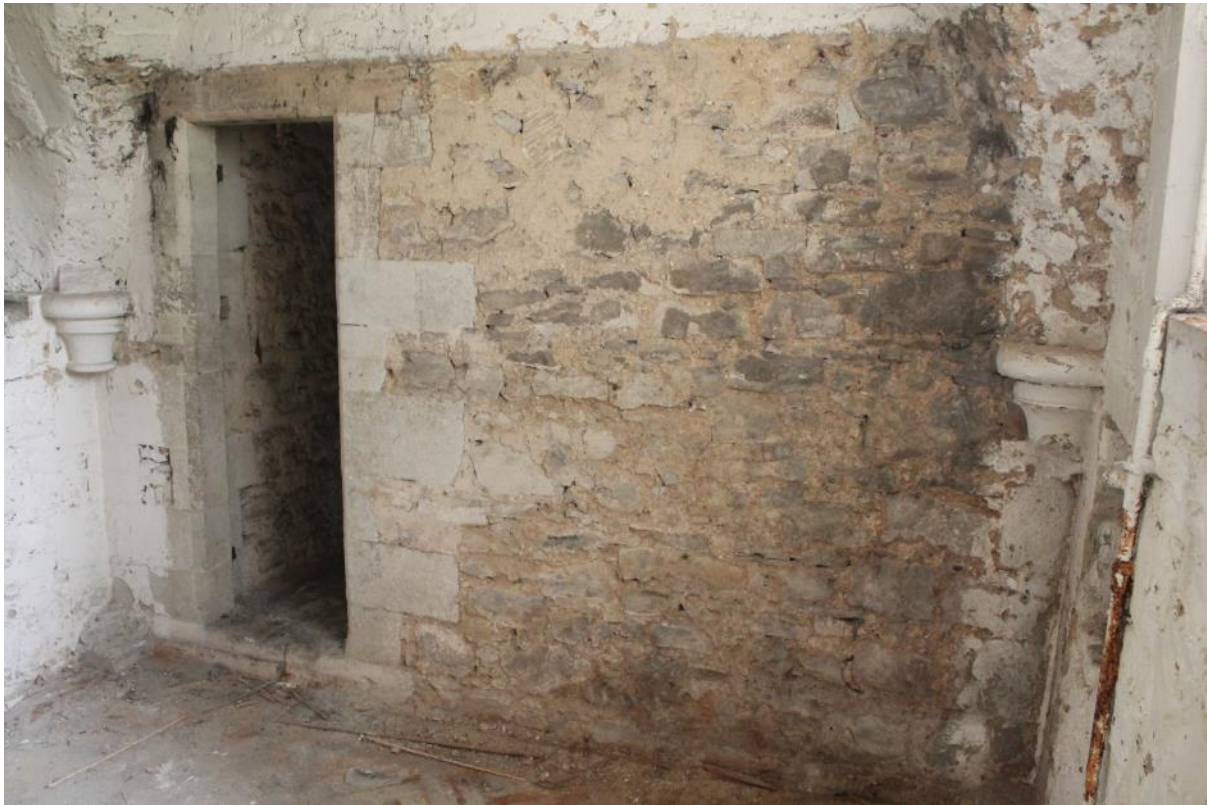
Plate 29: The east wall of the side-crypt (former cleaner's store) cleared of shelving in August 2014. The door to the mural passage and (blocked) stairs and the remnants of the engaged colonette shafts were exposed as expected.

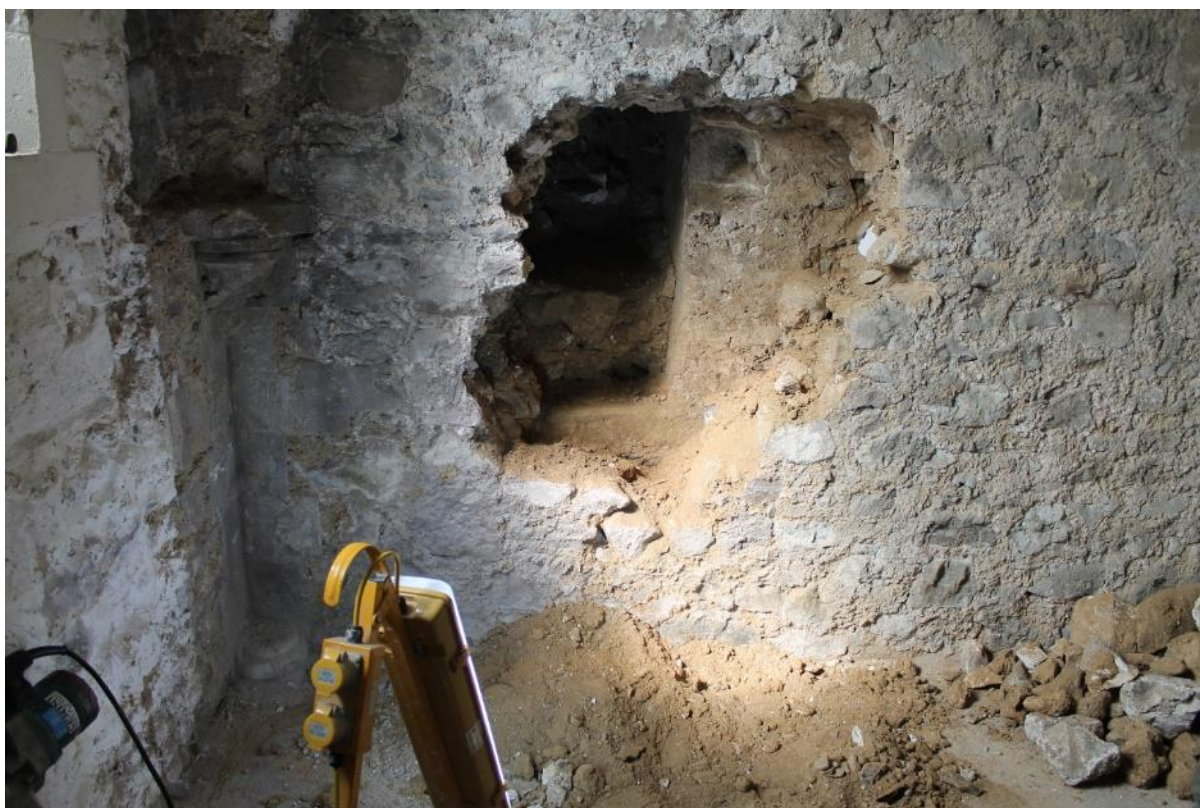
Plate 30: The gradually expanding hole in the west wall of the side crypt on 19 September 2014, a few days after the masonry had first been exposed. It was becoming clear that one side (the jambs) and a threshold step of a doorway had been found, but this had to pre-date the 1179 fire which had caused the rebuilding of the eastern arm and crypt of the Cathedral.

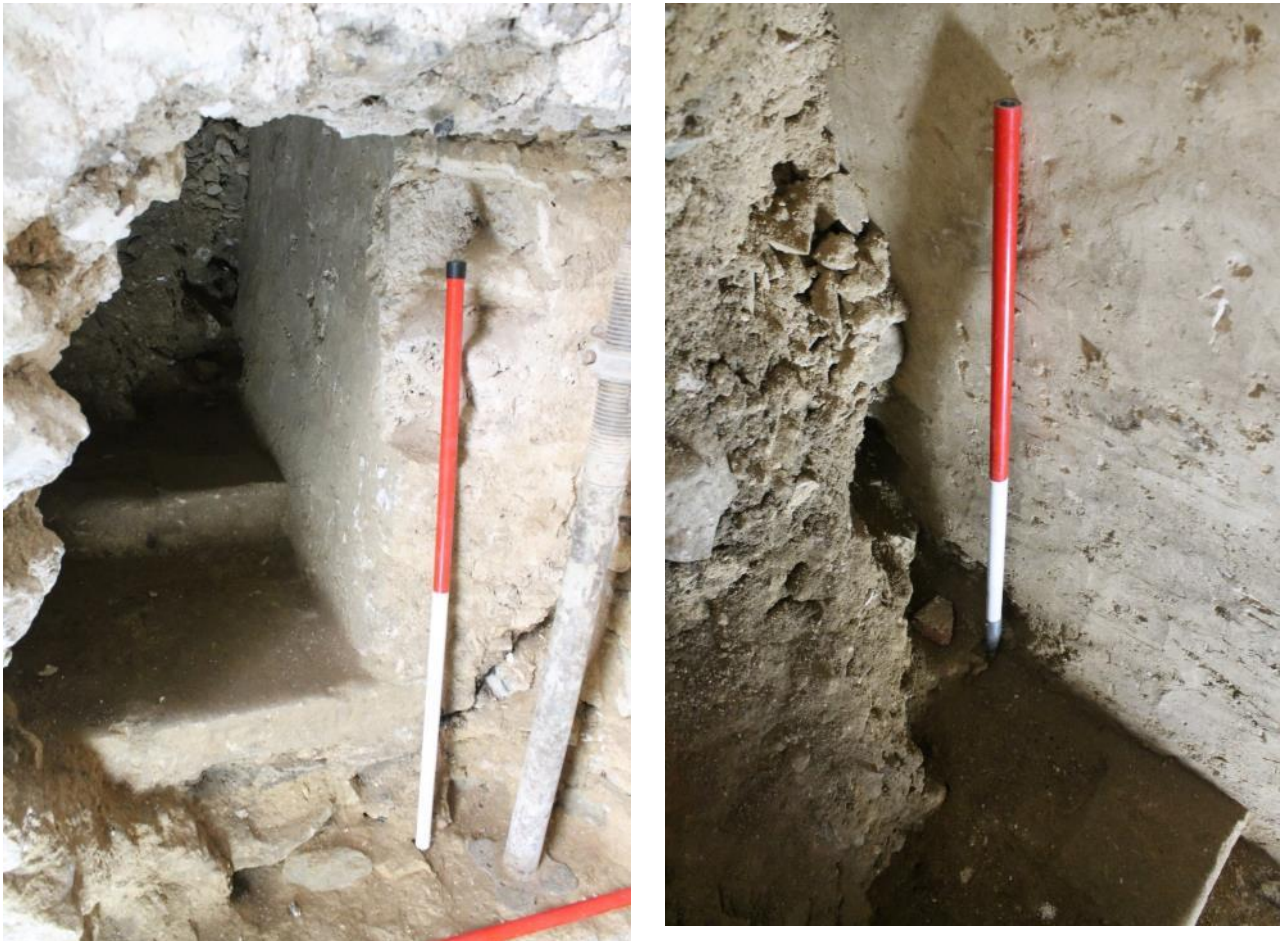
Plate 31: The north jamb (with its tufa blocks), threshold and step exposed behind the west wall of the store. The 'ghosts' of two further steps are visible in the right-hand photograph. Scale 1m in 0.5m sections.

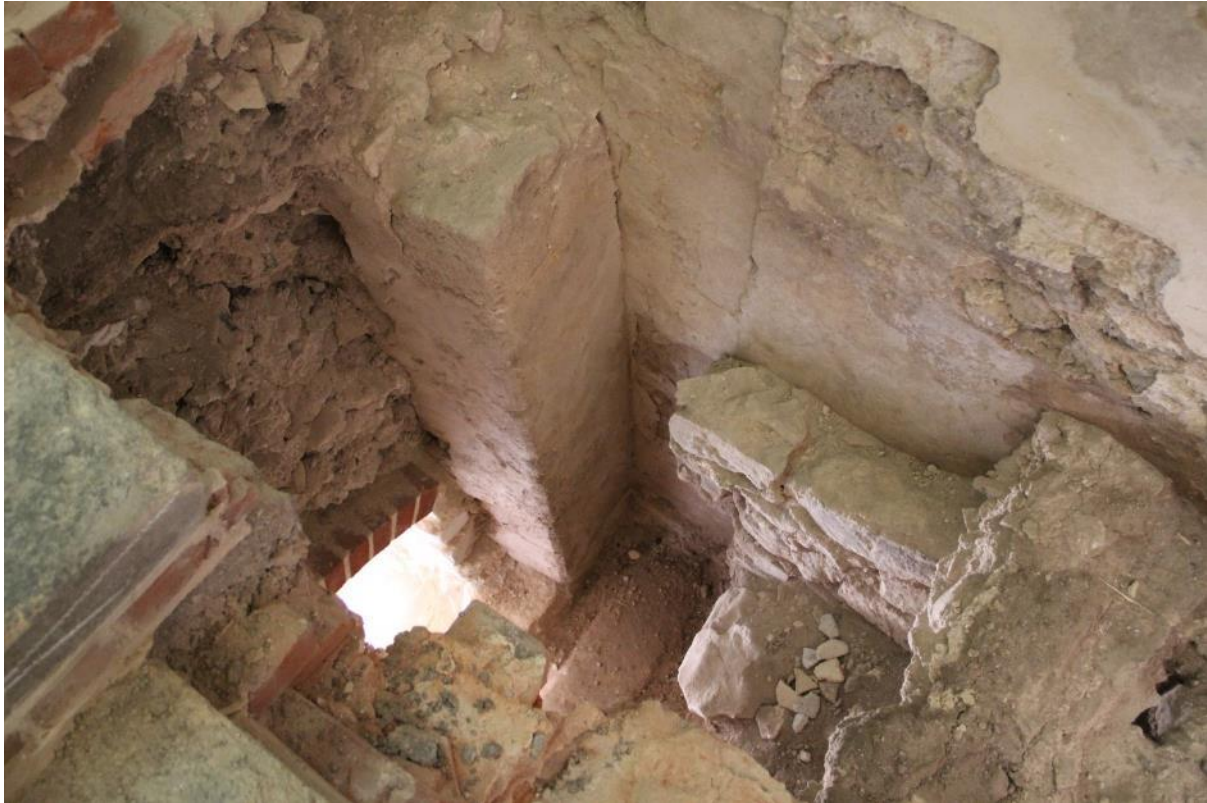
Plate 32: View of the Norman remains in the lift pit excavation, with jamb 214 butting against wall 215. The window jamb to the west of 214 is clearly visible, with infill 213 blocking it. Note the outline of the removed treads of the Kent Steps at top right as well.

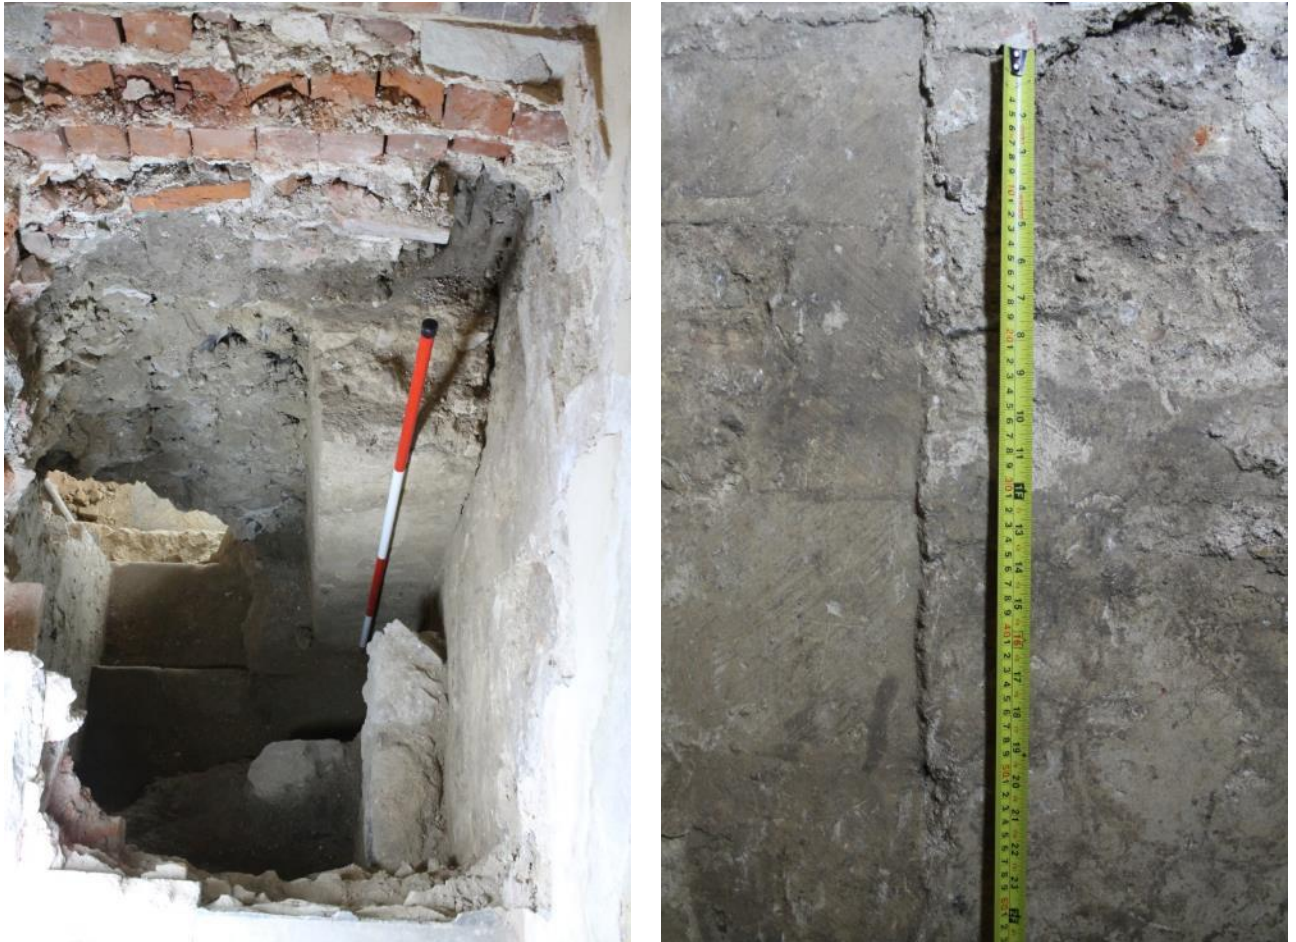
Plate 33: Left – the door jambs seen from behind, ie the west, with the wall of the South Quire Aisle to the right. Scale 2m, in 0.5m sections. Right – the jambs of what must be a window – it does not continue to floor level – with later (presumably late 12th/early 13th-century) rendered blocking to the right. Note the high quality and crisp condition of the tooling on the jamb stones.

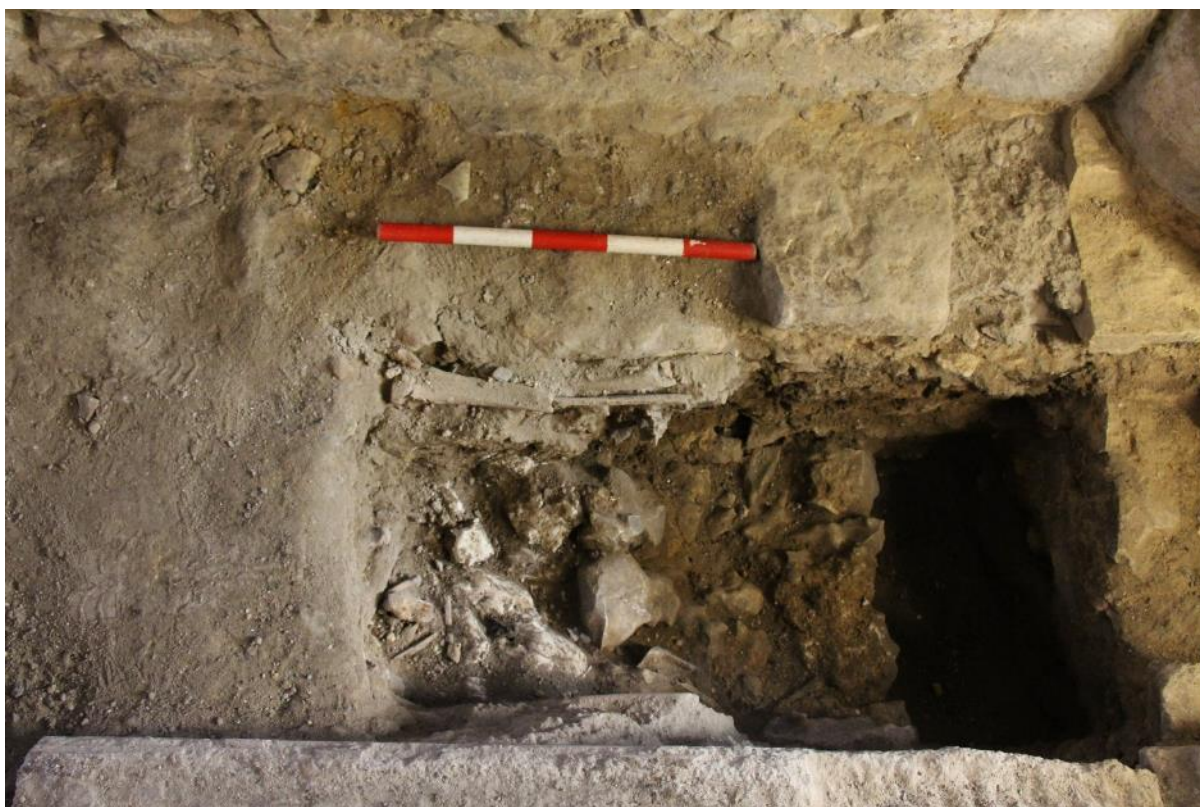
Plate 34: Medieval skeletons 3 and 4 against the north wall of the late 12th-century crypt, both much disturbed. Note that the bones overlie wall 842 of the Norman north annex.

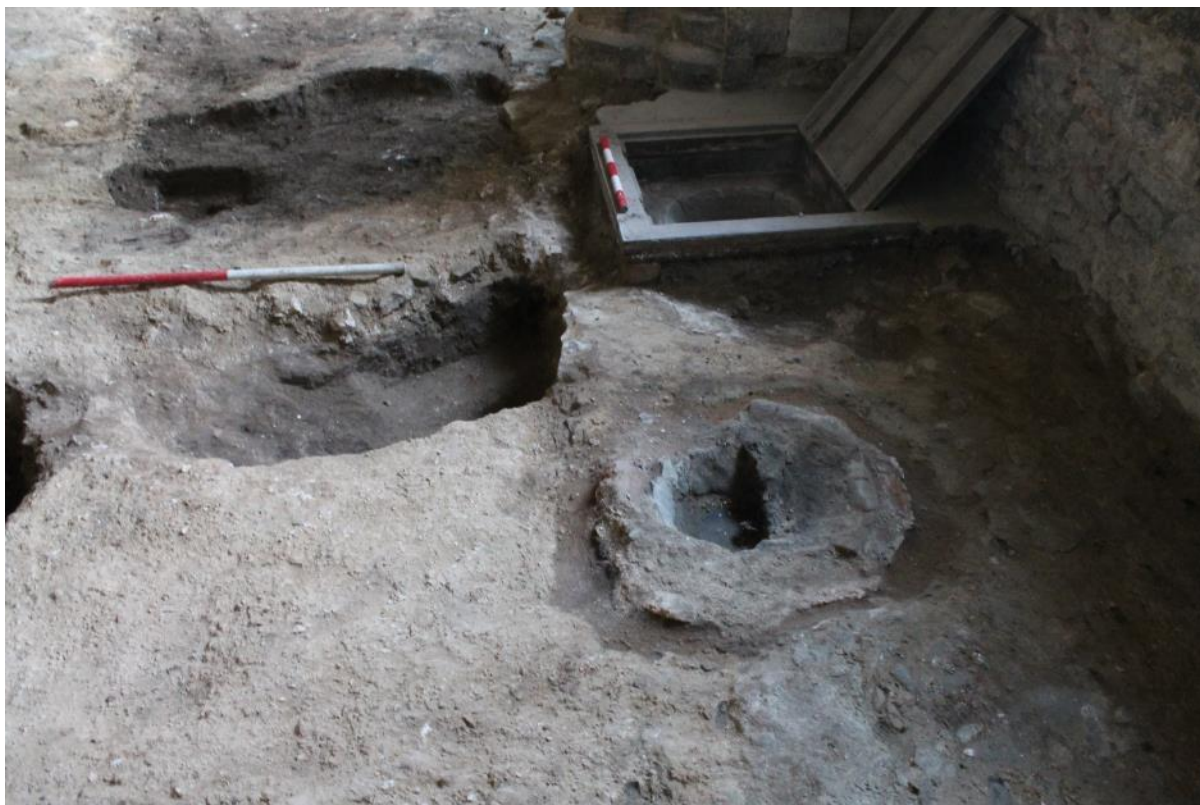
Plate 35: Post-medieval industrial features 703 (nearer the camera) and 701 (with the wooden cover lifted back). Feature 763 in front of the 1m scale may have been a medieval grave, but it lay well below the depth needed for the new crypt floor. It was therefore not excavated any further.

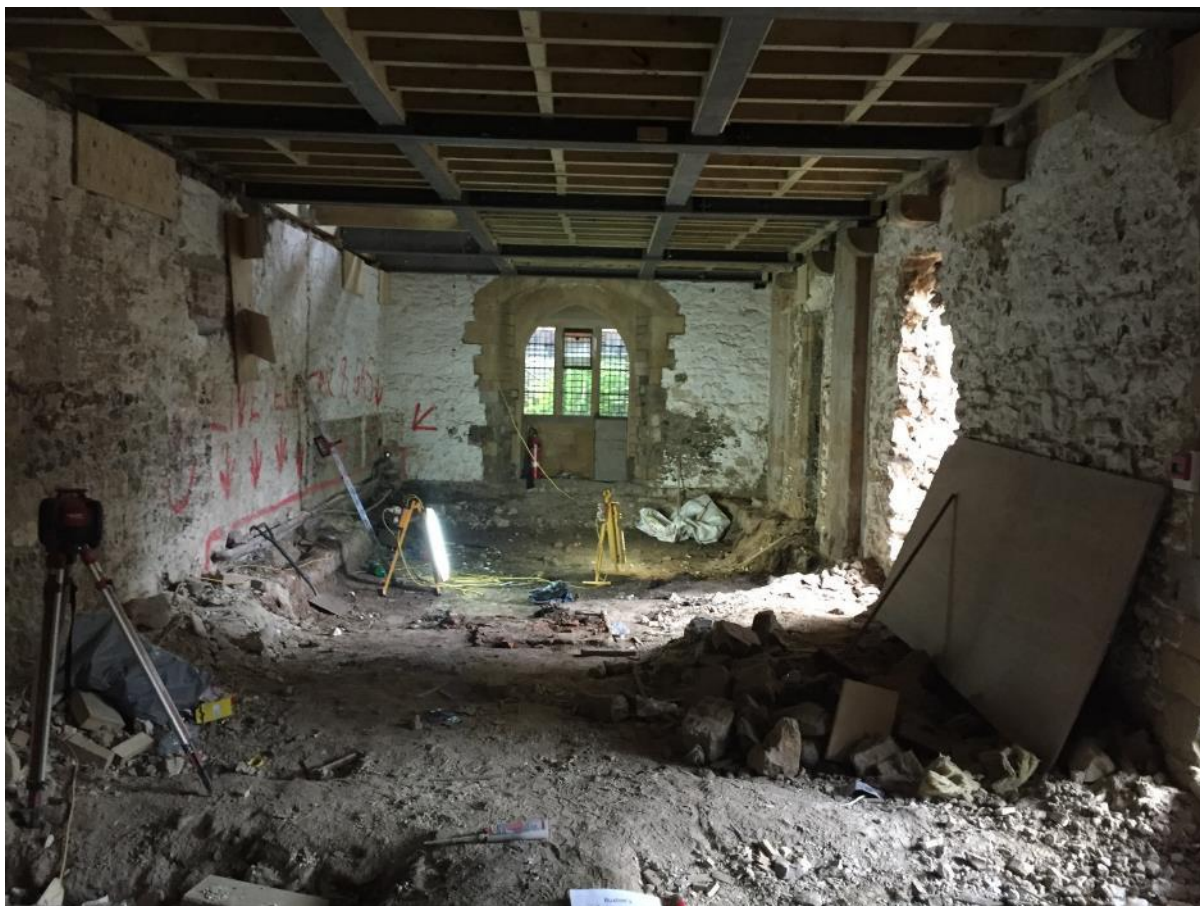
Plate 36: The vestry off the south-east corner of the main crypt under excavation in October 2015. The wall bench can be seen in the background, with tiled hearth 1111 in the centre of the room.

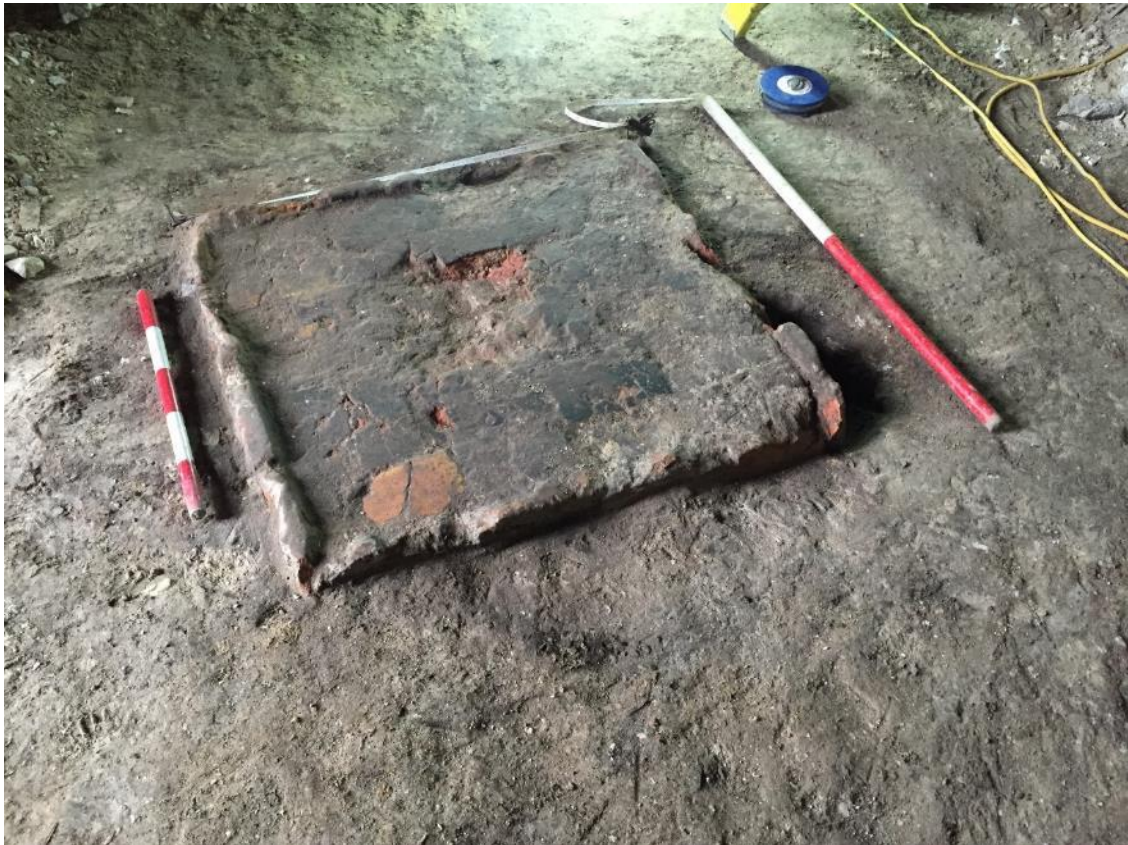
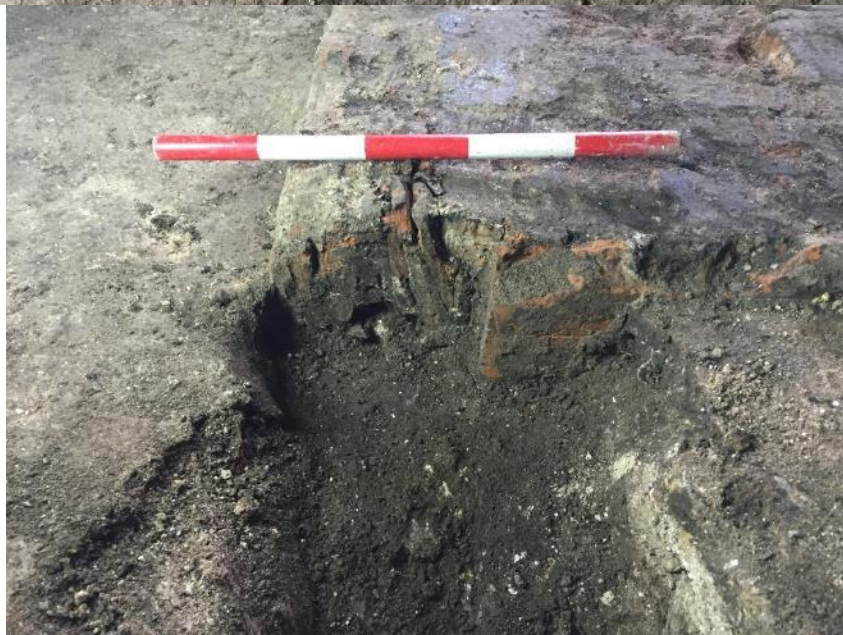
Plate 37: Top, hearth 1111 looking west. Bottom, edge-set tiles at the north-west corner of the hearth.

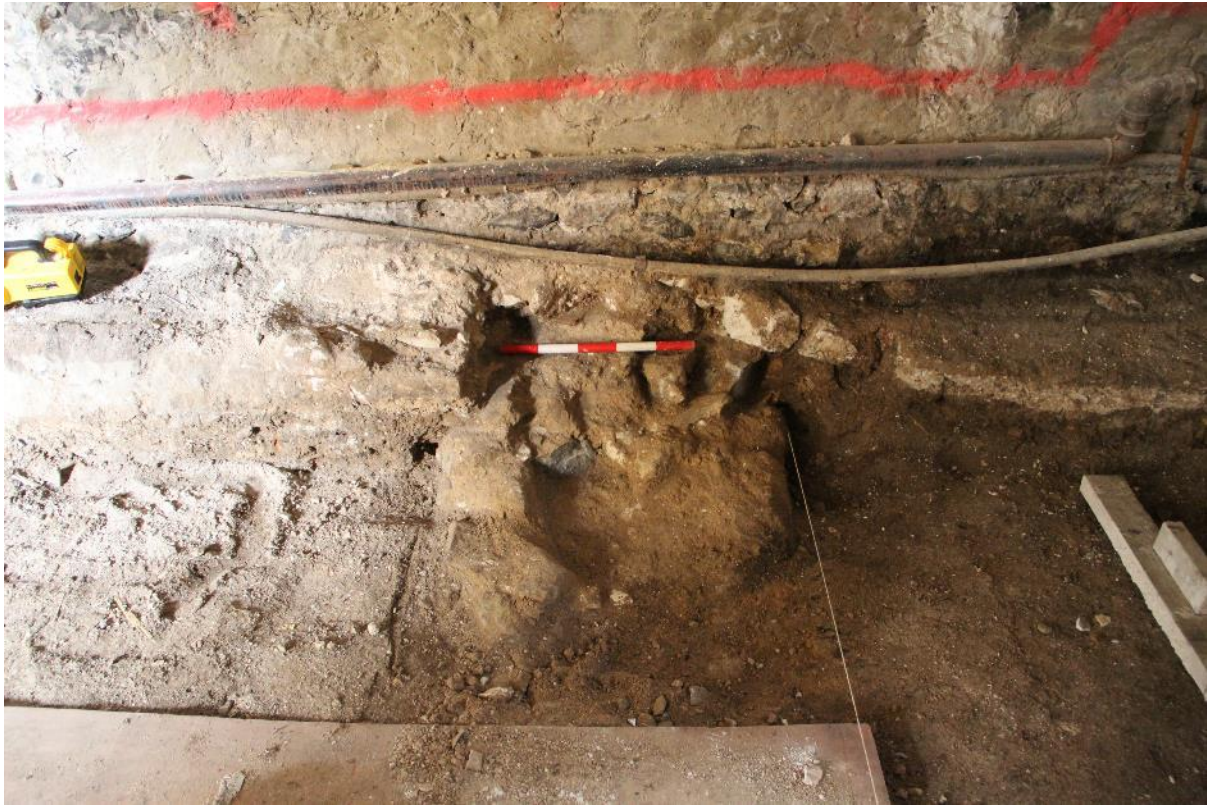
Plate 38: Remnants of stone bench 1106 and its bedding 1139, with earlier wall 1116 running south in the middle (with the 0.5m scale resting on it).

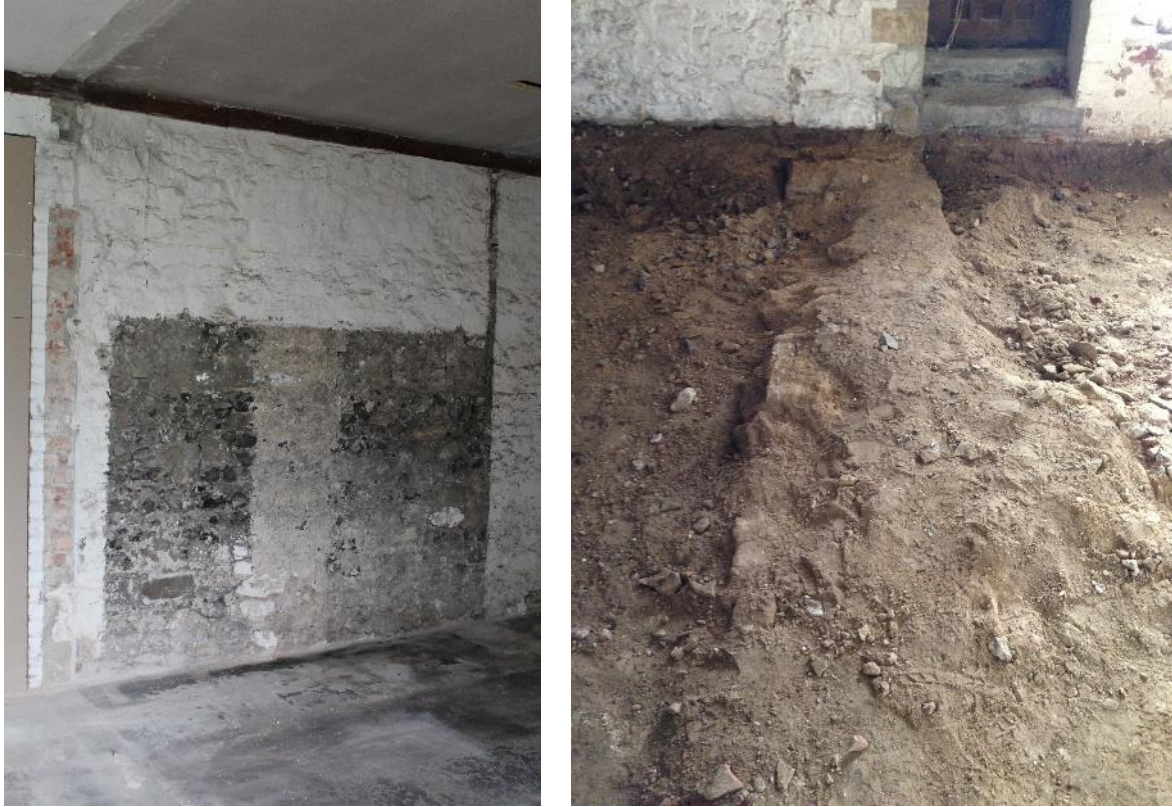
Plate 39: Left – the scar of wall 1160 in September 2014 after the vestry had been stripped out (the below-ground works would wait for another year, so the foundation was only exposed then). Right – foundation 1159 abutting the south wall of the vestry.

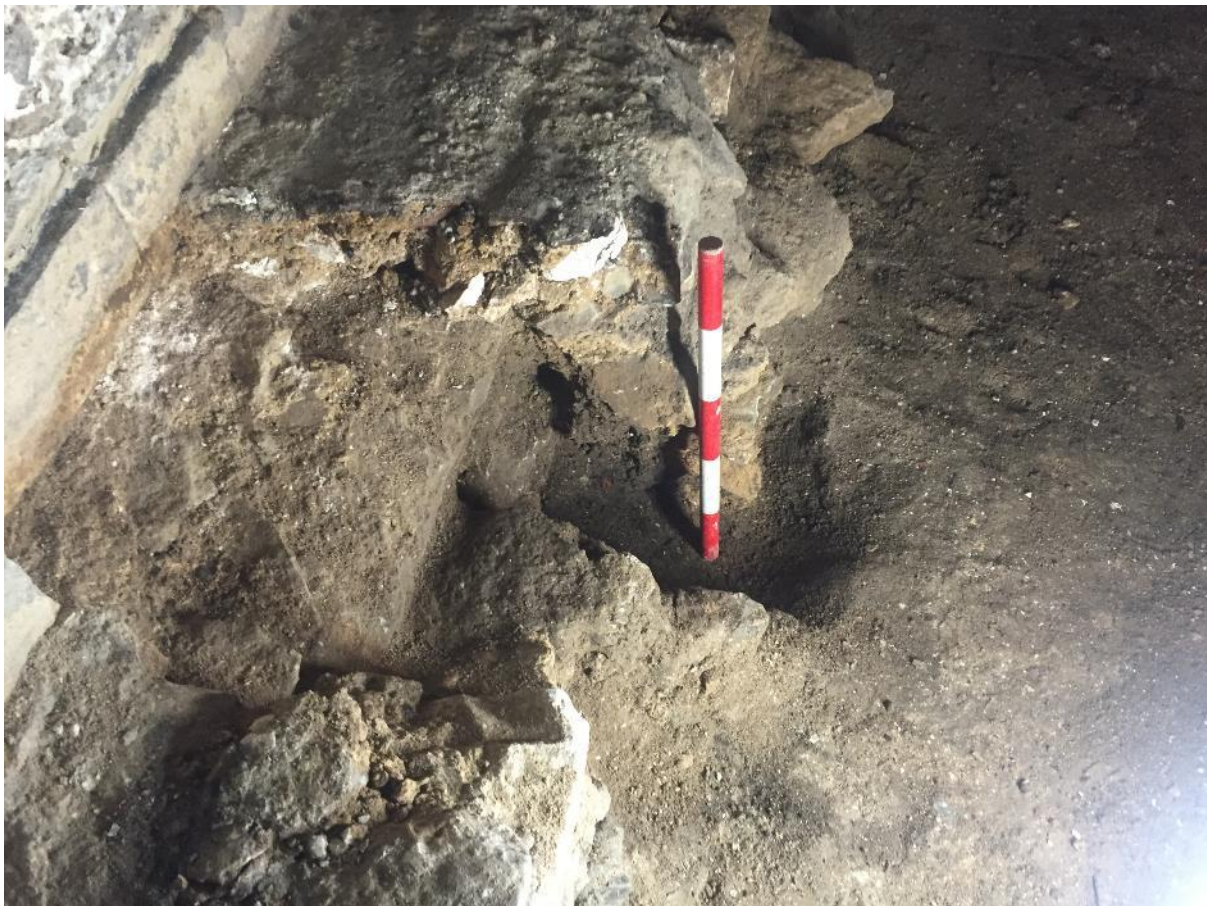
Plate 40: The south end of wall foundation 1116 (behind the 0.5m scale) butting against the Chapter House foundation (1102) to the left, with the stone bench (1105) oversailing both (partly removed to reveal the offset 1102). The base of the external face of the Chapter House itself can just be seen to the top left.

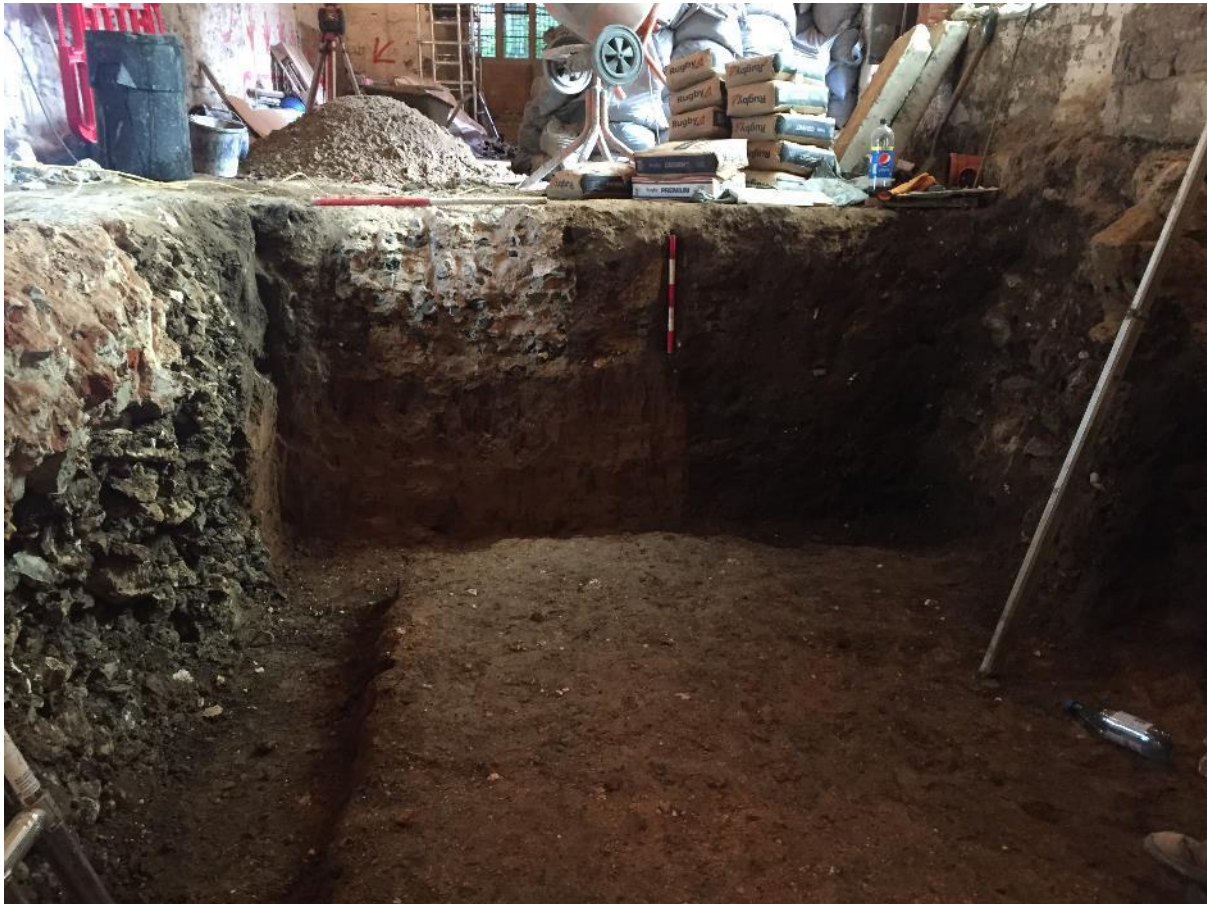
Plate 41: View of the vestry lift pit looking east. The south edge of the foundation/robber trench for wall 1173 lies immediately to the left of the 0.5m scale, while its north edge is on the left-hand side and below the flint-lined pit, 1166 (the 1m scale rests on this).
