ROCHESTER CATHEDRAL CRYPT

INVESTIGATIONS TO ASSESS TO EFFECTS OF LASER CLEANING

(Notes on sampling strategy discussions – Feb. 2015)

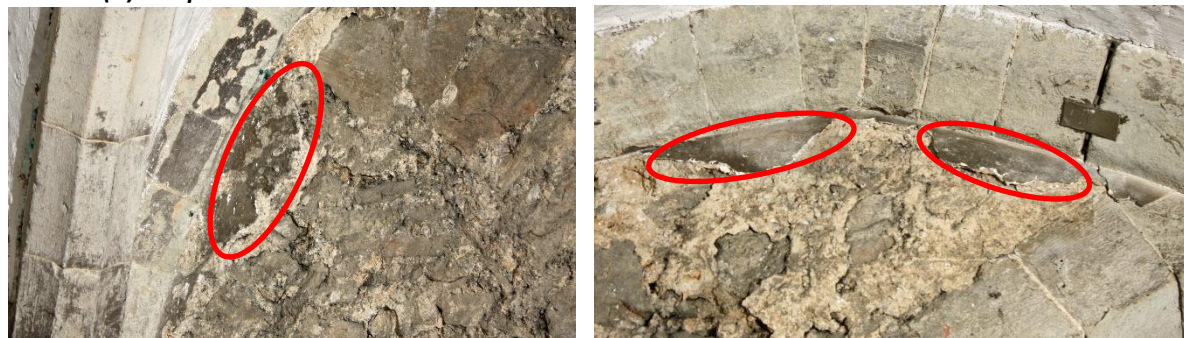
Fig 1. Islands of plaster and unpainted early-limewash on **Bay 19**, north wall before dusting and plaster edge repairs. It has not been established if the red ochre masonry line paint exists on these fragments. (A) samples (2 x limewash, 2 x paint(?)) = **4 (A) samples (max)**.

However, as discussed at the meeting, we are unlikely to find entirely untreated limewash or red paint on the laser cleaned vaults. In that event the (A) samples will be obtained from two untreated areas: Bay 19, north wall; recently revealed painted plaster on the arch soffit between Bays 13 and 20.

Possible (A) sample locations:

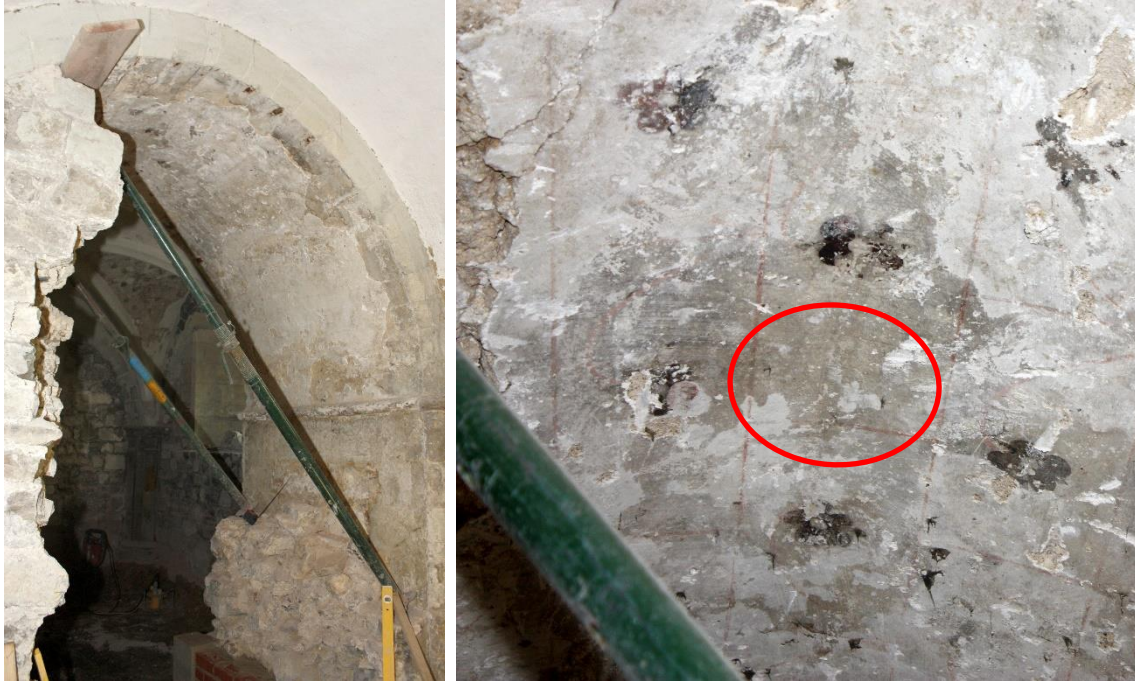
Fig 2. Recently revealed painted plaster on the arch soffit between Bays 13 and 20. This area had been blocked in since 1776-78. The whole soffit is untreated but the discoloured patches more closely resemble pre-treatment Phase 1 surfaces. (A) samples (2 x limewash, 2 x paint) = 4 (A) samples.

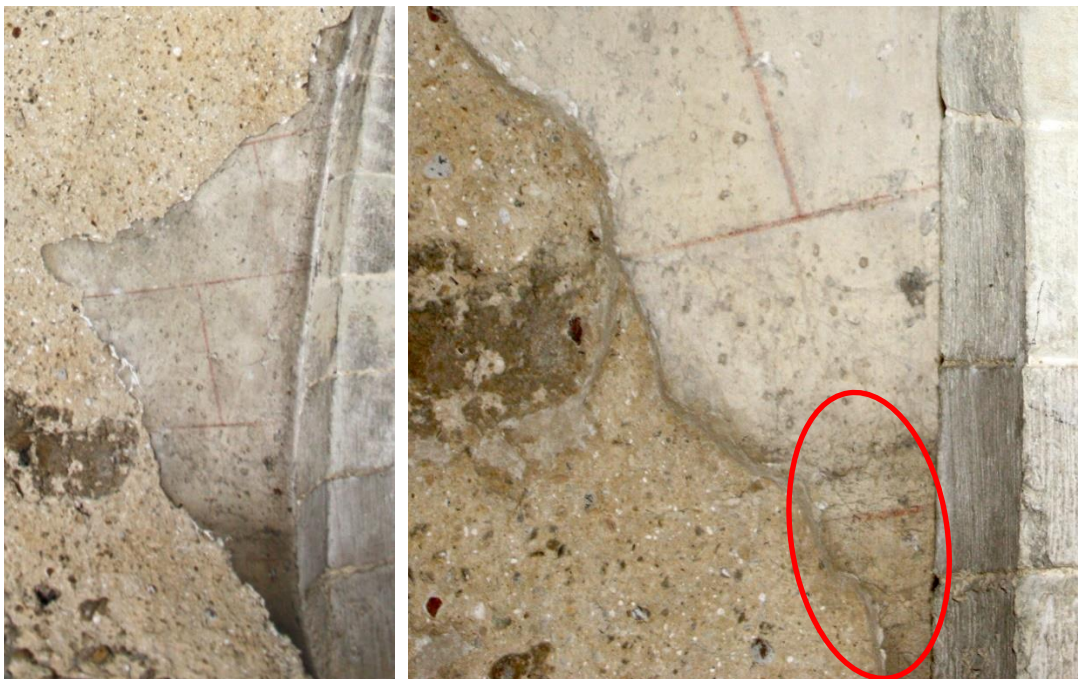
Fig 3. Island of plaster on Area L soffit before and after TAC cleaning. The discoloured lower part is the most suitable for (B) samples. (B) samples (2 x limewash, 2 x paint) = 4 (B) samples.

Similarly, we are unlikely to find TAC cleaned only limewash on the laser cleaned vaults and soffits, except for the Bay 13b and c (where the laser was used sparingly). In that case the (B) samples will be obtained from the discoloured lower part of the fragment of soffit plaster in Area L.

Possible (B) sample location:

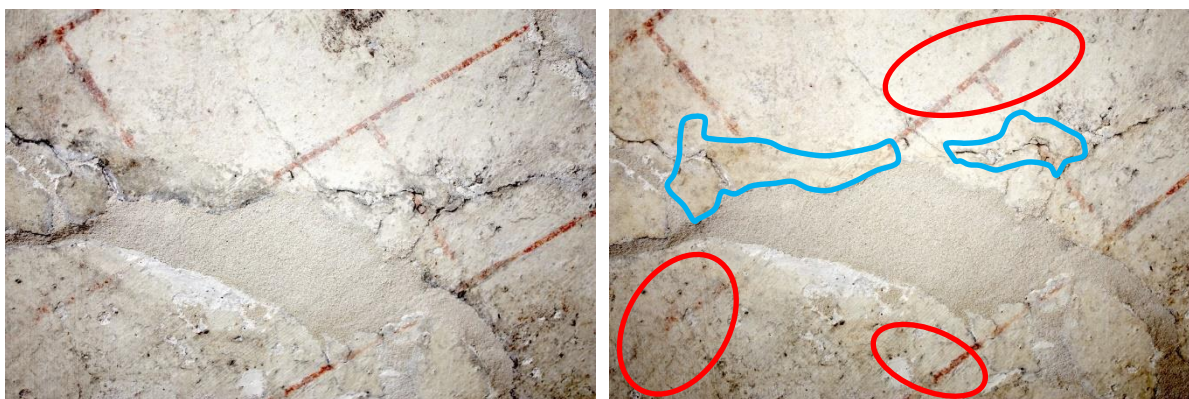
Fig 4. Detail of ingrained dirt along the edges of a crack in the **Bay 13c** vault plaster, before (*left*) and after (*right*) spot laser cleaning. Areas outlined in red are suitable for B samples but only for comparison with the adjacent (C) sample areas (outlined in blue) since, uniquely, the whole of Bay 13 was overpainted at an early stage with a plain red ochre layer. (B) samples (2 x limewash, 2 x paint) = **4 (B) samples**. (C) samples (2 x limewash, 2 x paint) = **4 (C) samples**.

Possible (B) and (C) sample locations:

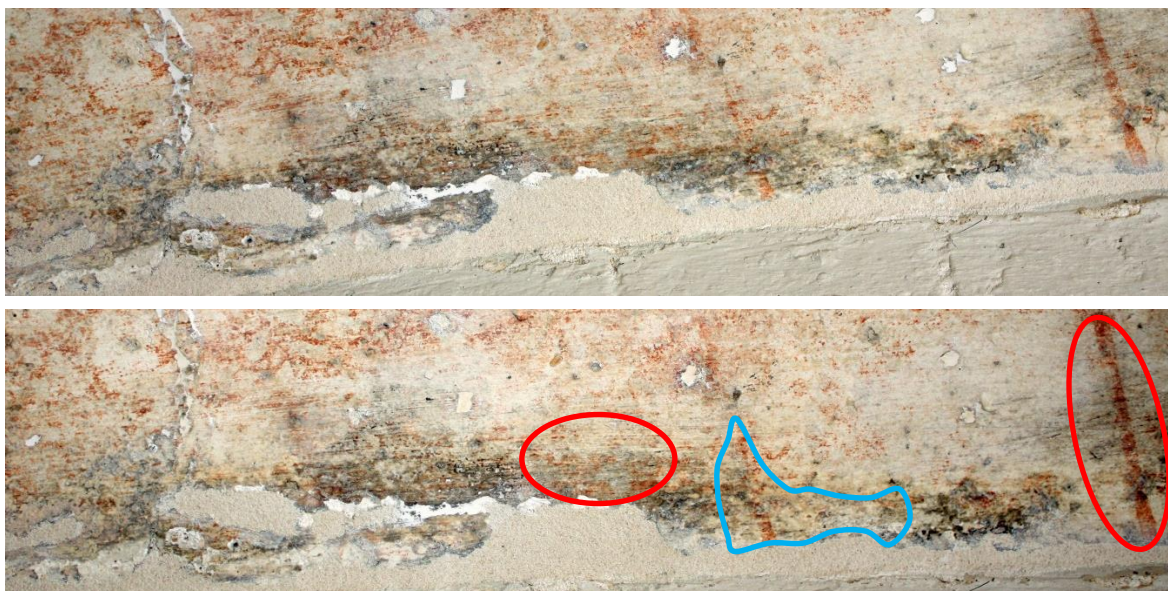
Fig 6. Details of **Bay 13a** before (*top*) and after (*bottom*) spot laser cleaning. . The areas outlined in red is suitable for (B) samples but only for comparison with the adjacent (C) sample areas (outlined in blue) since, uniquely, the whole of Bay 13 was overpainted at an early stage with a plain red ochre layer. (B) samples (2 x limewash, 2 x paint) = **4 (B) samples**. (C) samples (2 x limewash, 2 x paint) = **4 (C) samples**.

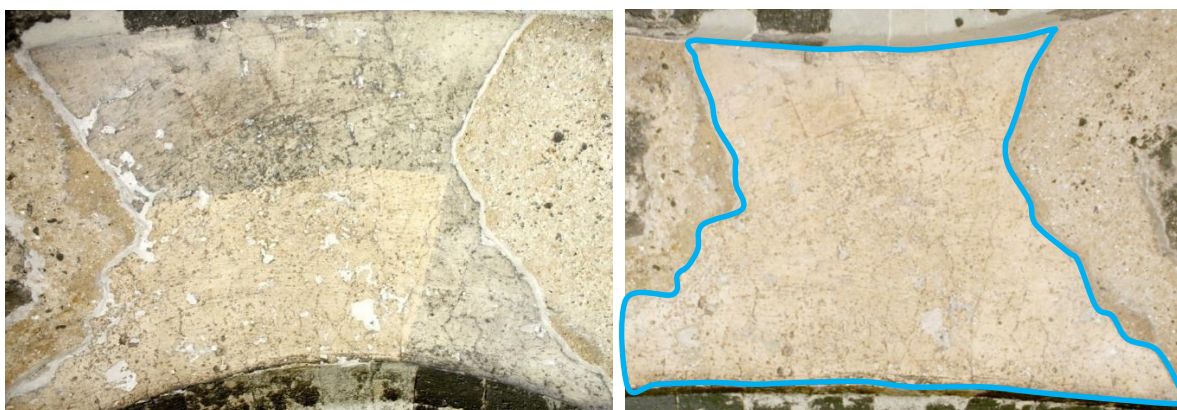
Fig 7. Details of **Area K** soffit plaster during (*left*) and after laser cleaning (*right*). It is unlikely (B) samples will be obtained from this arch soffit plaster. The area outlined in blue is suitable for (C) samples (2 x limewash, 2 x paint) = **4 (C) samples**.
